ATSB TRANSPORT SAFETY REPORT

Aviation Occurrence Investigation AO-2007-026

Rotor Strike – Maryfield Station, NT

Robinson Helicopter Company R22 Beta

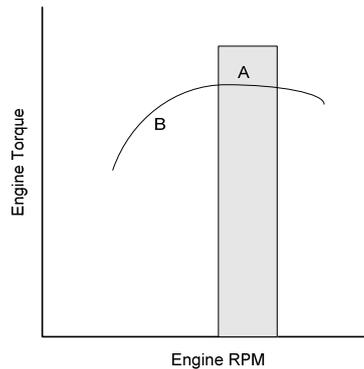
Figure 4: Typical piston engine torque vs. RPM characteristics²⁰

The operation of a piston-engine helicopter within the normal RPM range (shaded region 'A' in Figure 4) results in a minimal variation in the available engine torque. However, as the RPM reduces below that operating range and into region 'B', there is an increasingly significant reduction in the available engine torque and power available to drive the rotor. In consequence, there can be a reduction in rotor RPM.

Overpitching occurs when the rotor RPM reduces to the point that the engine cannot produce sufficient power to overcome the increased drag on the rotor as a result of the pilot acting to maintain height. The effect is a further reduction in RPM, and a subsequent loss of height.
