ATSB TRANSPORT SAFETY INVESTIGATION REPORT

Aviation Occurrence Report – 200700357

Engine failure
28 km west-southwest of Warialda, NSW
2 February 2007
VH-HRT
Bell Helicopter Company 407

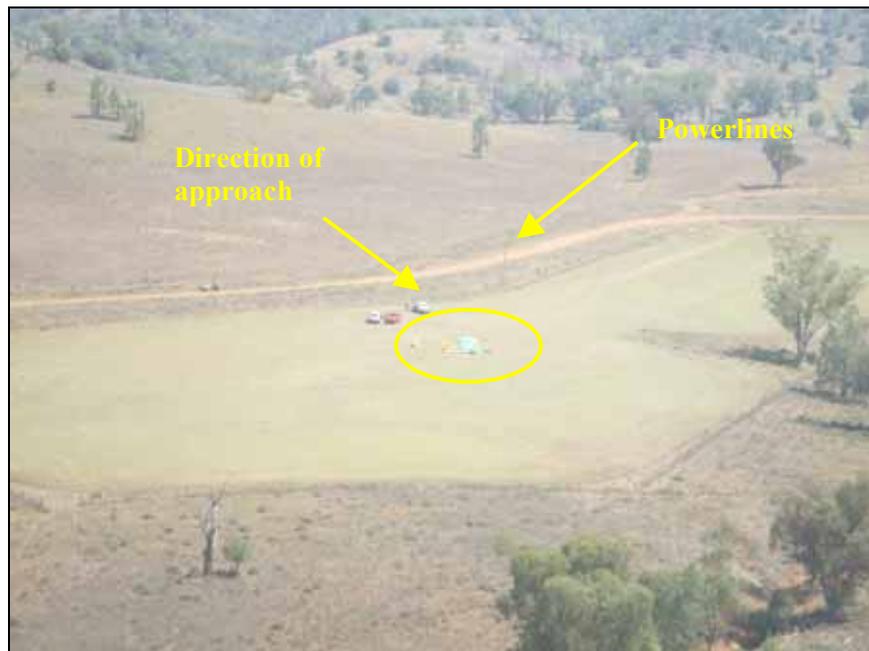
Figure 1: Helicopter accident site circled in yellow

The pilot reported that during the approach to land, the helicopter's altitude was high for the approach profile and that he manoeuvred the helicopter to decrease altitude. Upon getting closer to the emergency landing area (figure 1), the pilot
