Aviation Occurrence Investigation AO-2007-049

Engine power loss (fuel tank exhaustion)

VH-TMP

Cessna Aircraft Company C404

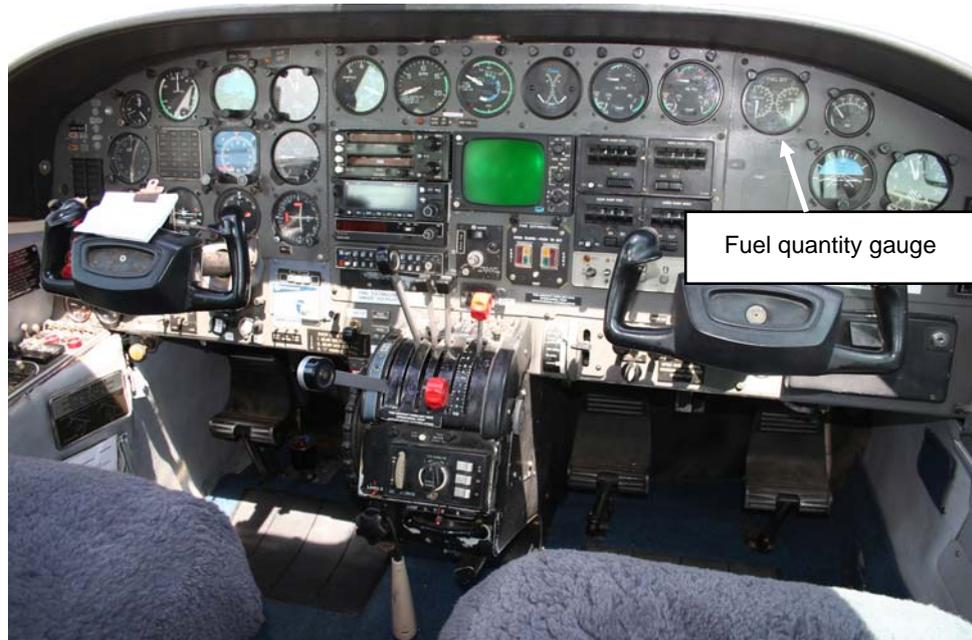
Figure 1: Aircraft instrument panel

The aircraft was equipped with an electrical capacitance-type fuel quantity indication system (FQIS) that was compensated for specific gravity. Each wing tank contained three internally mounted probes, which were electrically connected to a signal conditioner located outside the tank in each wing. The signal conditioner was electrically connected to the fuel quantity gauge in the cockpit (Figure 1). The gauge, located in the upper right instrument panel, displayed each tank's quantity in 50 lb and 30 US Gallon units (Figure 2).
