ATSB TRANSPORT SAFETY INVESTIGATION REPORT
Rail Occurrence Investigation 2007/008
Final

Collision between Tandem Tip Truck and the *Indian Pacific* Passenger Train, 4SA8

Virginia, SA

13 December 2007

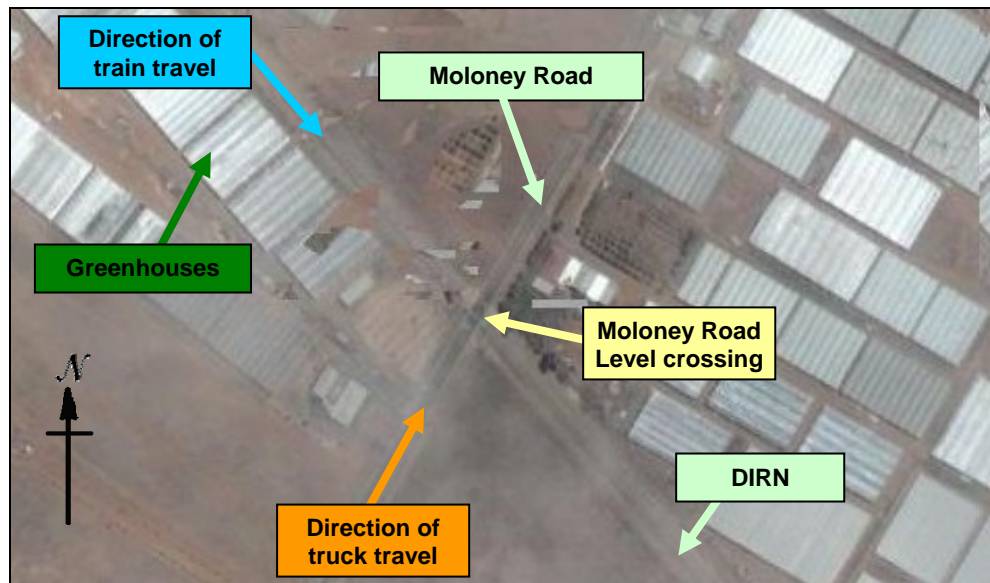
Figure 2: Aerial view of Moloney Road level crossing, Virginia SA

Moloney Road, (Figure 2), can be accessed from Penfield Road, 360 m to the north-east of the level crossing, or the Old Port Wakefield Road, 760 m to the south-west.

Moloney Road is a fully sealed local road, there is minimal grade differential at the road and track interface. The level crossing is passively³ controlled by signs that require road users to stop at the 'Stop' sign and give way to trains on or approaching the level crossing. The road crosses the level crossing at an angle close to 70 degrees.
