A U S T R A L I A N T R A N S P O R T S A F E T Y B U R E A U

AIR SAFETY INVESTIGATION

200100348

**Cessna C310R, VH-HCP
3 km E Newman Aerodrome
26 January 2001**

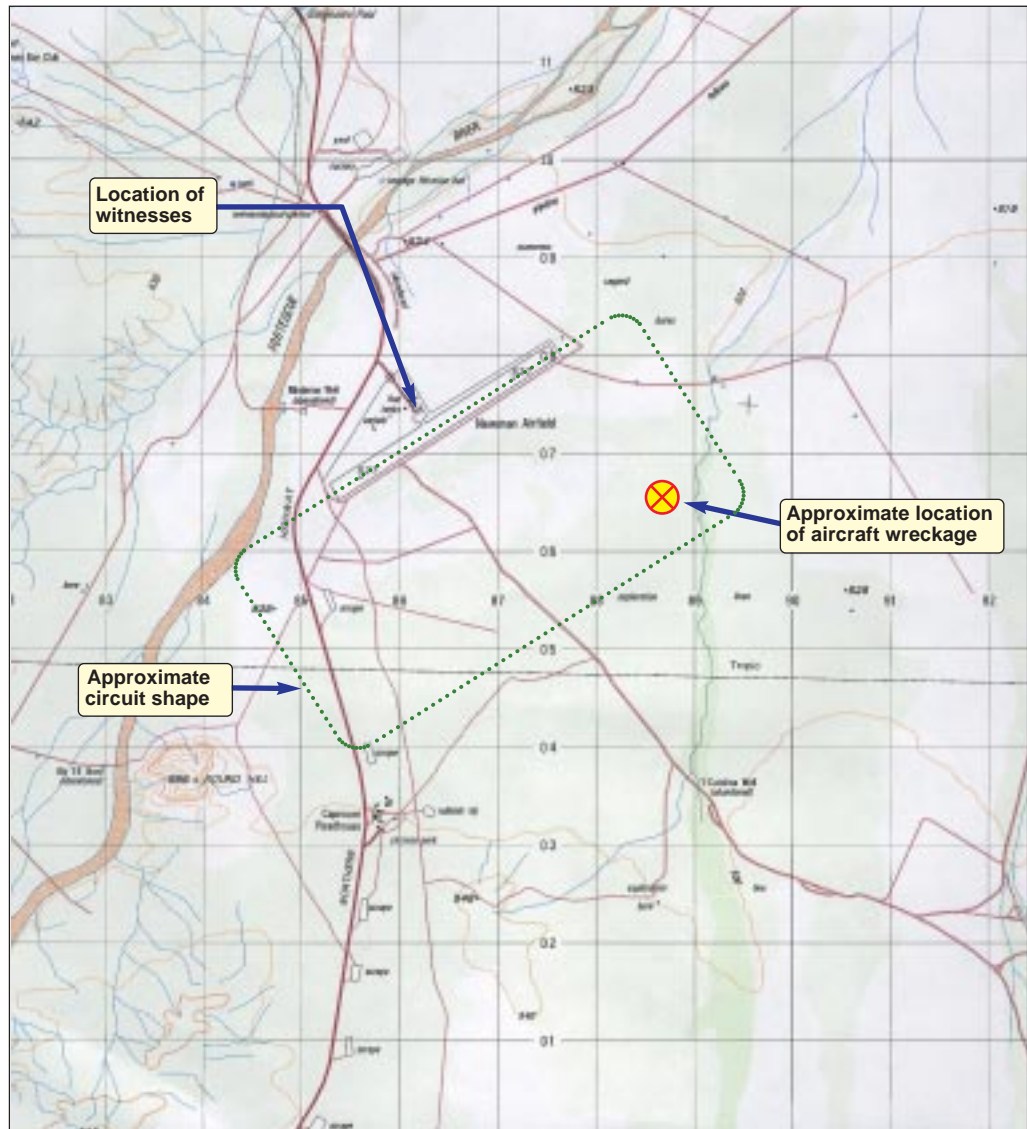
FIGURE 1:
Newman aerodrome and accident site

Fig. 1 shows a map of Newman aerodrome, including the location of the accident site, and the location of the witnesses. Fig. 2 shows the location of Newman aerodrome relative to the township and the approximate track from Kiwirrkurra.

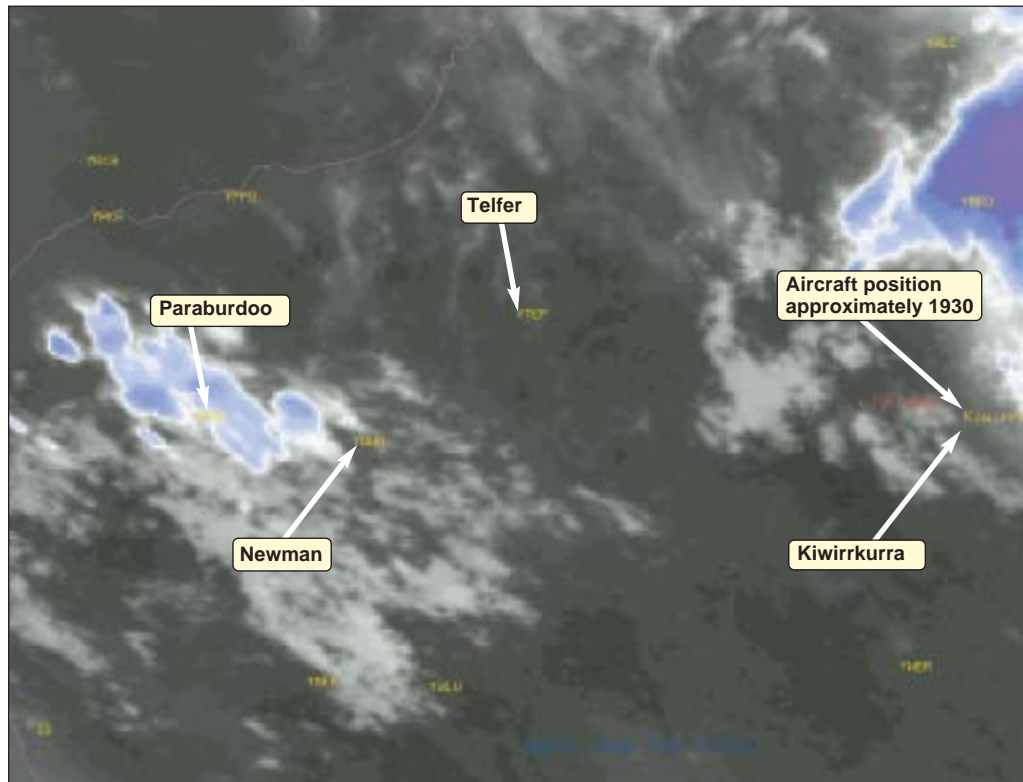
FIGURE 4:
Satellite image taken approximately 1930

Archived data from ground-based lightning sensors¹⁴ recorded thunderstorm activity in the region on the night of the accident, which included activity proximal to the track from Kiwirrkurra to Newman. Although the hourly satellite imagery did not reveal evidence of significant thunderstorm activity along the aircraft's track during the flight, a number of lightning strikes were recorded by the lightning sensors. Some of these strikes were within 30 NM of the aircraft's probable position (see fig. 5 to 7) and could be correlated with areas of cloud depicted on the satellite imagery. It was possible that there was thunderstorm activity along the track Kiwirrkurra to Newman during the occurrence flight, and it was likely that some lightning activity was not detected by the ground-based lightning sensors.
