MARINE SAFETY INVESTIGATION
REPORT 183

Independent investigation into the fire in the hold of
the Netherlands flag general cargo vessel

Marion Green

Report No 183
November 2003

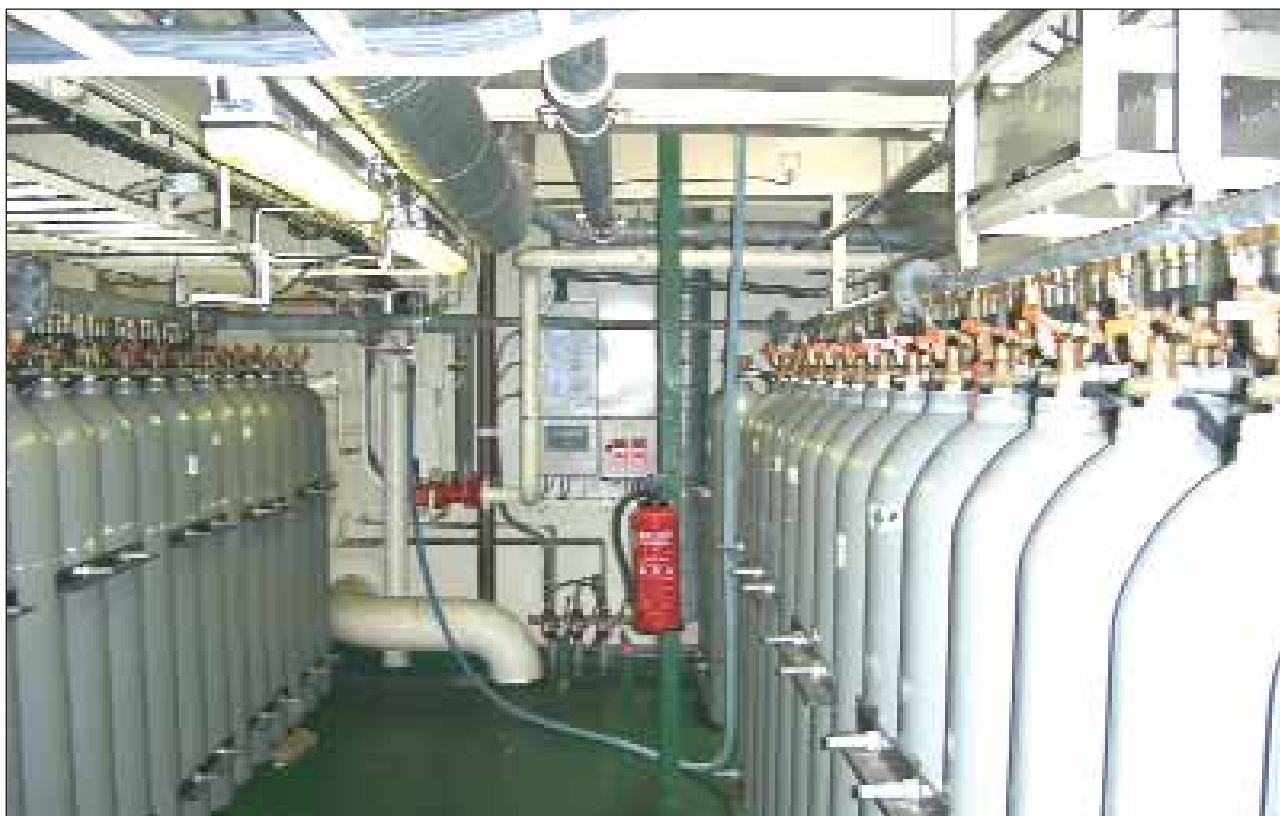
FIGURE 2:
CO₂ room, showing banks of gas bottles for CO₂ flooding of cargo holds

At 1150, the mate started to manually release the CO₂, one bottle at a time, into the hold. Initially, 25 bottles were released, after which it was decided to wait for the CO₂ lines to depressurise and to don breathing apparatus again, as there were several leaking connections in the CO₂ room. The vessel's managers in Rotterdam were advised of the situation.
