MARINE SAFETY INVESTIGATION
No. 193

**Independent investigation into
the equipment failure aboard the Australian
flag roll-on/roll-off cargo vessel
Searoad Mersey
in Bass Strait
on 21 March 2003**

December 2004

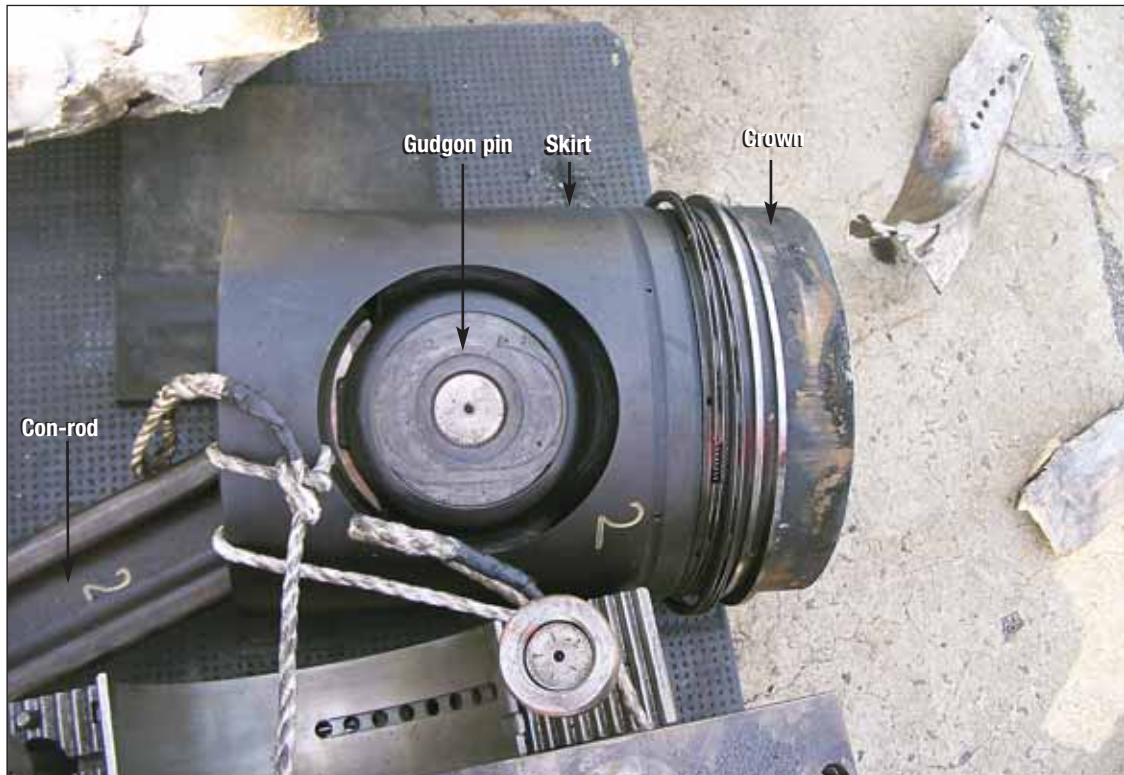
FIGURE 2:
Piston assembly on pallet

The pistons fitted to each main engine cylinder (or unit) are comprised of two parts, a forged steel crown which is bolted onto a nodular cast iron skirt. The gudgeon pin, which attaches the connecting rod (con-rod) to the piston assembly, is housed in a 'socket' which is cast into the piston skirt (figure 2).

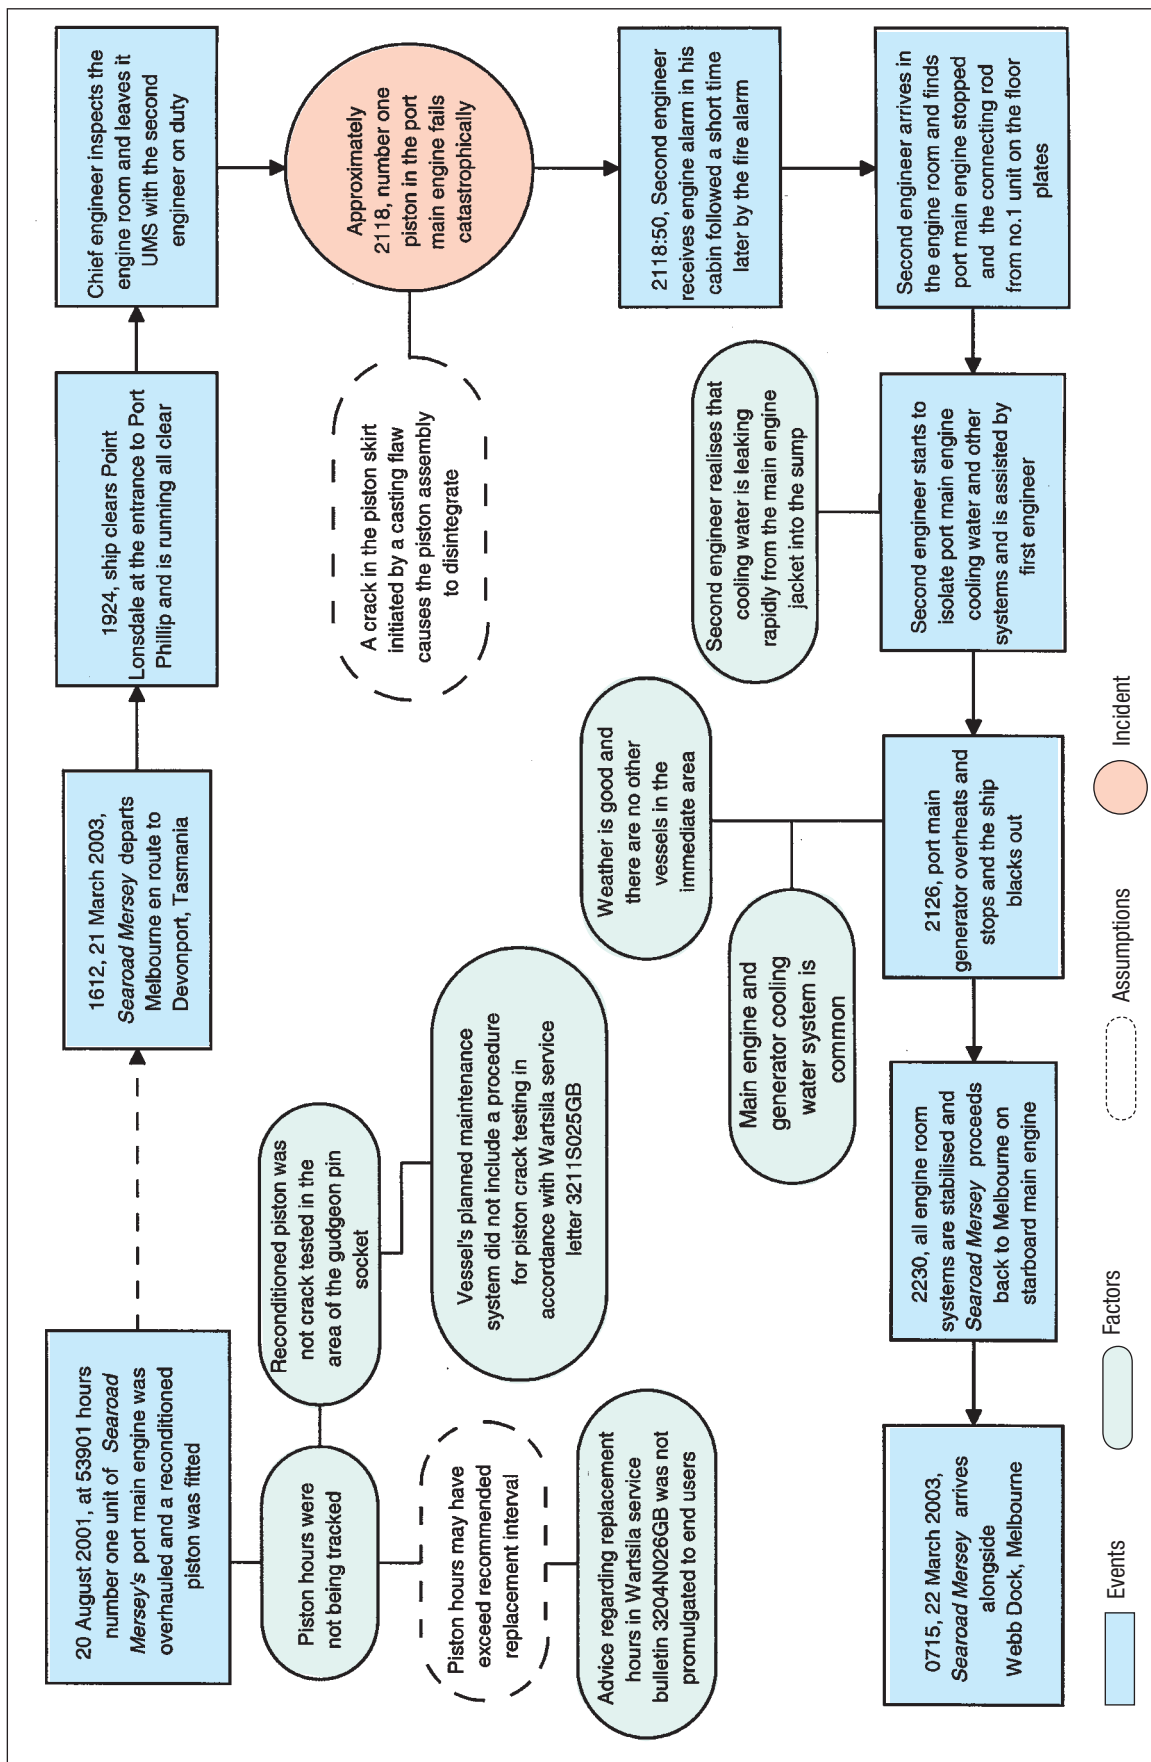
FIGURE 10:
Searoad Mersey: Events and causal factors chart

1. The casting flaw found in the piston skirt fitted to number one unit initiated a fatigue crack which eventually caused the piston to fail in service.
2. The vessel's maintenance system did not include a system for tracking the total operating hours of the main engine piston assemblies.
3. The vessel's maintenance system did not include a procedure for crack testing the piston skirts in the areas stipulated by the manufacturer in their service bulletin *Piston overhaul of VASA 32 engines after 24 000 running hours and later overhauls*.
4. The critical manufacturer's *Main Components maintenance intervals for VASA 32, 32LN and 32GD* bulletin had not been provided to the vessel or its technical manager.
5. The evidence strongly suggests that Wartsila Vasa 32 engines have had a history of piston skirt failures similar to that experienced by *Searoad Mersey*.
