MARINE SAFETY INVESTIGATION  
No. 192

**Independent investigation into the  
grounding of the Liberian registered  
bulk carrier  
*Pactrader*  
in the port of Thevenard, South Australia  
on 1 March 2003**

June 2004

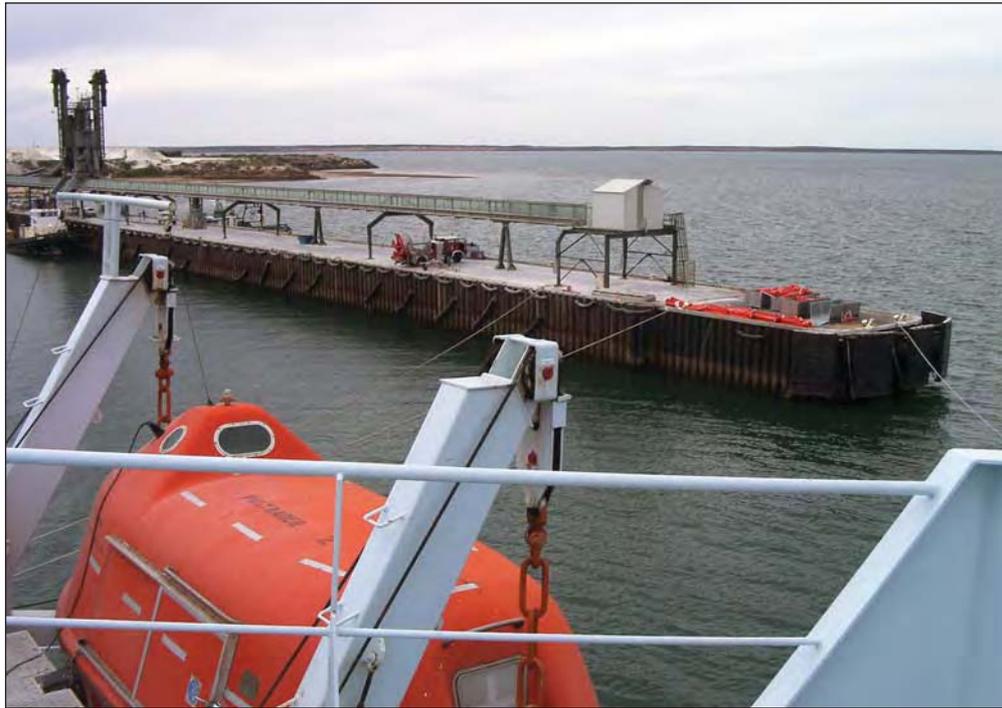
**FIGURE 3:**  
**Thevenard wharf**

The commercial wharf at Thevenard consists of a single, very closely piled and faced, concrete jetty approximately 392 metres in length extending westward from Cape Thevenard (see figure 3). The wharf extends about 380 m from Point Thevenard and is aligned 080°T/260°T. Ships can berth on either the northern or southern side of this wharf but, in either case, usually berth heading outward (westward). Both berths are at the seaward end of the jetty and are 198 m long and 30 m wide. The maintained depth alongside in both berths is 9.80 m. There is a set of berthing leading marks established for both sides of the wharf. These leads mark the edge of the deep water and are used as clearing marks. The wharf is provided with a 'soft nose' fendering system on the outer, seaward end.

The pilot's options for sailing were also limited, to a degree, by the design of the wharf fenders. The outer end of the wharf consisted of a 'soft nose' designed to protect the end of the wharf as a ship berths. The fendering is proud of the line of the jetty. The 'soft nose' fender is seen as being vulnerable if contacted by a ship leaving the jetty (see figure 3). An incident involving previous damage to the outer end of the wharf was a factor the pilot took into account. The tendency was to ensure that ships sailing from the berth did not contact this fendering. The pilot, therefore, did not consider the option of warping the ship along the jetty, or staying very close to the jetty on departure. His main concerns in conning the ship, as he perceived it, were on his port side. The pilot remained on the port bridge wing as *Pactrader* cleared the berth.

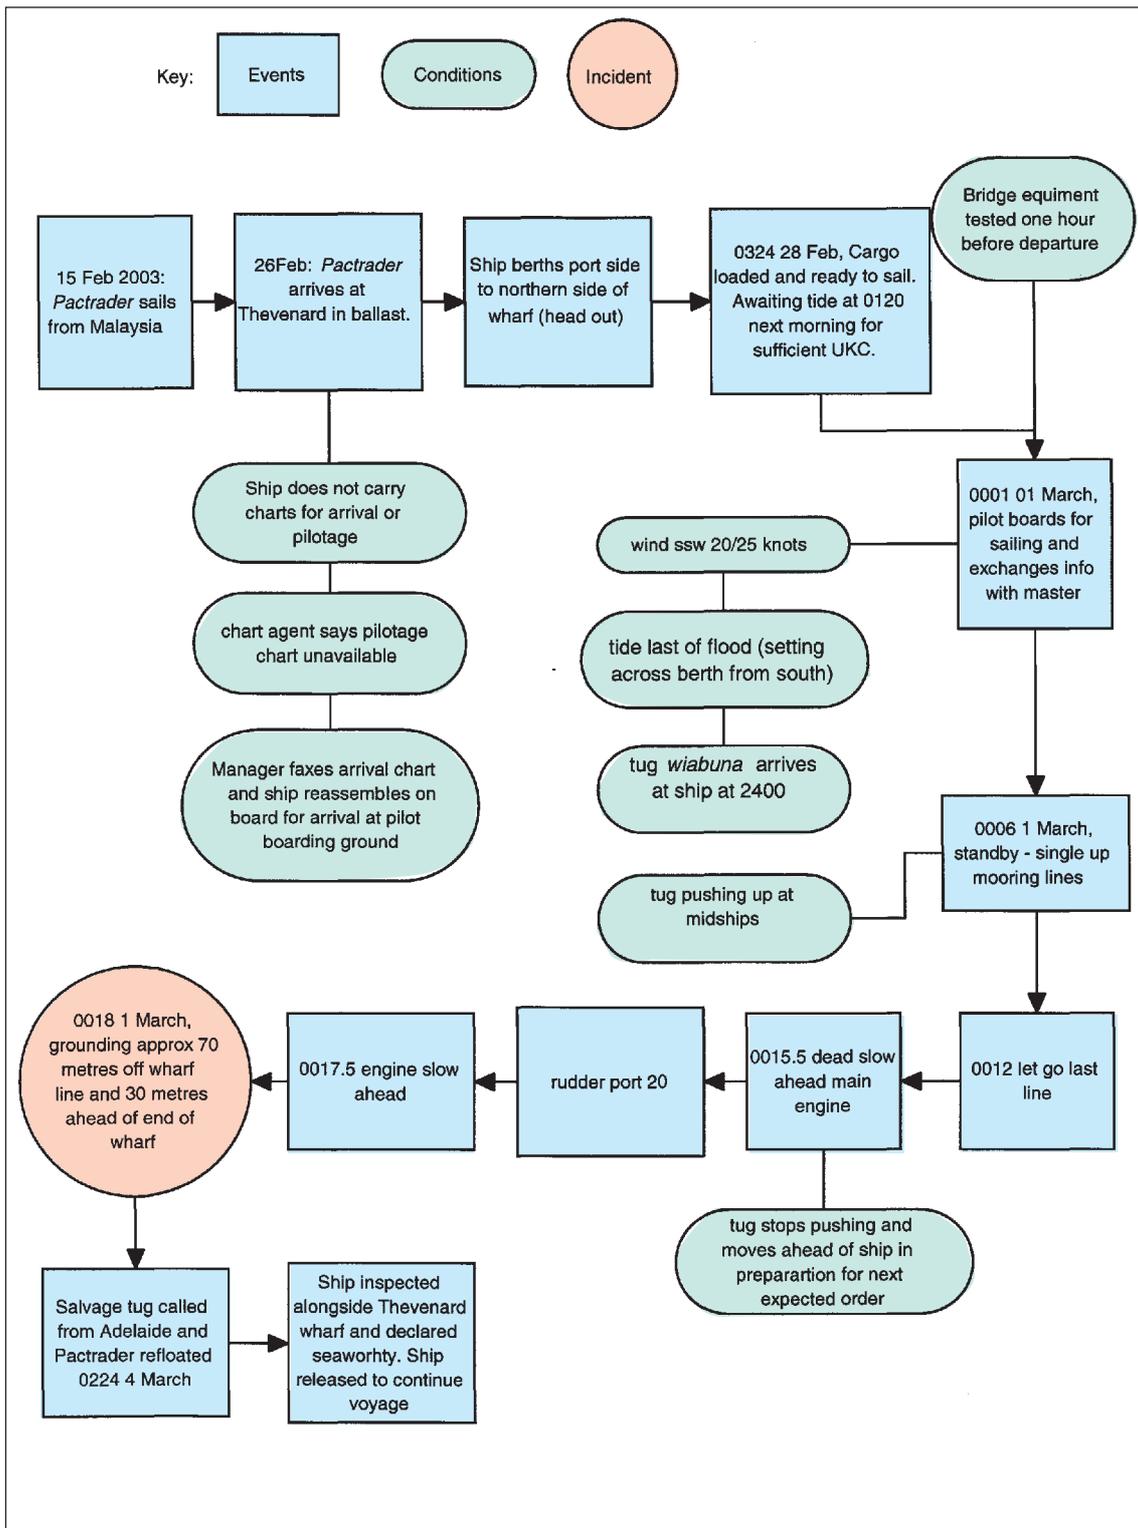
**FIGURE 5:**  
**Pactrader. Events and causal factor chart**

4. The allowance made by the pilot for the 'soft nose' fenders was excessive.
5. Alternative un-berthing strategies were not properly considered.
6. The lack of Chart 120 and Chart 341 limited the ship's staff in their ability to plan or monitor the inward and outward passages. The absence of the charts, however, can only be considered as marginal in terms of causal factors.
