In-flight cargo door separation 28km NW Sunshine Coast Airport 1 December 2009

Abstract

On 1 December 2009 at approximately 0730 EST, the forward, left-side cargo door of a Eurocopter AS350D helicopter (registered VH-PIH) separated from the helicopter fuselage during fire-fighting operations near Maryborough, Queensland. The helicopter subsequently landed safely and there were no injuries.

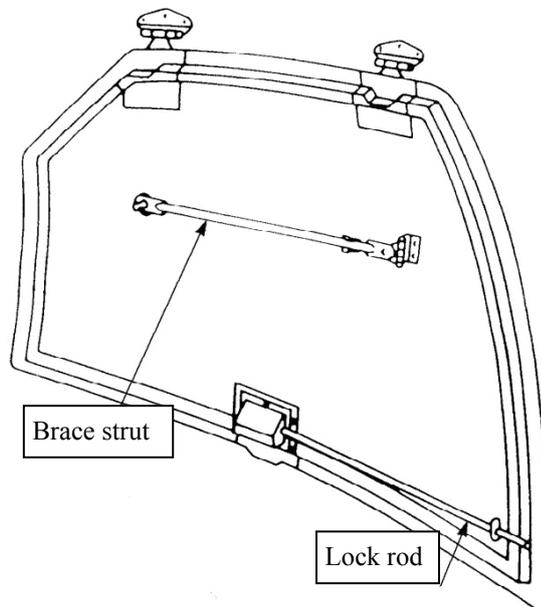
Figure 1: AS350 Left cargo door

The cargo door was of a lightweight, composite construction, consisting of a foam core and fibreglass skins. Door hardware comprised two hinge points on the upper edge, and a locking mechanism, which consisted of a centre latch on the lower edge of the door, and a lock rod running parallel to, and securing the lower forward edge of the door (Figure 1). An internal brace strut was installed for supporting the door in the open position. Correct engagement of the latch and rod extinguished the 'cargo door' indicator light on the cockpit warning panel.
