Department of Transport
Bureau of Air Safety Investigation

INVESTIGATION REPORT
B/921/1032

Boeing 727-277 VH-ANA
Brisbane Qld
4 July 1992

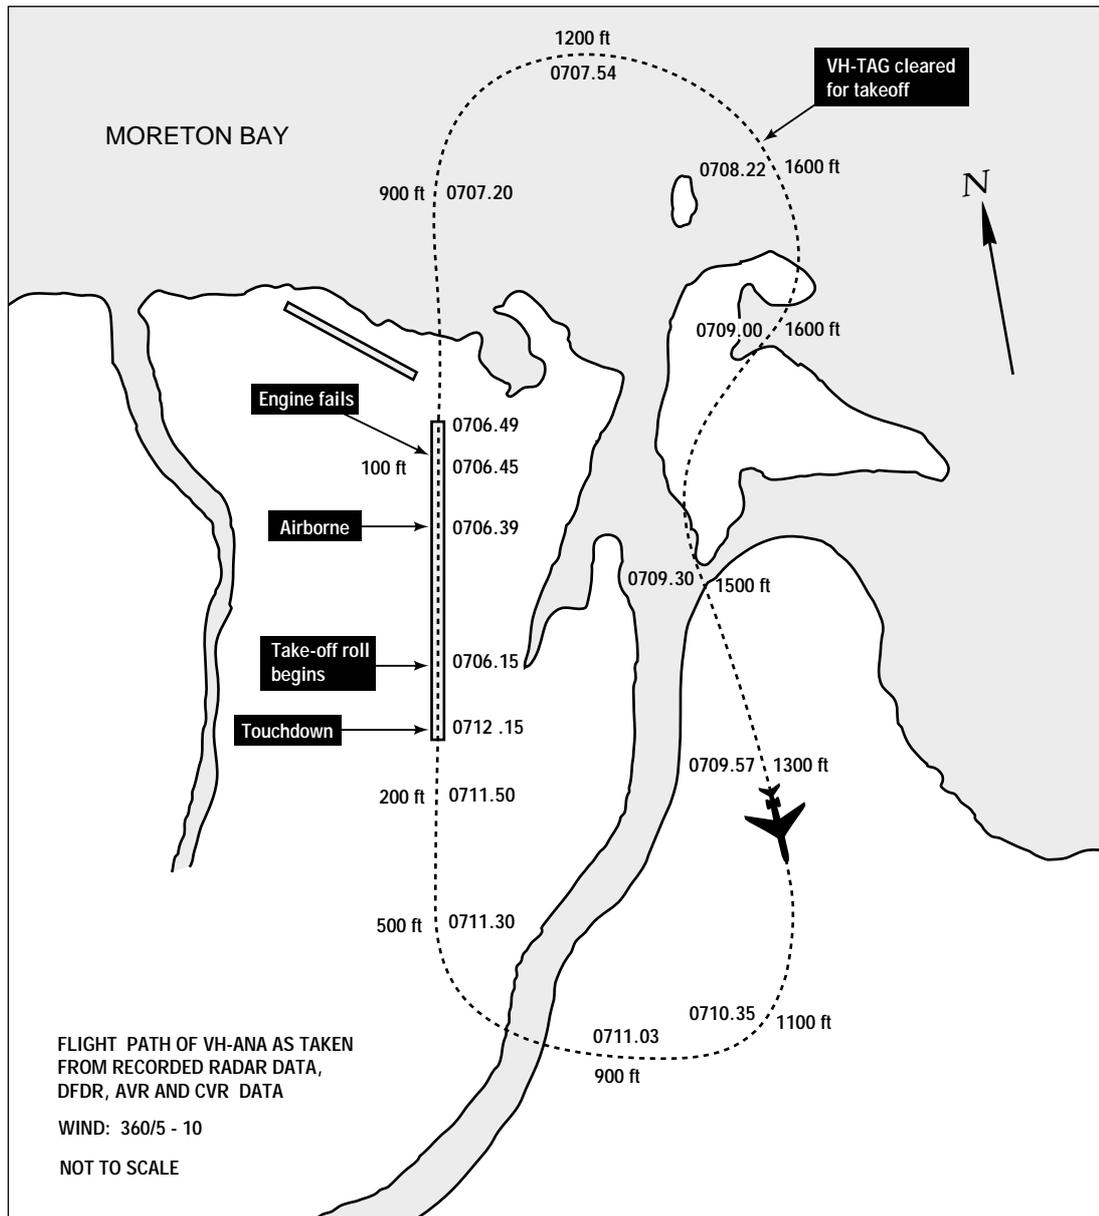
The aircraft landed normally, less than 6 min after the engine failure. About 20 seconds after touchdown, the crew asked the tower controller whether any fire was still visible. On being informed that there were some small flames around the front of the centre engine, the crew advised that they would stop the aircraft adjacent to the fire vehicles positioned on taxiway A4S. Figure 1 shows the flight path of the aircraft from takeoff at 0706.15 to touchdown at 0712.15 following the inflight emergency.
