Collision with terrain, VH-DSD

85 km NW of Julia Creek, Queensland

9 May 2011

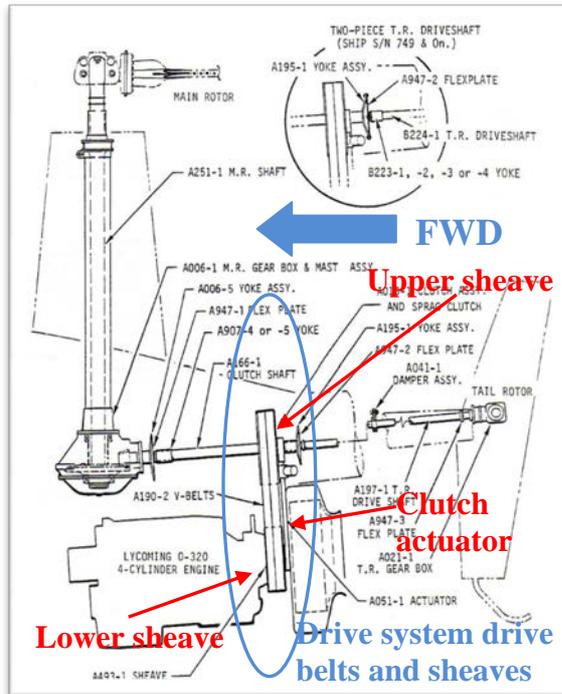
Figure 4: R22 drive belt system

On the R22 helicopter, engine power was transmitted to the rotor system through a drive-belt system that consists of two rubber double V-belts, running on matching multi-grooved sheaves (Figure 4). Both the upper and lower sheaves were constructed of aluminium alloy with a thermally-sprayed, metallised coating applied to improve wear resistance.

The upper drive sheave was mounted on the clutch shaft adjacent to a flexible coupling and could be moved relative to the engine-mounted drive sheave by means of an electric clutch actuator. That movement had the effect of varying the tension applied to the belts.

- **Drive belts.** Check for defects or damage such as blistering, cracking or delamination.
- **Drive sheaves.** Check for incorrect alignment, poor sheave surface condition and/or uneven groove wear patterns.
- **Clutch actuator.** Check for incorrect tension, such as indicated by rotor engagement during engine start.
