Summary

The German flag, 35,303 gross tonnes container ship Berlin Express, while proceeding through the dredged cut, in the South Channel, Port Phillip Bay, en route to Melbourne, took a rapid sheer to starboard, as a result of which the

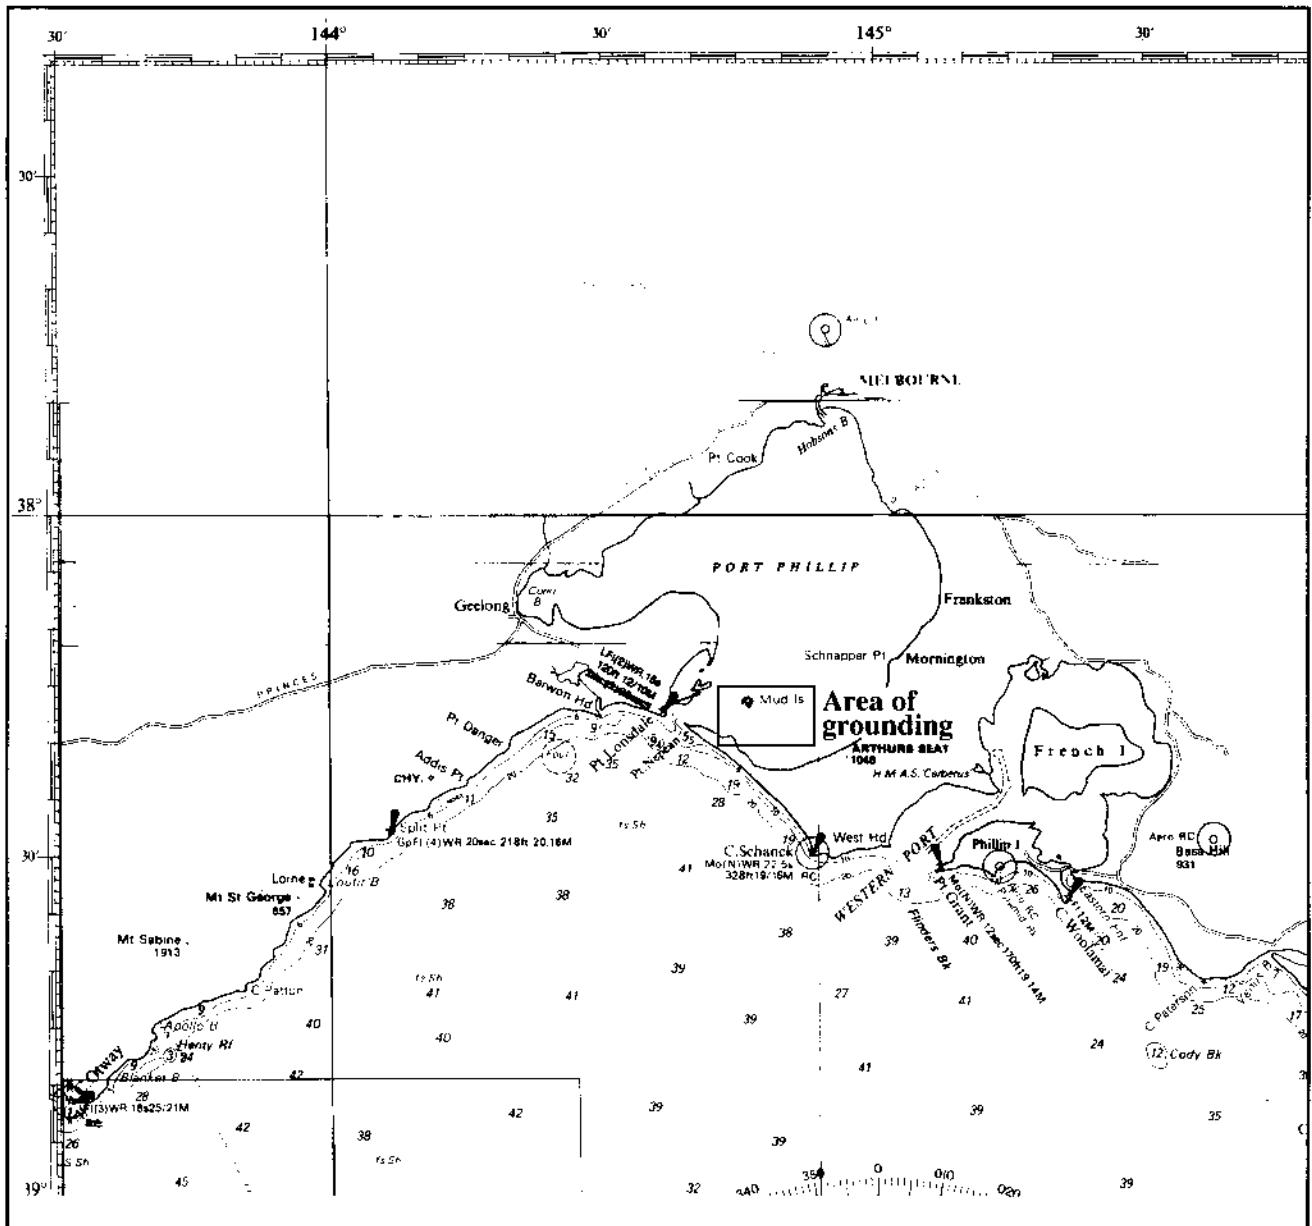
Part of chart Aus 422 showing area of grounding

ship grounded adjacent to South Channel Pile beacon.

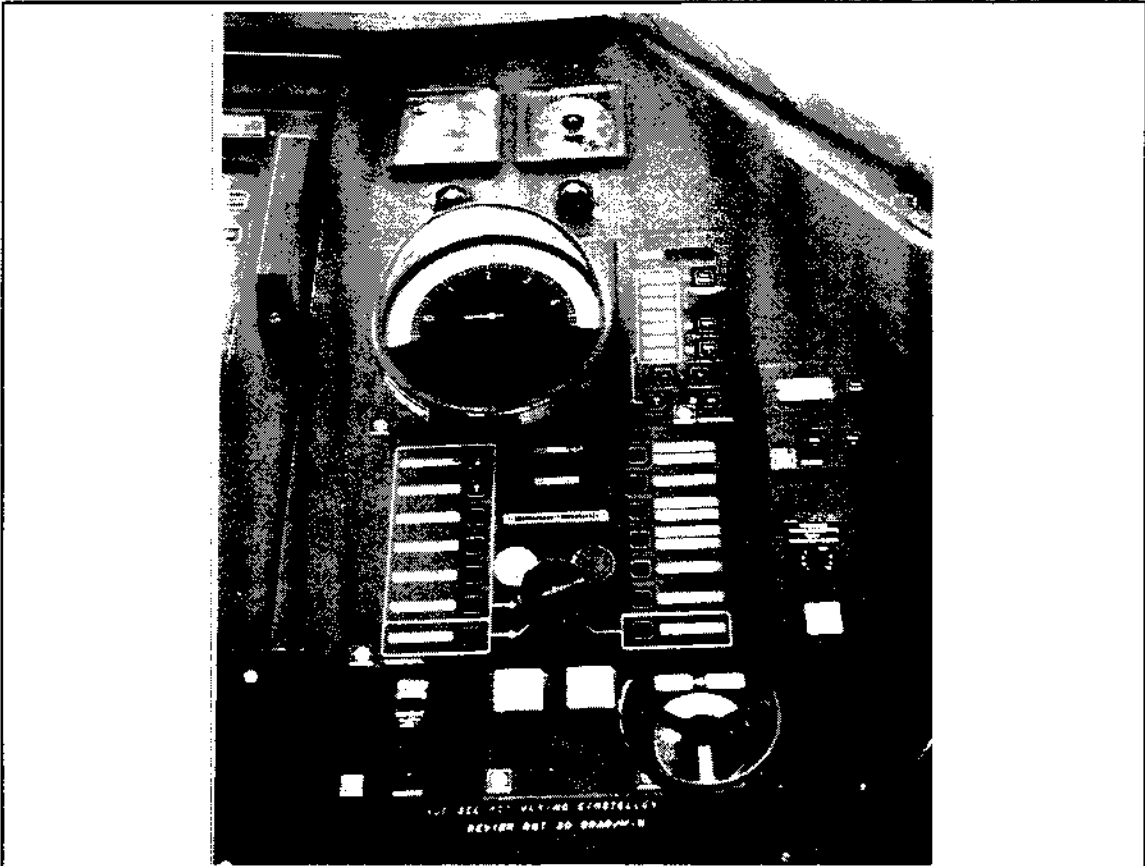
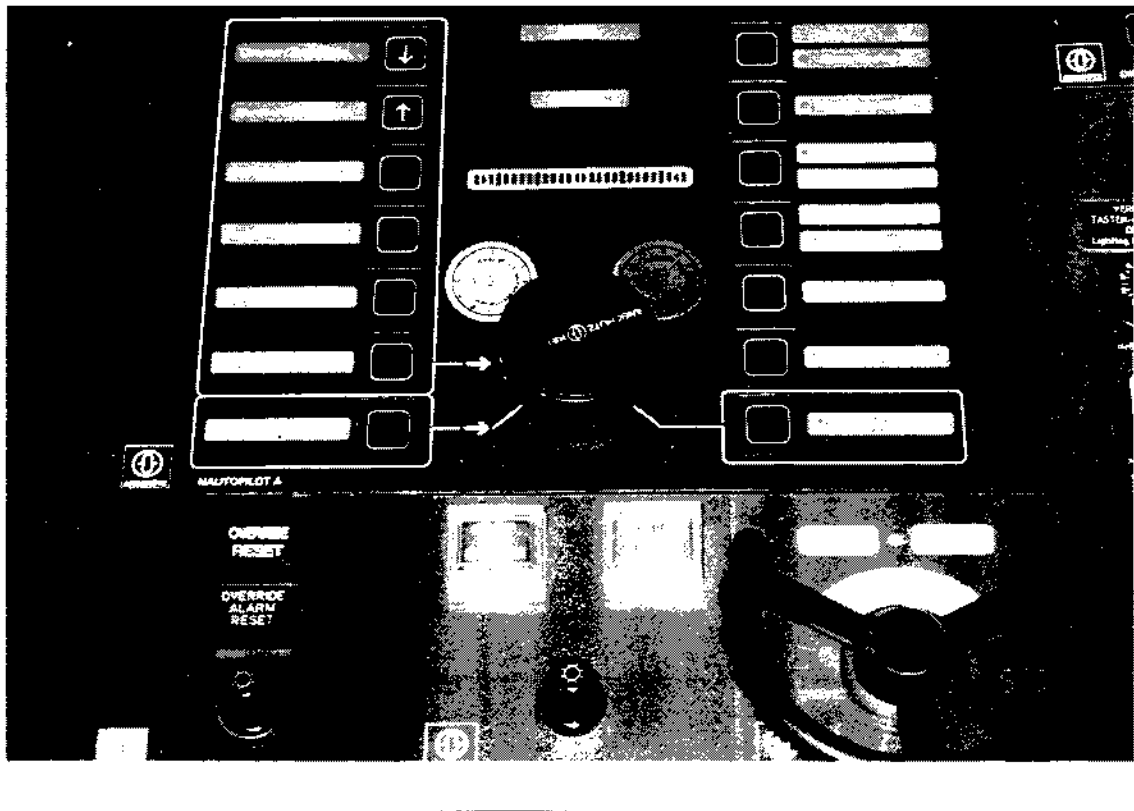
Photographs of Berlin Express Anschutz Nautopilot controls

The ship is equipped with an Anschutz "Nautopilot A" automatic steering system, a computerised
