RAIL SAFETY INVESTIGATION

2002/001

# Collision Between Suburban Electric Passenger Train 1648 and Suburban Electric Empty Train 1025

Epping, Victoria, 18 June 2002

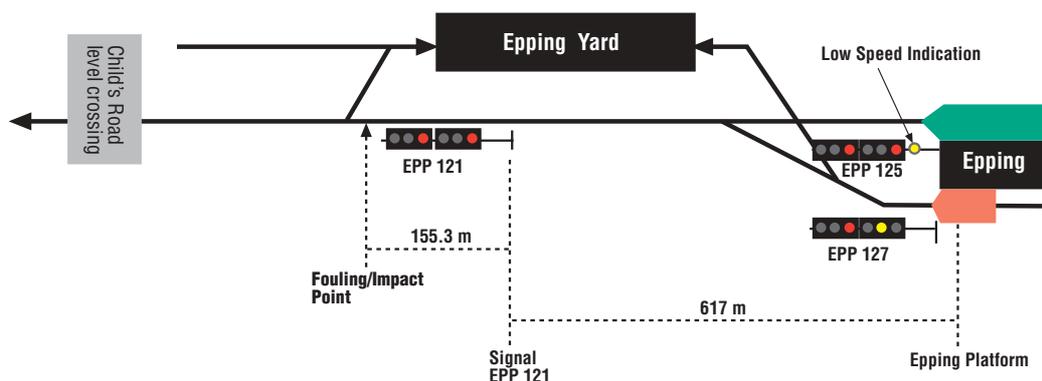
**FIGURE 1:**  
**Signal distances at Epping**

The evidence available, including an expert medical assessment, suggests that the driver of train 1648's performance was impaired by his physically 'unwell' condition. He could not recall events between the departure from Epping station on the up journey and the point that the train passed signal EPP121 at stop, a period of about one minute. As a result, signal EPP121 was passed at stop and a collision occurred. Train 1648 was travelling at about 60 km/h and train 1025 at about 12 km/h, at the point of initial impact.

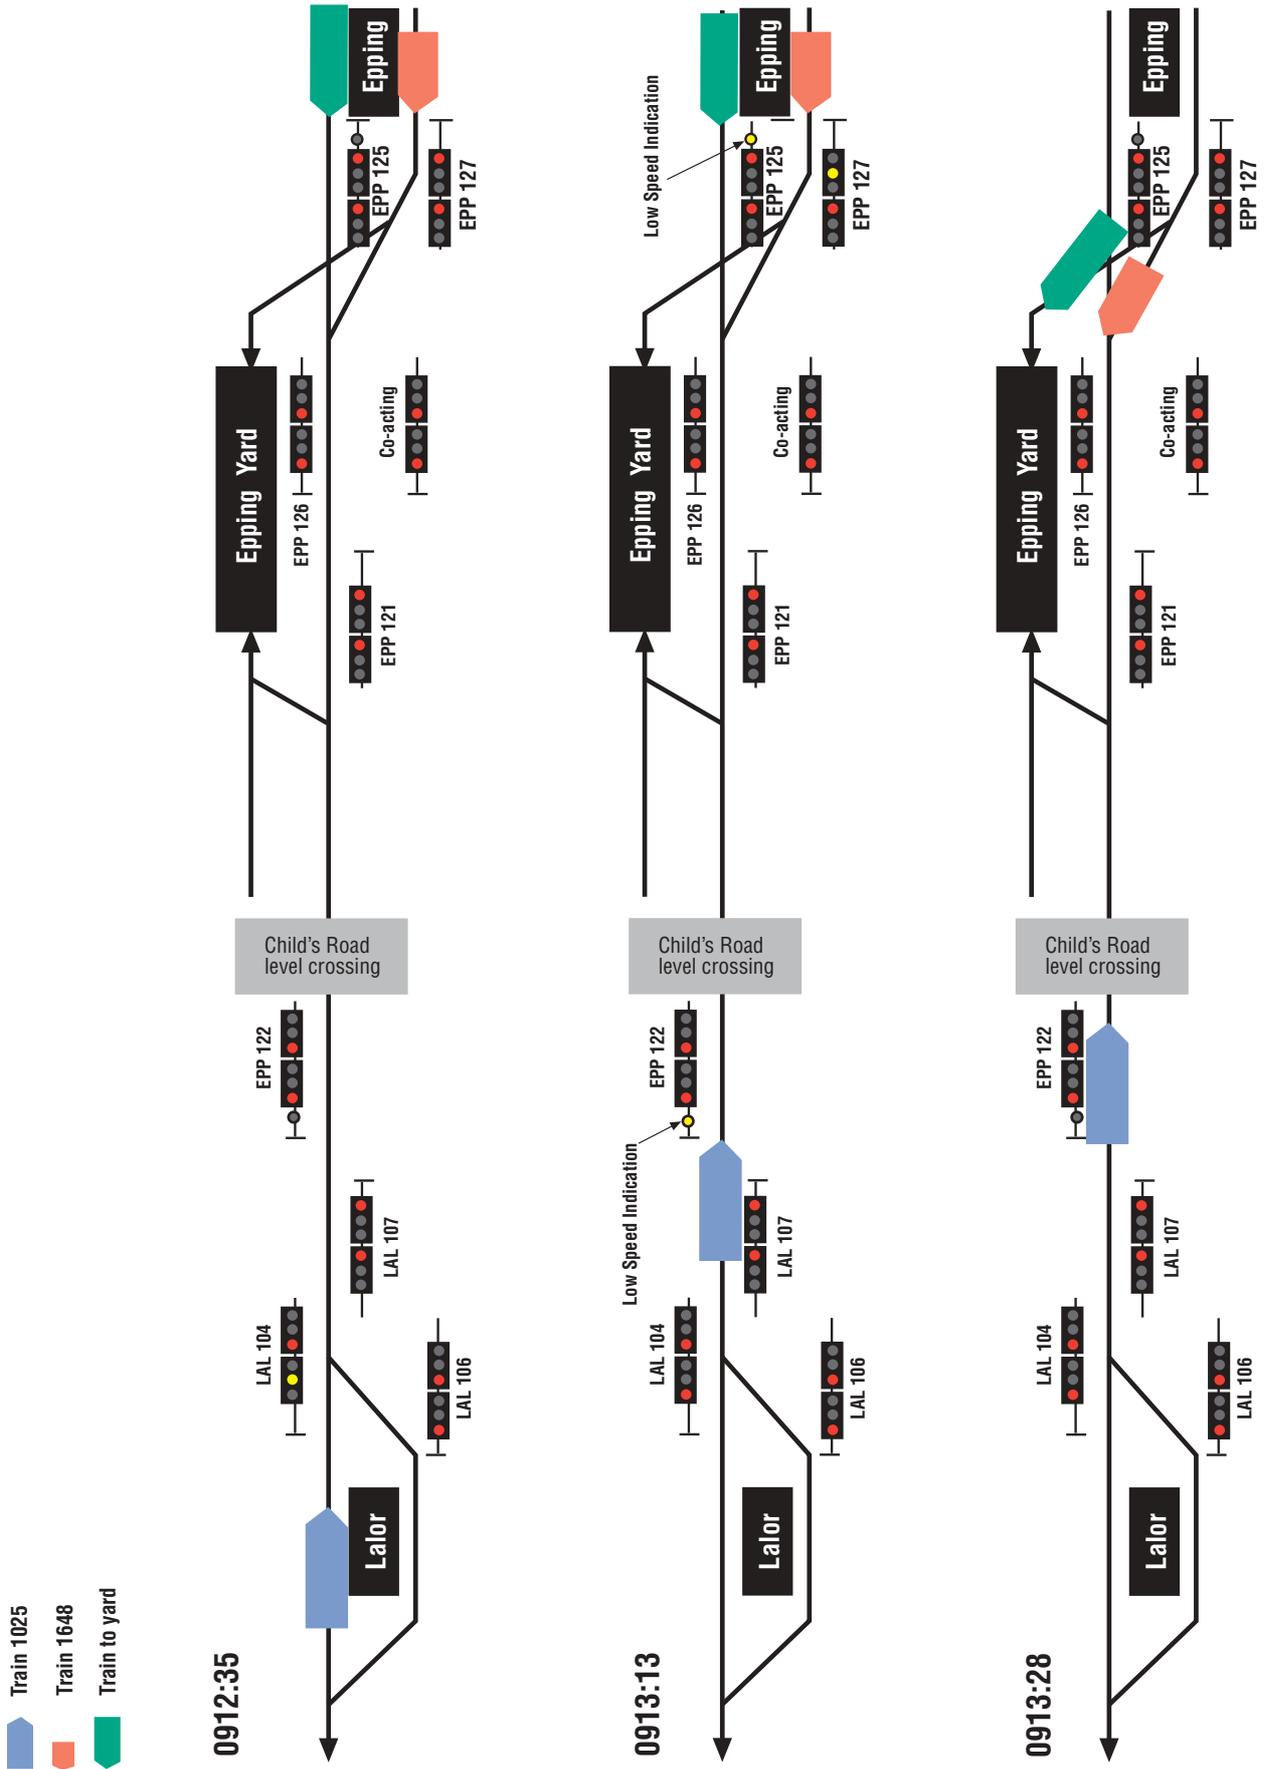
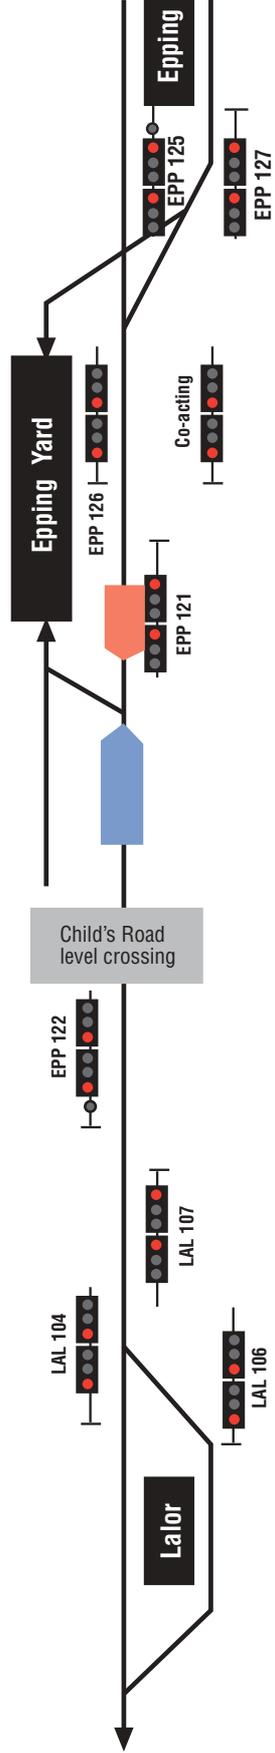
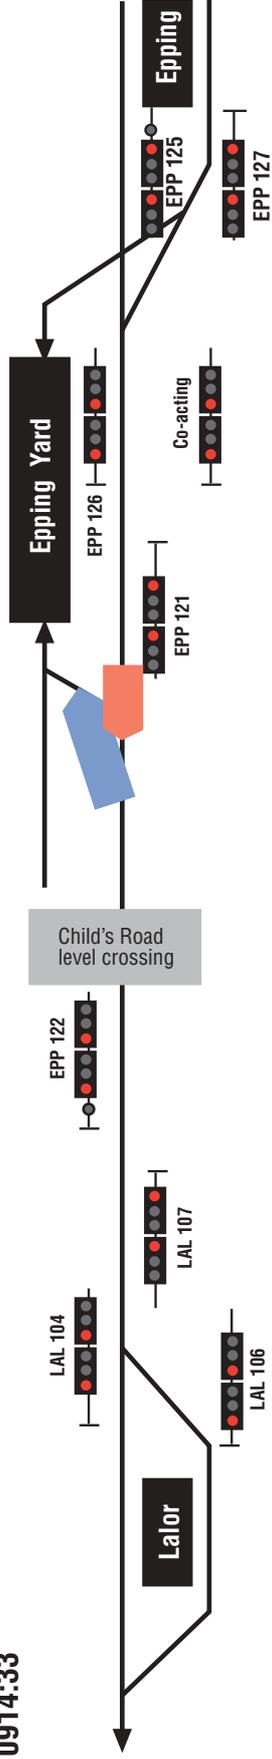
**FIGURE 3:**  
Sequence of events

Train 1025, the 0836 empty service, left platform 1, Flinders Street, Melbourne at 0850:21, almost 15 minutes late and was due at Epping Yard at 0913. In addition to the driver, there were two other Connex drivers travelling as passengers in the driver's compartment. From Flinders Street the train had an uninhibited passage through to Lalor platform. The train passed Lalor, down end, at 0912:35, some two minutes and 35 seconds behind the scheduled passing time of 0910, before slowing for a low speed signal indication to proceed across Child's Road level crossing into Epping Yard.

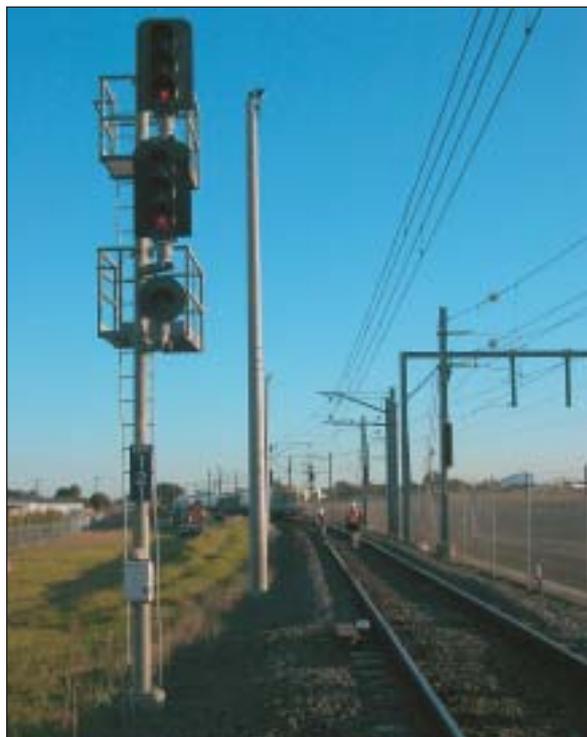
**FIGURE 8:**  
**Signal EPP121**

All the track circuits were within specification. Several of the relay boxes had additional wiring modifications carried out on them such as an additional power supply, protection varistors, and additional resistors added. However those modifications were not considered to have had any effect on the safety of the signalling.

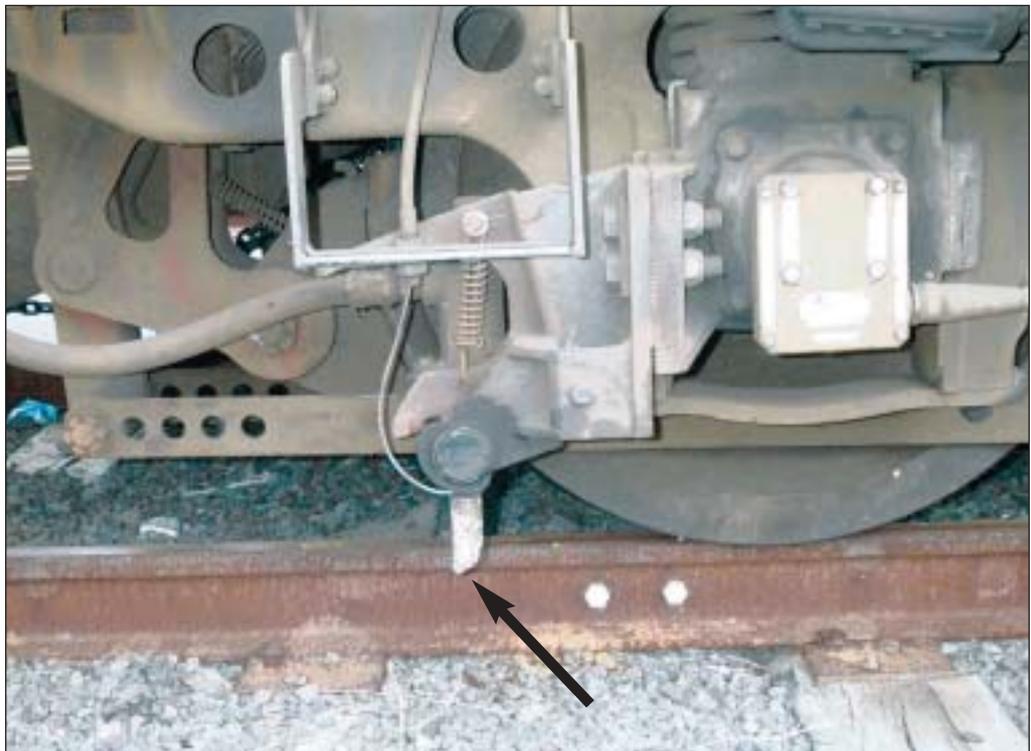
**FIGURE 11:**  
**Train trip<sup>25</sup> mechanism**

Most signals in the Victorian suburban network are equipped with an automatic train stop, which consists of an electric or air operated tripping arm. When the signal is at proceed, the tripping arm is below rail level and does not interfere with the normal running of trains. However, when the signal is at stop, the arm moves to above rail level. When a train passes over it, the arm strikes a lever attached to the train trip, causing the brake pipe to exhaust to the atmosphere thereby applying the emergency brakes and bring the train to a stop.

<sup>25</sup> A train trip is a safety device that works in conjunction with signal train stops. It is fixed to the bogie under the driving position, on the left hand side.

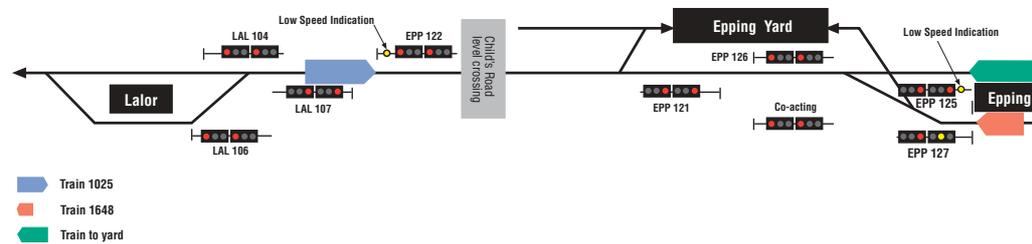
**FIGURE 12:  
Displayed signalling**

With train 1648 preparing to leave Epping platform, and train 1025 departing Lalor platform, the signalling system displayed the following indications:

A train driven at the cautionary speed of 40 km/h would require about 75 m to stop under emergency braking conditions<sup>26</sup>, given good track and weather conditions. If a train is not driven at the cautionary speed, but at full line speed, the stopping distance is much greater. In the case of the suburban line between Keon Park and Epping the full line speed is 80 km/h. A train tripping on the signal trip arm at 80 km/h would require approximately 280 m to 320 m in which to stop, the actual distance being subject to weather and line condition, brake condition and type, and the consist<sup>27</sup> of the train.

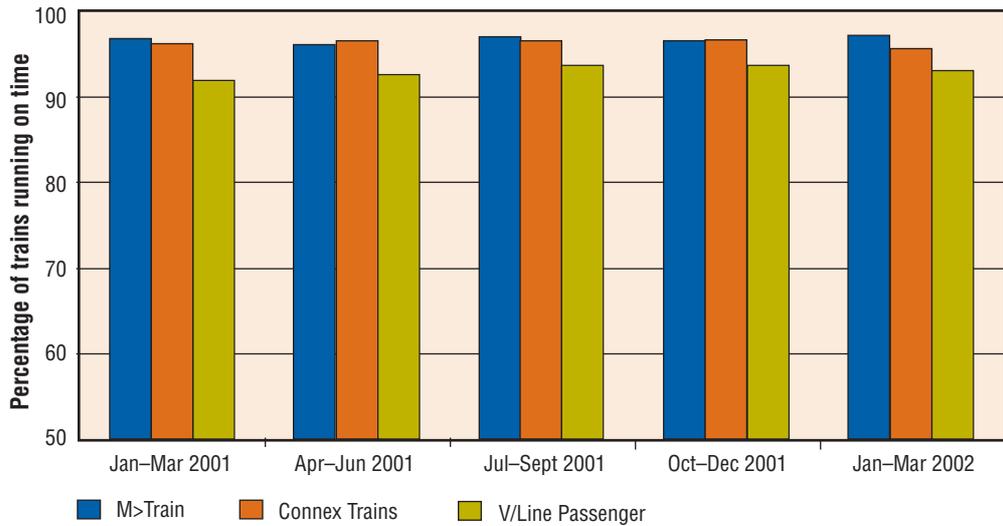
**FIGURE 15:**  
**Excerpt from Victorian Department of Infrastructure publication Track Record 10**

Discussions with Connex staff have indicated that they were aware of the penalties imposed for below target level performance. Most staff commented that they felt that on time running was the most governed and monitored performance indicator.
