**ATSB TRANSPORT SAFETY REPORT**  
Aviation Occurrence Investigation – AO-2009-007  
Final

**Collision on ground**  
**Townsville Aerodrome, Queensland**  
**11 February 2009**  
**VH-SBW**  
**Bombardier DHC-8-315**

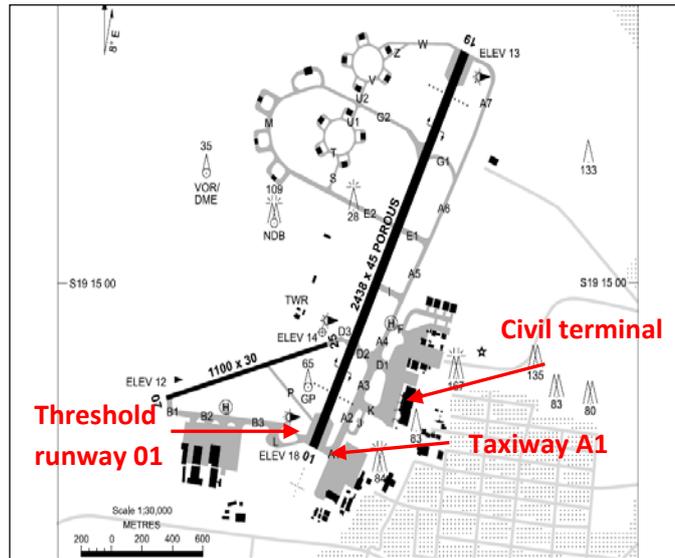
Figure 2: Townsville Aerodrome diagram

Townsville Aerodrome included the main, north to south-oriented runway 01/19 and the crossing runway 07/25 (Figure 2). Runway 01 was 8,000 ft (2,438 m) long and access from the civil terminal to the runway 01 threshold for takeoff was available via taxiway A1. Ordnance loading areas (OLA)<sup>11</sup> were situated either side of the runway 01 and 19 thresholds.

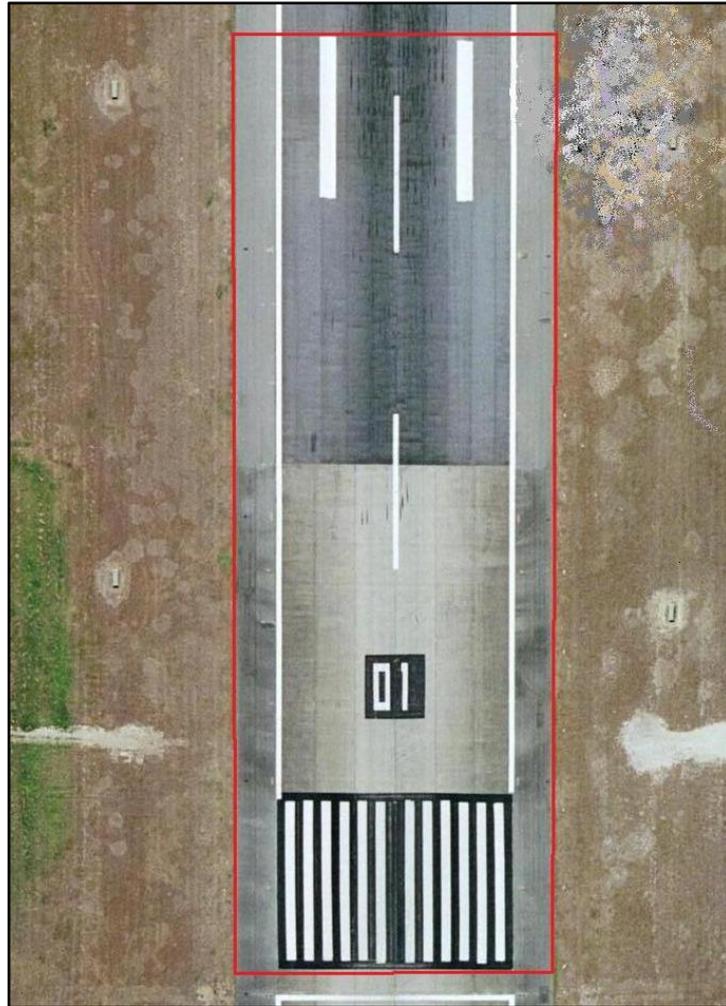
**Figure 5: Aerial view of Brisbane runway 01**

Civil use aerodromes do not have OLAs (Figure 5 shows the Brisbane runway 01 take-off area). The surface areas between the commencement of runway 01 and the 500 ft markers at Townsville was 25,690 m<sup>2</sup>, and at Brisbane 10,560 m<sup>2</sup> (Figures 4 and 5).
