**ATSB TRANSPORT SAFETY REPORT**  
Aviation Occurrence Investigation  
AO-2009-012  
Final

**Tailstrike and runway overrun  
Melbourne Airport, Victoria  
20 March 2009  
A6-ERG  
Airbus A340-541**

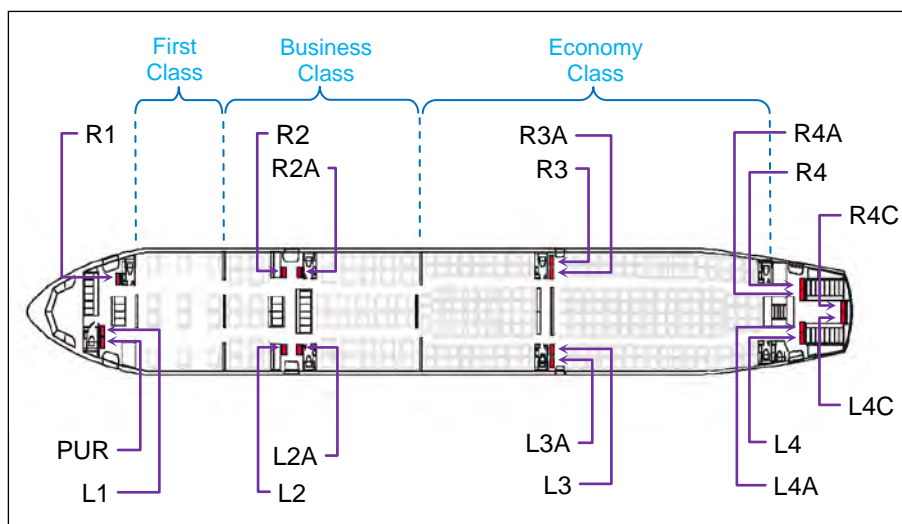
**Figure 16: Cabin crew seating arrangement**

The purser was positioned at door left 1 (L1), one senior flight steward was positioned at door L4 and the other was positioned at L4C (Figure 16). The remaining cabin crew were positioned throughout the cabin. According to cabin crew reports and the operator's procedures, the senior flight steward who was located at L4C should have been at R2A, which remained vacant for the entire flight.

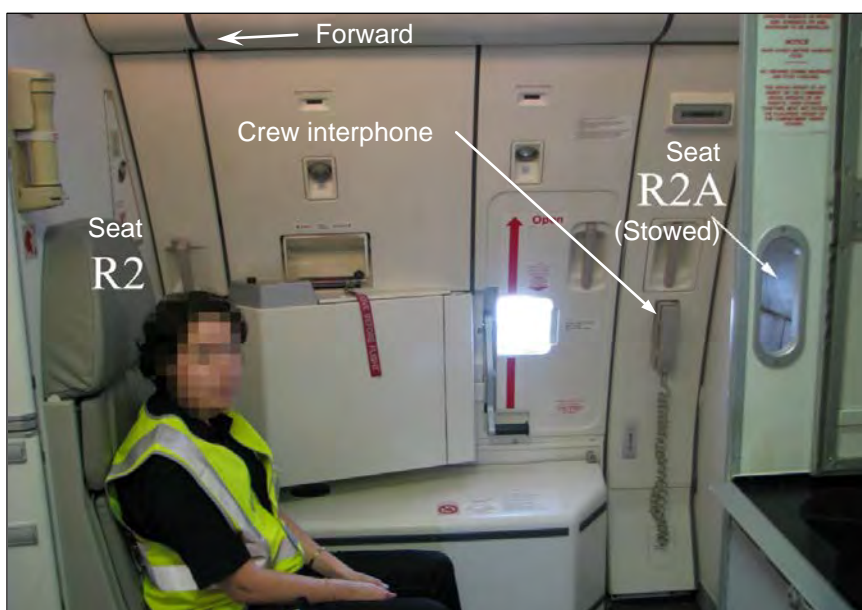
**Figure 22: Door R2 interphone**

The captain requested that the cabin crew remain seated for the duration of the flight and that all communication between the cabin crew was via the interphone system. The only report of any difficulty with the interphone system was from the cabin crew member who was seated at door R2 who reported that she was unable to reach the interphone from her door operator position at R2 (see Figure 22).

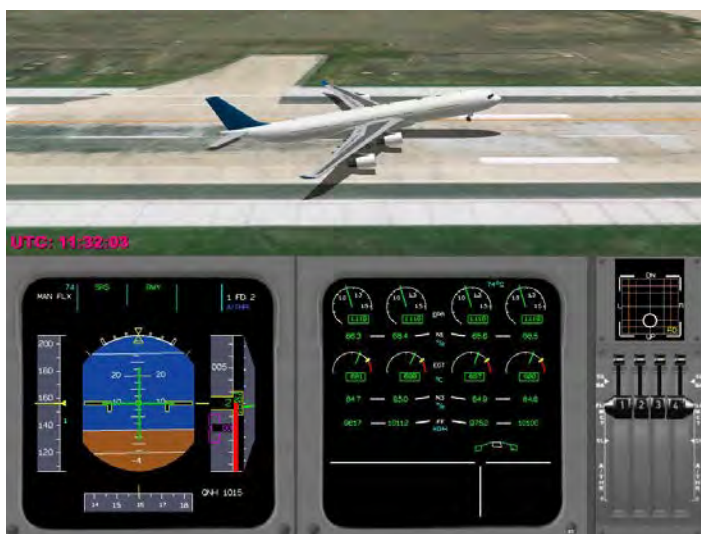
2232:03 The tail made first contact with the runway surface.  
CAS: 156 kts Distance to runway end: 265 m

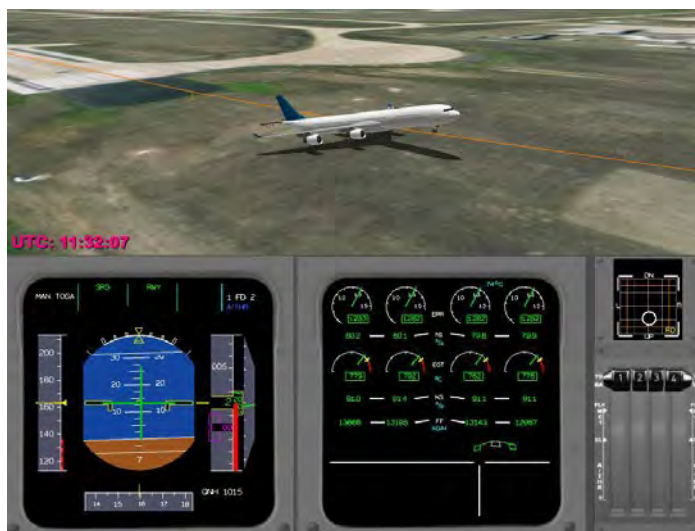
2232:07      The tail lifted off from the ground.  
CAS: 161 kts      Radio altitude:      -1 ft<sup>90</sup>

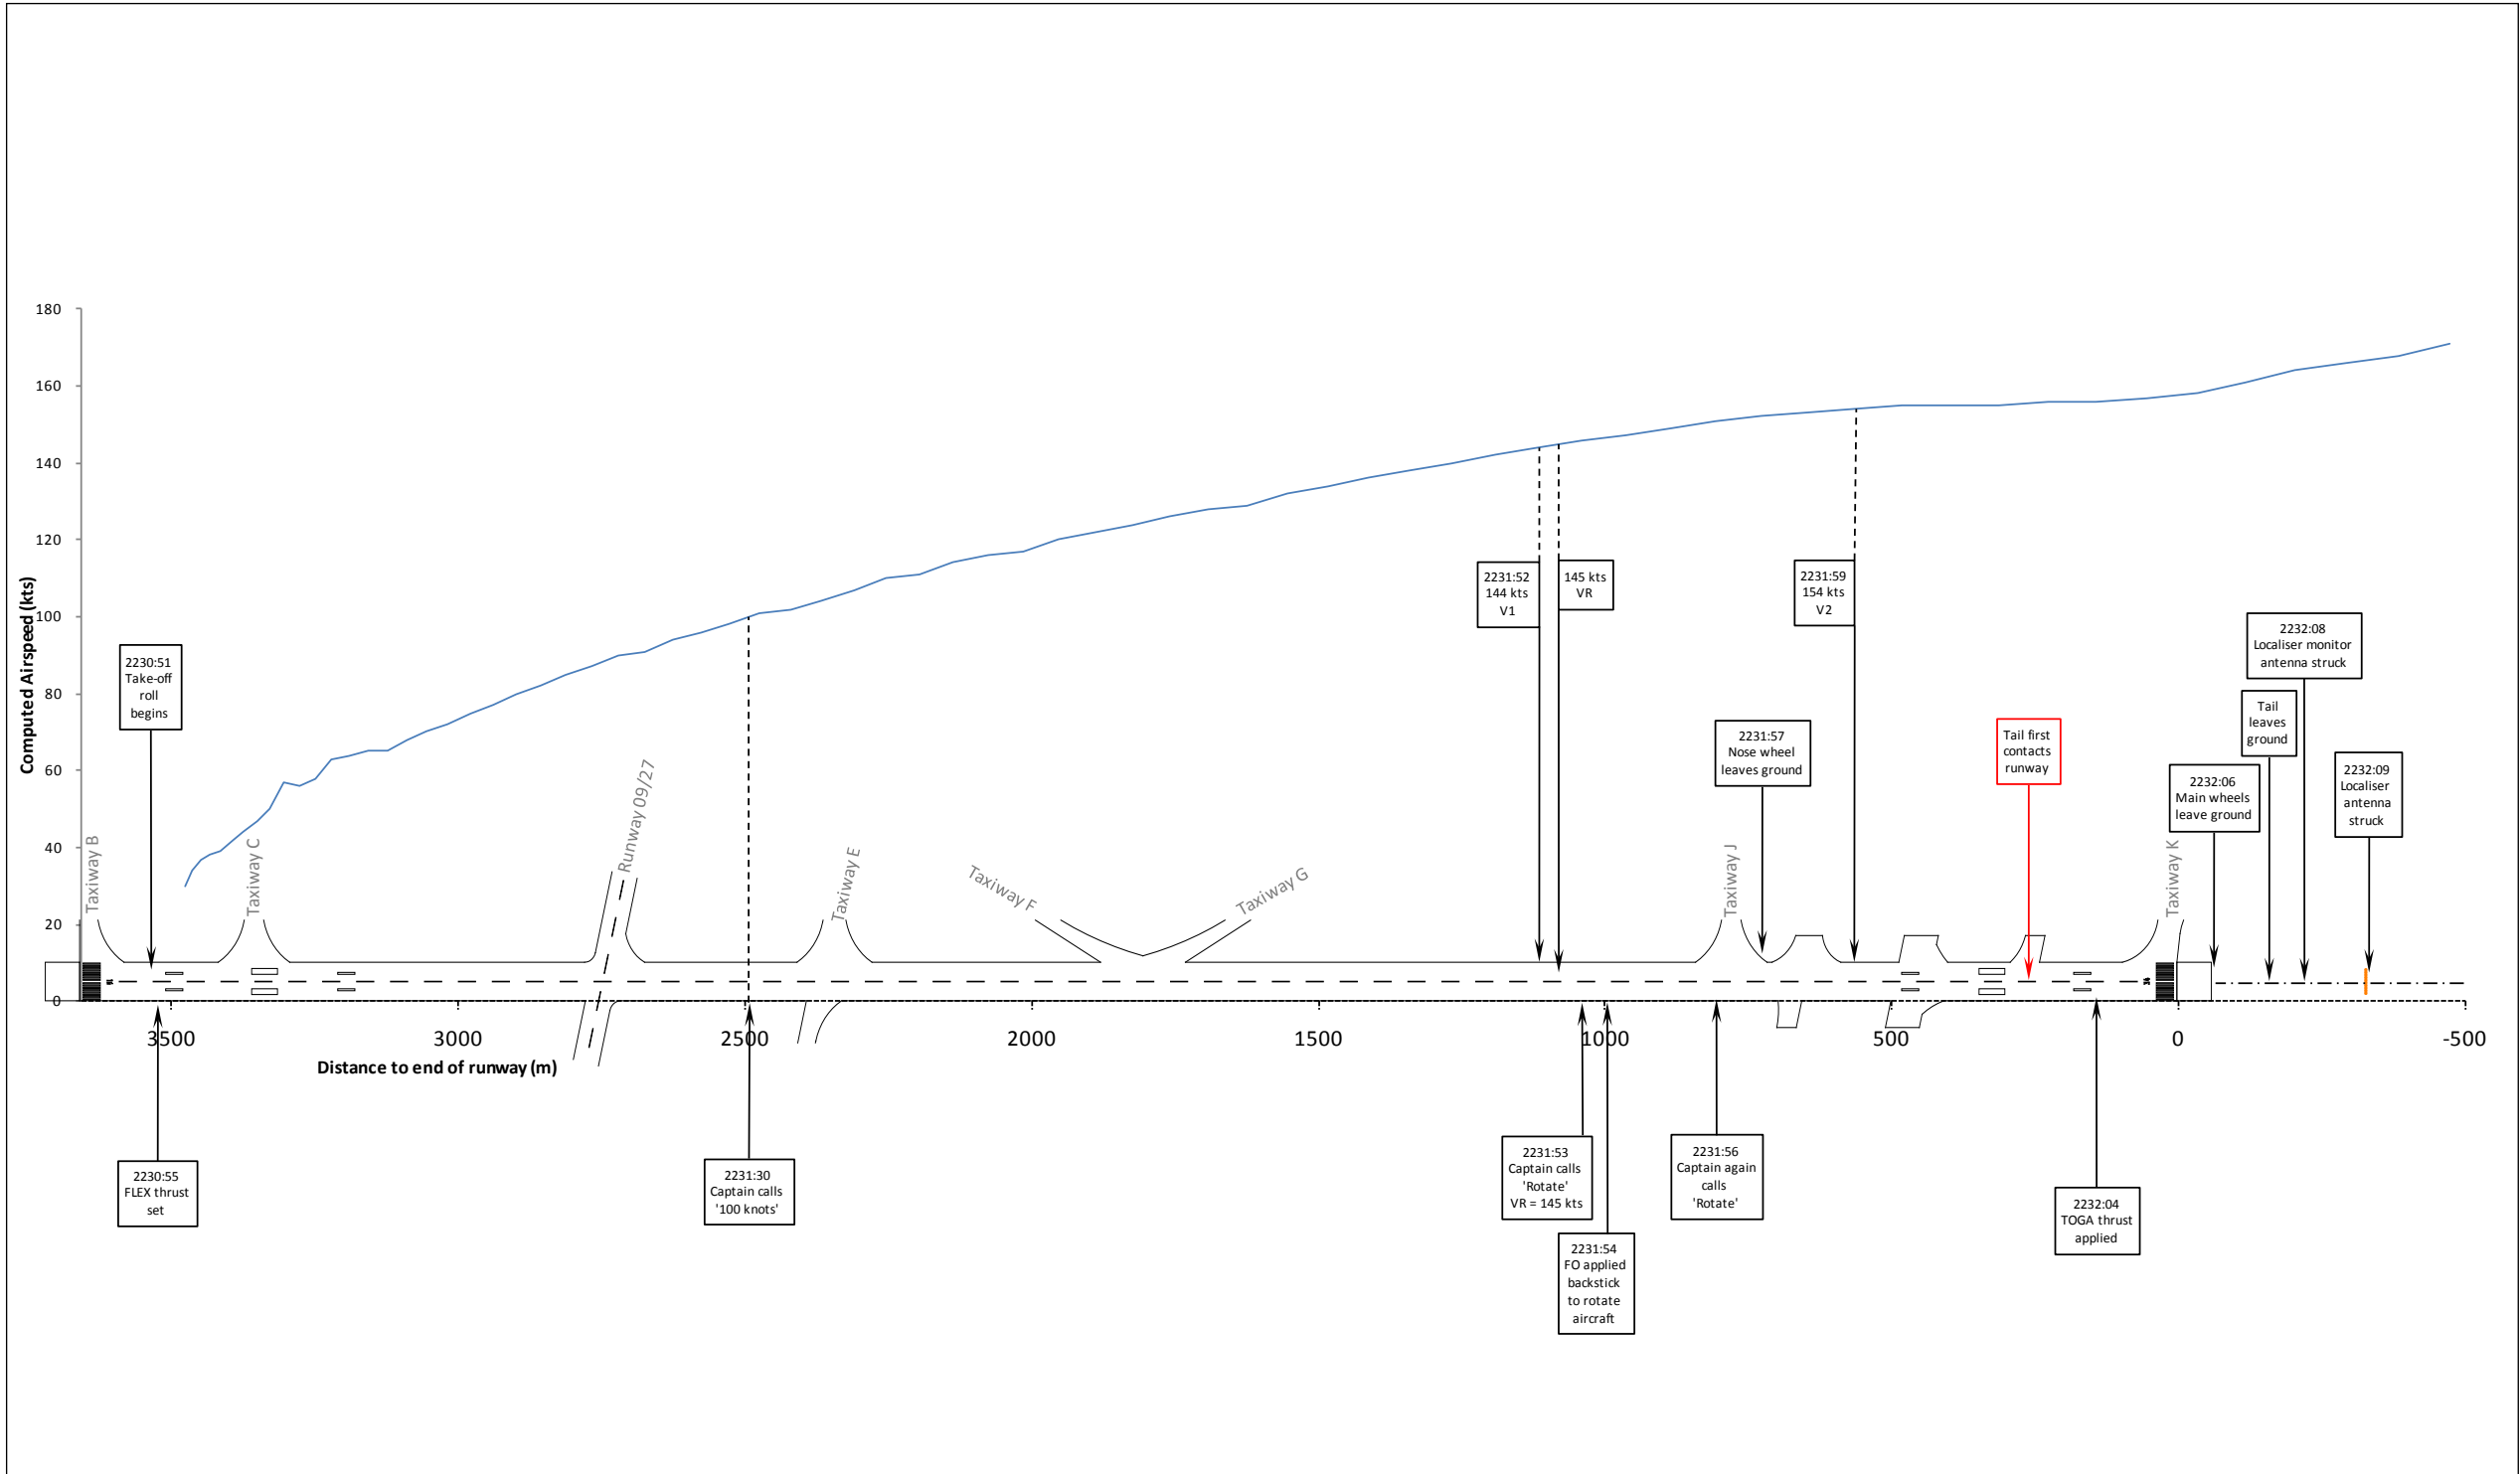
Figure 32: Take-off events

The following is a chronology of the events during the takeoff and initial climb. The aircraft's location and airspeed along the runway during this sequence of events is presented in Figure 32.

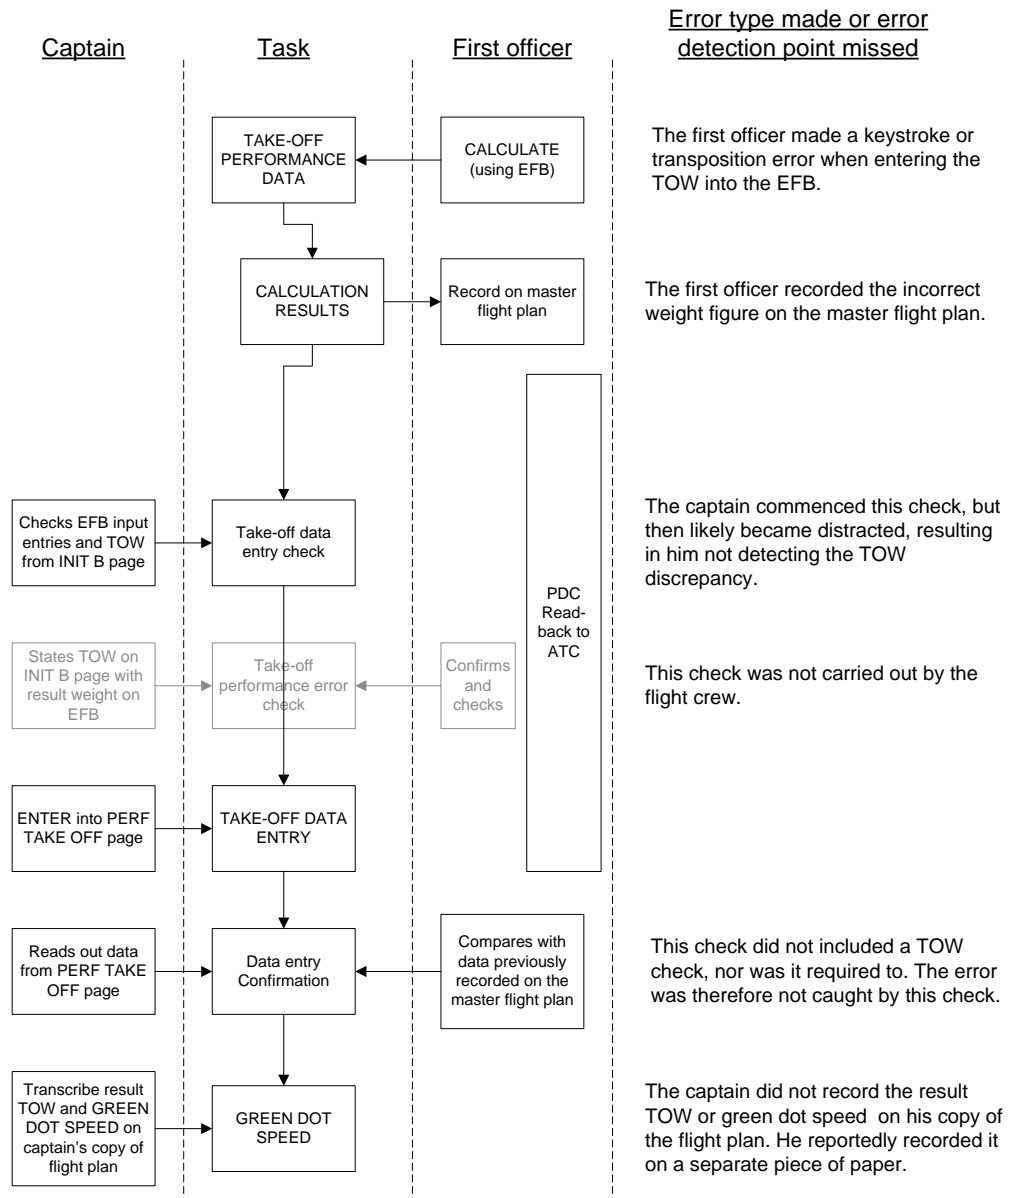
**Figure 33: Take-off performance error check**

The take-off performance error check included a check of the data input into the EFB that was performed silently by the captain, and a verbal check by the captain and first officer of the EFB 'result' take-off weight against the FMGS INIT B page take-off weight (Figure 33).

Although not required by the operator's procedures, had the augmenting captain the opportunity to perform his own check of the take-off performance calculations, he may have detected the take-off weight entry error.

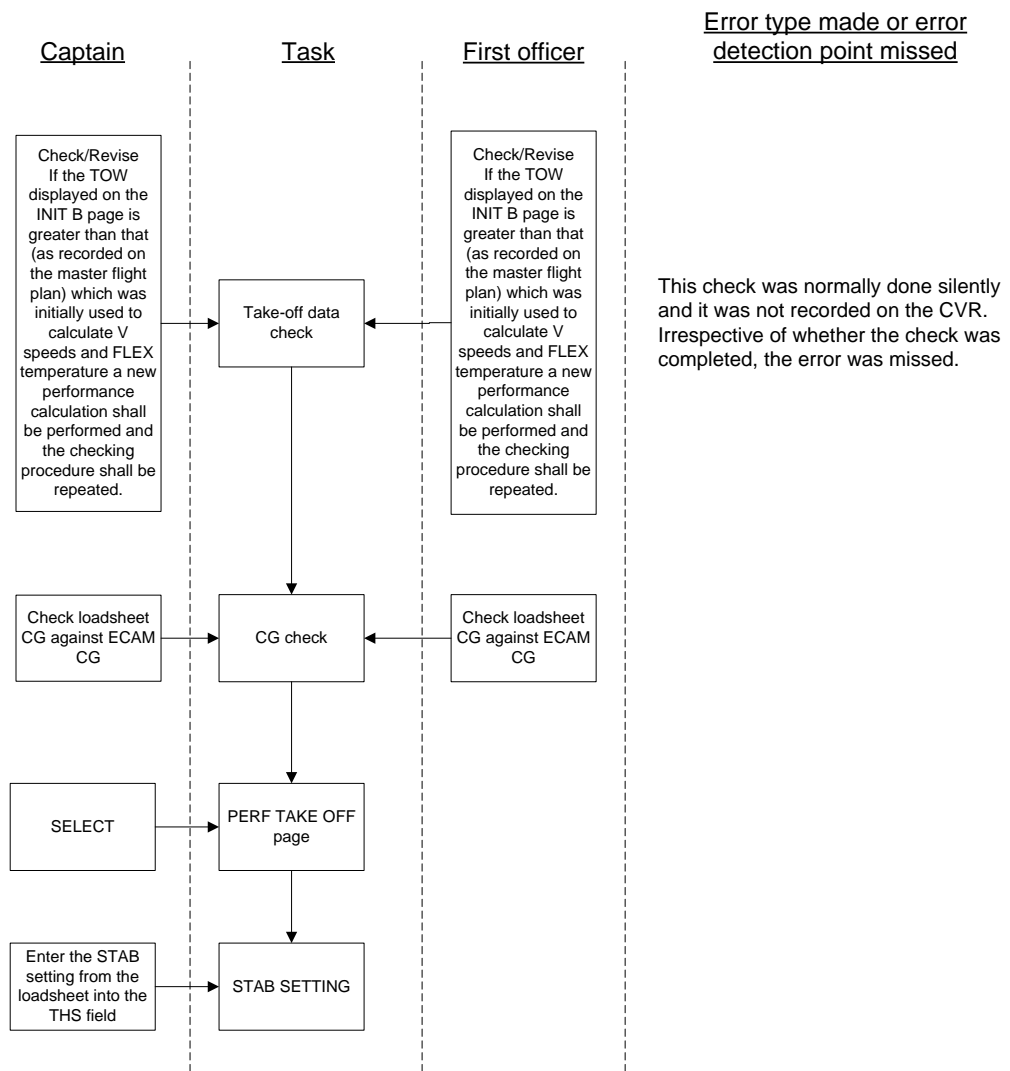
**Figure 34: Take-off data check**

The take-off data check was to be carried out following receipt of the final load sheet, and included a requirement for both crew members to silently verify that the take-off weight displayed on the INIT B page was greater than the FLEX-limiting take-off weight previously recorded by the first officer on the master copy of the flight plan (Figure 34).

The lack of a requirement to verbally verify the two take-off weights prevented the investigation from confirming whether this check was carried out by the crew. However, if it was carried out, it was ineffective and neither the captain nor the first officer detected the erroneous take-off weight.

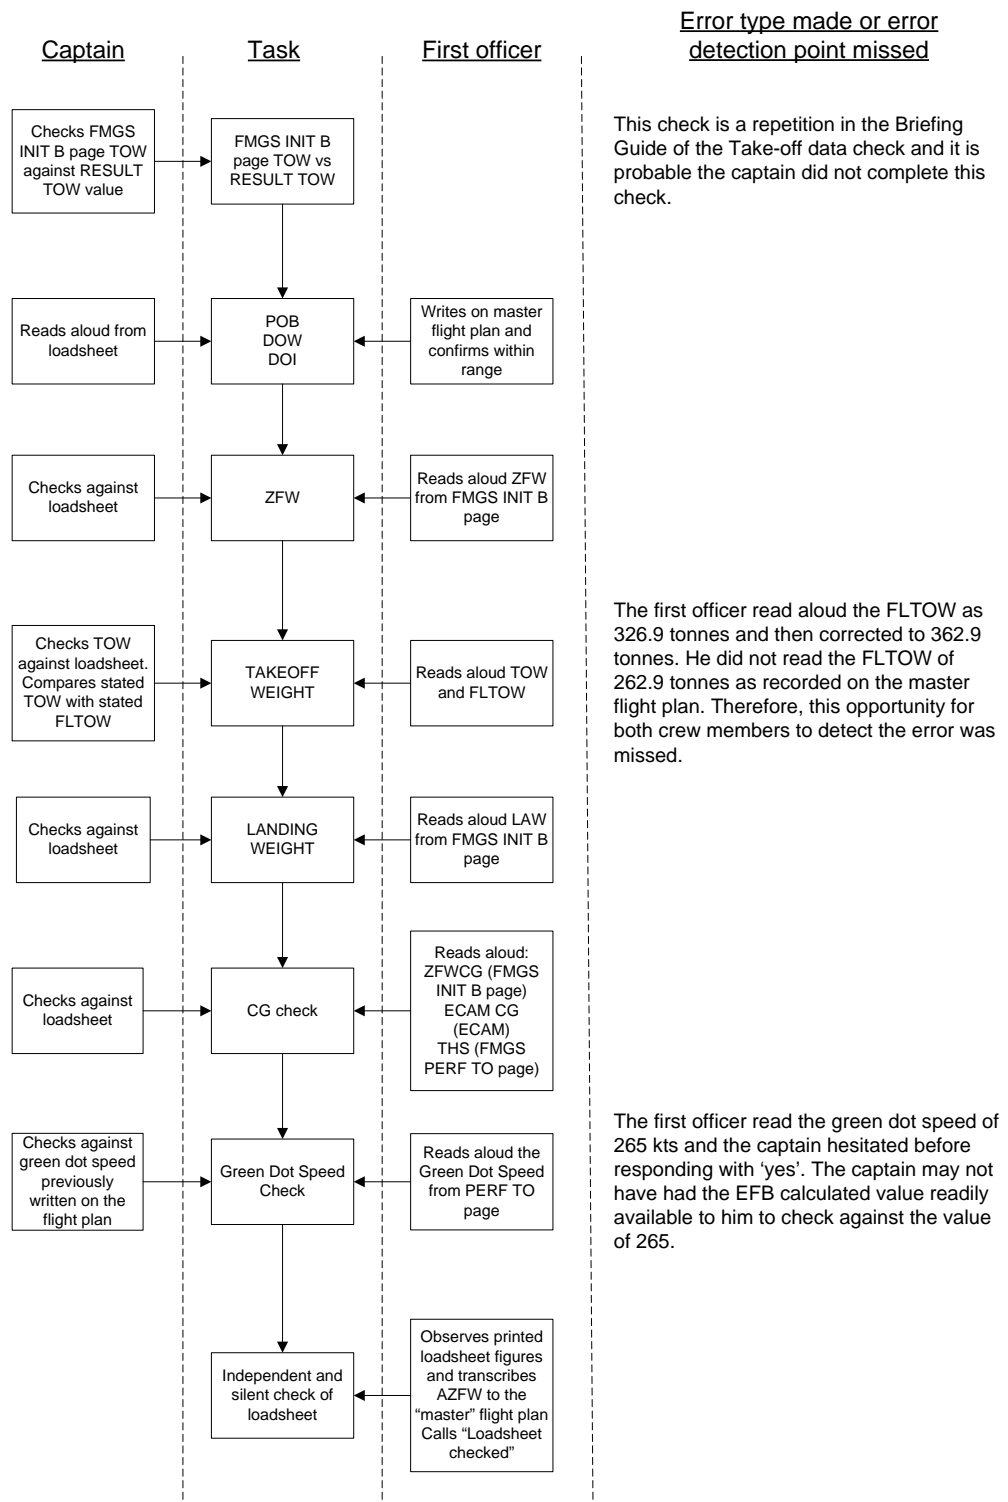
**Figure 35: Loadsheet confirmation procedure**

The loadsheet confirmation procedure provided the final two procedural defences to detect the error in the take-off weight (Figure 35). The first was when the first officer read out the take-off weight from the FMGS INIT B page and then the 'result' take-off weight from the master flight plan.

procedures as a defence was likely reinforced by their previous experience of those procedures routinely detecting such errors.

In summary, the crew's non-detection of the erroneous take-off weight entry in the EFB was multifaceted, and reduced the effectiveness of the procedural checks that could, individually, have detected the error. It is possible for errors to pass

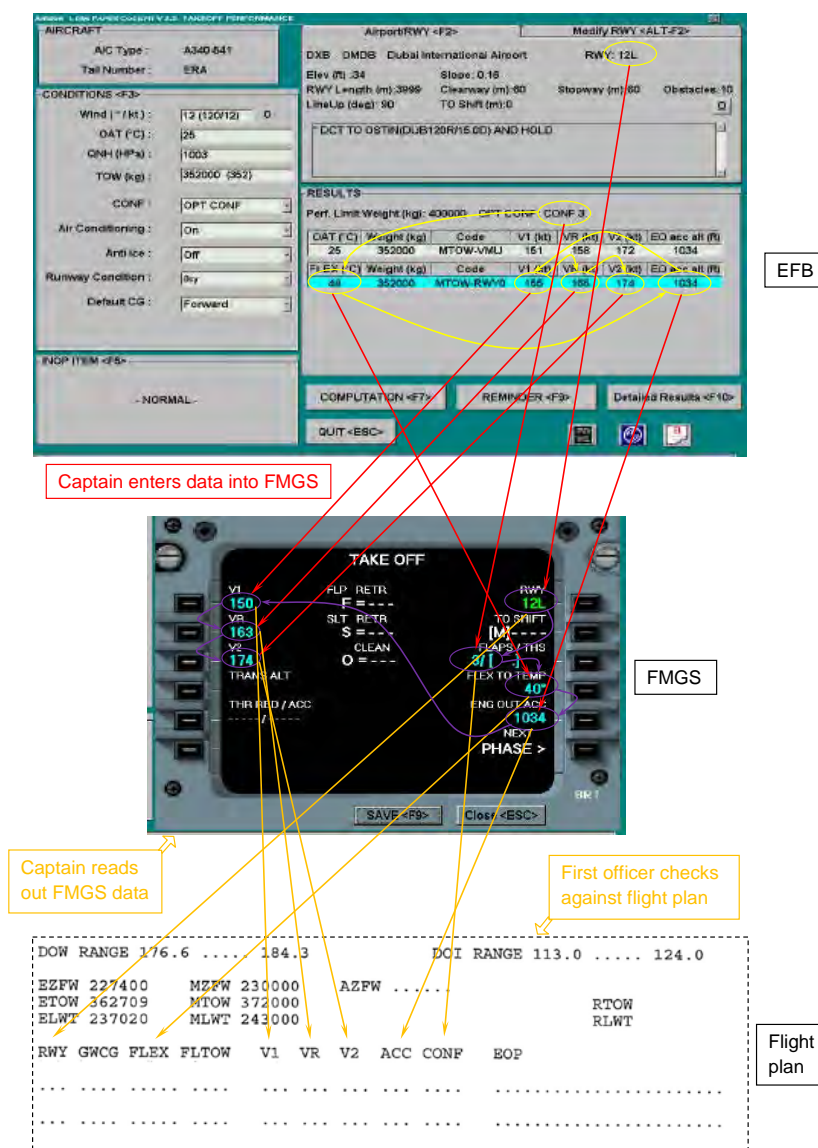
Figure 36: Link analysis on EFB

This included a review of the flow of information into the EFB, from the EFB to the flight plan, from the EFB to the FMGS, and from the FMGS to the final check against the flight plan. Figure 36 shows the link analysis for the flow of information from the EFB to the FMGS and then to the flight plan for the final check.

In addition to the flow of information, a number of other issues were highlighted. The first related to the inconsistency in the weights entered into the EFB and recorded on the flight plan, which varied between tonnes and kilograms. The possibility of transposition errors would be reduced if the units were consistent.

The second issue was related to the initial entry of data into the EFB. The EFB required the user to enter the take-off weight and not the individual ZFW and fuel load figures. The previous incidents highlighted the number of times that the zero fuel weight was entered into the EFB instead of the take-off weight. If the user was required to enter the ZFW, the fuel weight and the take-off weight, the EFB could perform an independent check of the figures to reduce the likelihood of a data entry error.

The final issue related to last-minute changes. To minimise the possibility of conducting last-minute recalculations of take-off performance parameters, it was common practice for users to enter a take-off weight that included an additional weight to account for the maximum permissible last minute change. This created a potential problem because, by adding this margin the flight crew could, inadvertently, enter an incorrect take-off weight into the EFB, or be less likely to identify an error in a weight value entered into the EFB because the original value had been deliberately altered during entry.

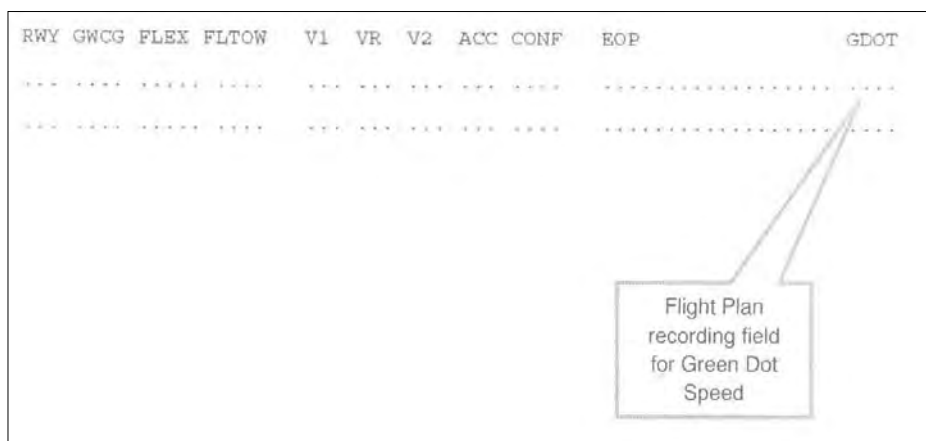
On 21 October 2011, Emirates advised that they had introduced a designated field for the crew to record the green dot speed on the flight plan. An example flight plan showing the location of the green dot speed in the revised plan follows.

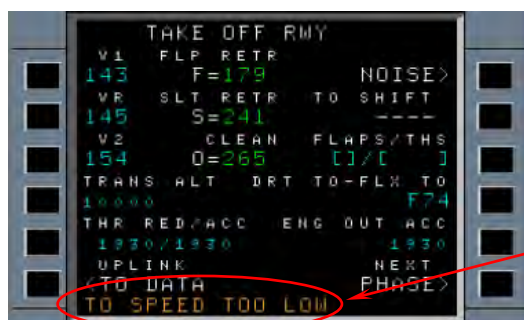
FMGS discrepancy message

On 28 May 2010, Airbus provided the ATSB with the results of a simulation of the TOS function for the A340 using the accident flight take-off performance parameters. The result is shown below.

In July 2009, Airbus announced in their *Safety First* magazine that they were developing a software package called the 'Take-off Securing' (TOS) function. The TOS function automatically checks the data being entered into the flight management and guidance system (FMGS) for consistency between the take-off parameters. A check is carried out on the takeoff reference speeds entered into the FMGS against take-off limitation speeds calculated within the FMGS based on the aircraft weight. If the TOS function detects a discrepancy between these speeds, it alerts the flight crew by displaying a message on the FMGS display unit.
