**ATSB TRANSPORT SAFETY REPORT**

Aviation Occurrence Investigation – AO-2012-130  
Preliminary

**Collision with terrain  
36 km SW of Gympie, Queensland  
1 October 2012  
VH-UXG  
de Havilland Aircraft Pty Ltd DH-84 Dragon**

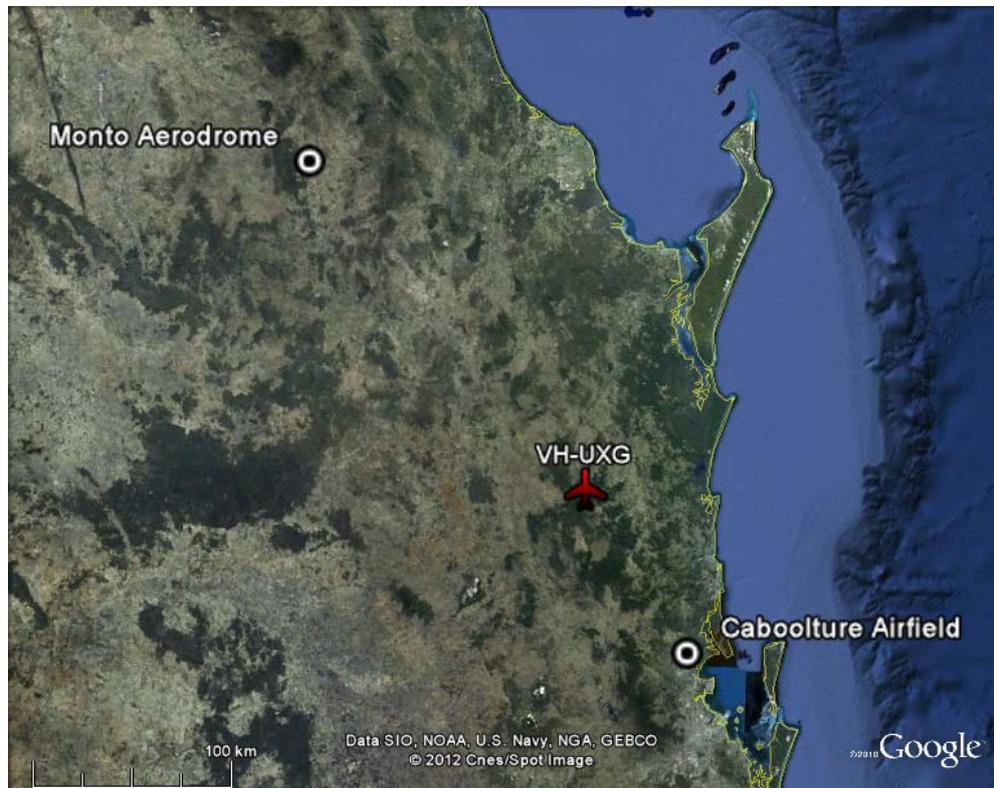
**Figure 1: Accident site location**

A search for the aircraft was coordinated by Australian Search and Rescue (AusSAR).<sup>4</sup> The aircraft wreckage was located on 3 October 2012, about 87 km north-west of Caboolture on the northern side of a steep, densely wooded ridge about 500 m above mean sea level (Figure 1). The Australian Transport Safety

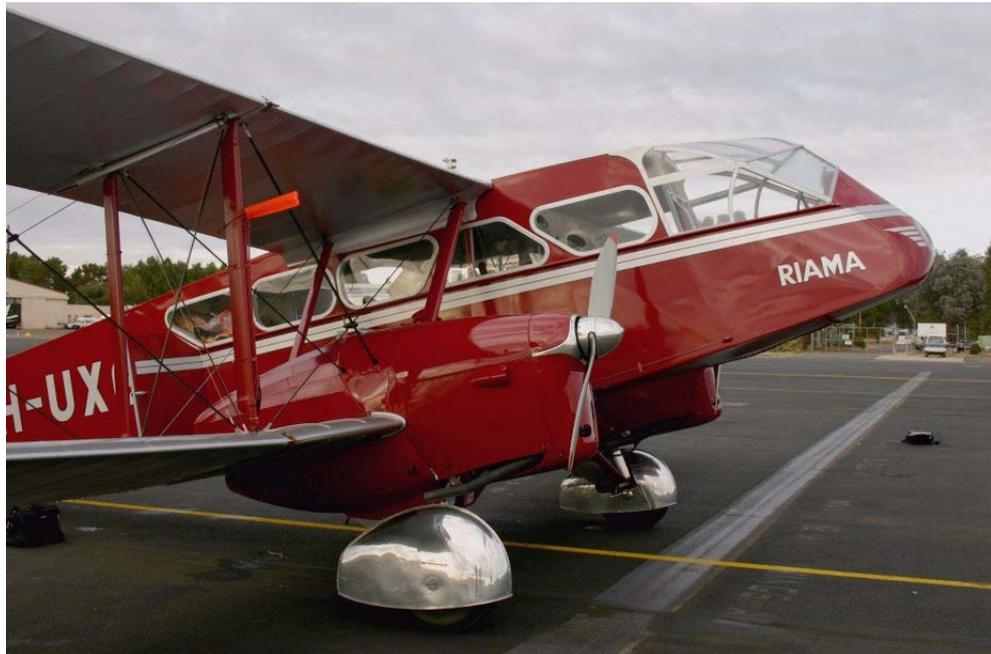
**Figure 3: VH-UXG in 2006**

The aircraft, serial number 6077, was a twin-engine medium transport biplane manufactured in the United Kingdom in 1934, and first registered in Australia in 1936. It later underwent an almost complete rebuild, which was finalised in about 2002 (Figure 3).
