ATSB TRANSPORT SAFETY REPORT

Marine Occurrence Investigation

MO-2011-011

Fatality while storing the products tanker

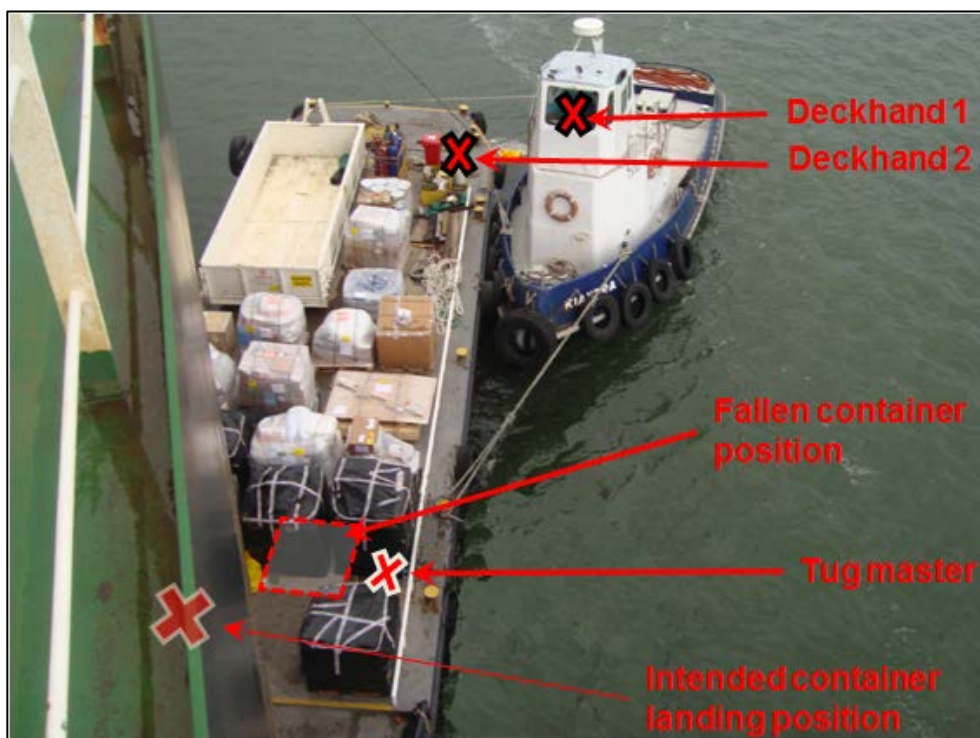
Figure 6: Barge as seen from the deck of *British Beech*

The deckhand in the wheelhouse of the tug heard a bang. He turned and looked forward and could see the container sitting atop the stores pallets on the forward port side of the barge (Figure 6). He then saw the tug master lying on the barge deck with his head on the kick rail at the side of the barge. With a shout of exclamation, he rushed to the tug master's aid.

When the two deckhands reached the tug master, they saw that the container was not lying on the tug master but above him, wedged between the pallets of stores forward and aft of where he lay. The two deckhands moved the container onto the barge's forward deck (Figure 7), away from the tug master, and began providing first aid to the seriously injured man. After checking his vital signs, the second deckhand hurried aft to the tug's wheelhouse to raise the alarm.
