Collision with a tree involving a Cessna 172, VH-EEC

19 km NNW Albany, Western Australia, 13 July 2014

ATSB Transport Safety Report
Aviation Occurrence Investigation
AO-2014-124
Final – 3 September 2014

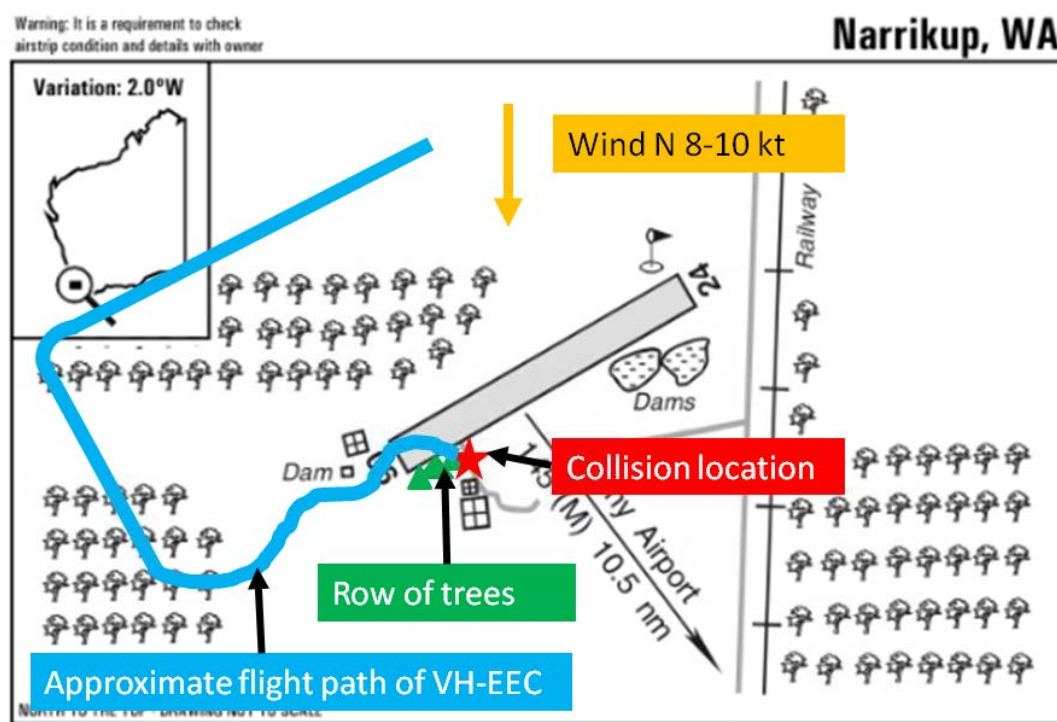
Figure 1: Narrikup – excerpt from The Country Guide

On 13 July 2014, the pilot of a Cessna 172 aircraft, registered VH-EEC (EEC), conducted a private flight from The Lily to Narrikup aeroplane landing areas (ALA), Western Australia (Figure 1), with two passengers on board.
