ATSB TRANSPORT SAFETY INVESTIGATION REPORT  
Aviation Occurrence Investigation No. AO-2008-021  
Preliminary

# Collision with terrain VH-NUK, Pitts S-2A 7 km NE Camden, NSW

18 March 2008

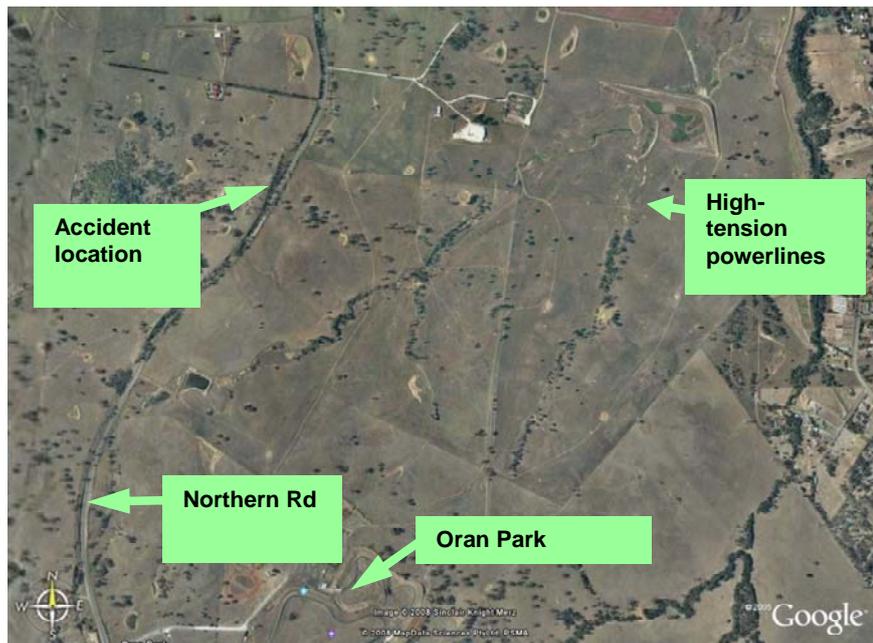
Figure 2: Accident location

Given the aircraft's position at that moment and an intended landing point in a field to its left, the path the aircraft would fly during the PFL lay across a line of high-tension powerlines running approximately south-east/north-west (Figure 2). The instructor asked the candidate if he had seen the powerlines, but there was no reply.

The terrain at the accident site was flat and surrounded by trees (Figures 2 and 3). The aircraft came to rest facing its point of entry to the site with its fuselage partly inverted and the right side of the fuselage facing away from the ground. The rear right side of the fuselage, in the area where the candidate was seated, had been broken open by impact forces.
