ATSB TRANSPORT SAFETY INVESTIGATION REPORT
Aviation Occurrence Investigation AO-2008-026
Interim Factual Report

Collision with water – 19 km SE Sydney, NSW

9 April 2008

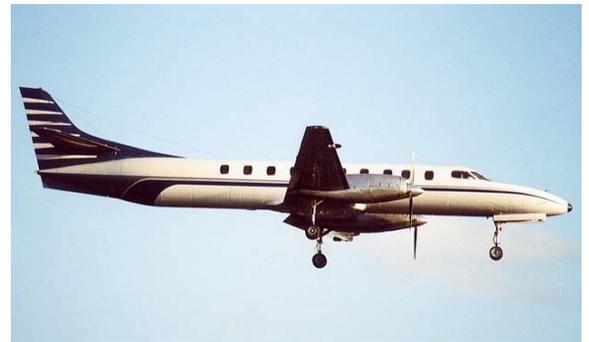
Figure 1: VH-OZA

On 9 April 2008 at 2316 Eastern Standard Time¹, the pilot of a Fairchild Industries Inc. SA227-AC (Metro III) aircraft, registered VH-OZA (Figure 1), taxied at Sydney, NSW, on a freight charter flight to Brisbane, Qld. The flight was operated under the Instrument Flight Rules (IFR) and the pilot was the sole occupant.

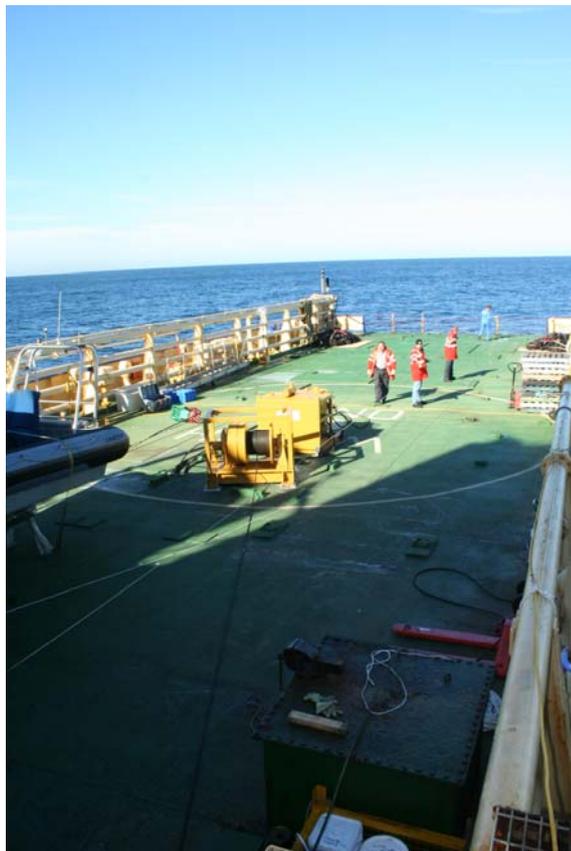
Figure 4: Deck of search and recovery vessel

The vessel contracted for the search and recovery was 76 m in length, fitted with a 3 tonne winch and was dynamic positioning (DP) capable (Figure 4). The DP capability enabled the vessel to maintain a geostationary position within 1 m using Omnistar navigation.
