Missing aircraft, VH-WRT, GA-8 Airvan, Buckingham Bay, NT. 16 Oct 2008

INFRA-08361

Abstract

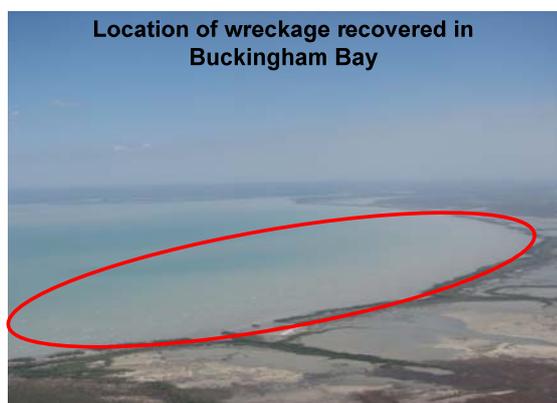
Figure 3: South-western part of Buckingham Bay

On 17 October 2008, items of wreckage were found in the south-western part of Buckingham Bay (Figure 3).

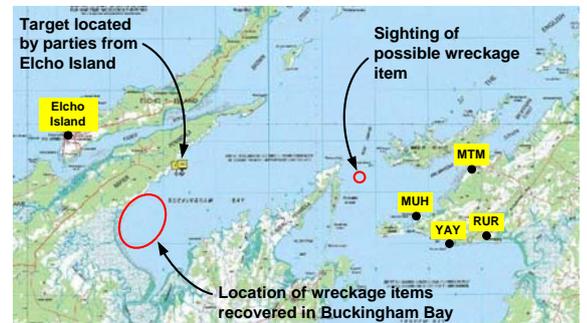
Figure 7: Location of wreckage recovered and sighted, and a possible wreck target

A target on the sea bed located by parties from Elcho Island using a side-scan sonar on the

western side of Buckingham Bay, just south of the direct track between Elcho Island Airport and MataMata, was at first thought to be the aircraft. NT Police divers searched this area, but found nothing at that site.

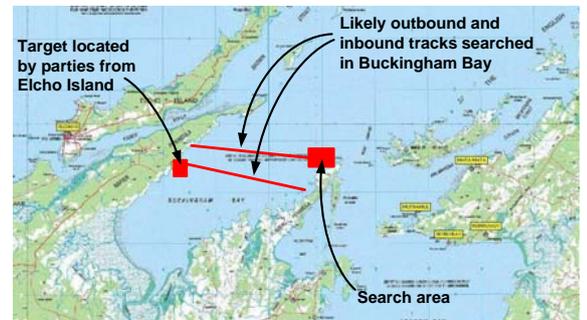
Figure 8: Location of NT Police and ATSB search effort

Subsequently, a systematic 6-day search was conducted by the NT Police and the Australian Transport Safety Bureau (ATSB) in the area around the suspected target mentioned above, as well as in the area west of the northern end of the Flinders Peninsula, and across Buckingham Bay along the possible outbound and return tracks it was believed the pilot would have been most likely to take (Figures 7 and 8).

Despite the use of side-scan sonar, a Remotely Operated Underwater Vehicle (ROV), and police divers, the wreckage of VH-WRT was not located.
