Derailment of Freight Train 6MP9 near Hines Hill, Western Australia 10 March 2008

INFRA-08438

ABSTRACT

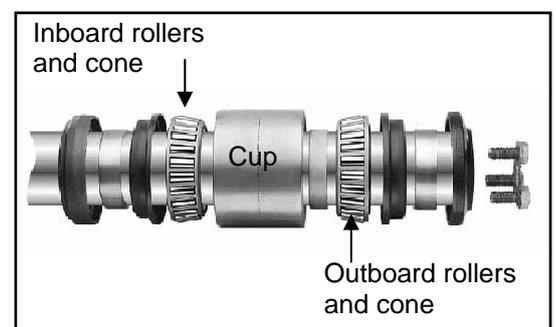
Figure 4: Roller bearing package

Based on the evidence available, the investigation determined that wagon ABFY2797U derailed due to a 'screwed journal' as a result of bearing number 189560 failing.

There was insufficient evidence to positively conclude what factor may have contributed to in the premature failure of the tapered roller bearing unit on wagon ABFY2797U.

SCT Logistics have implemented an upgrade program for ABFY wagons whereby the 50 t bogies are replaced with 70 t bogies, which use bearings other than 10 X 5.5 inch. To date, no other bearings have been found with any defects that may lead to a failure. All but a very few of the 50 t bogies have been phased out of service.
