Derailment of train 3DM4 near Manton Dam NT

22 April 2008

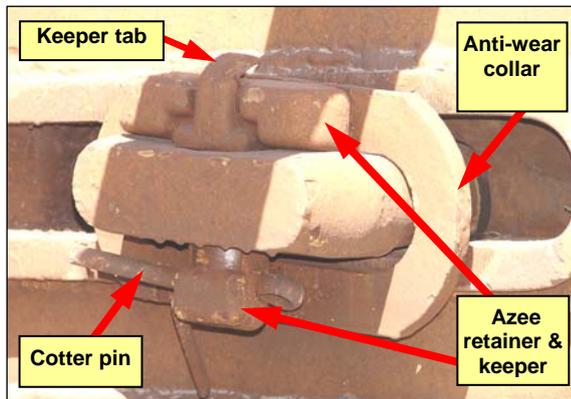
pins with and without anti-wear collars (Figure 5 and Figure 6). Azee⁵ drop-forged retainers, with and without the keeper, were also found on various wagons. It is of note that negligible retainer pin contact wear was evident on the draft sill lips where anti-wear collars had been fitted over the ends of the draft keys.

Figure 5: 'Azee' draft key retainer with keeper, anti-wear collar & cotter pin (correctly installed on another wagon in the consist)

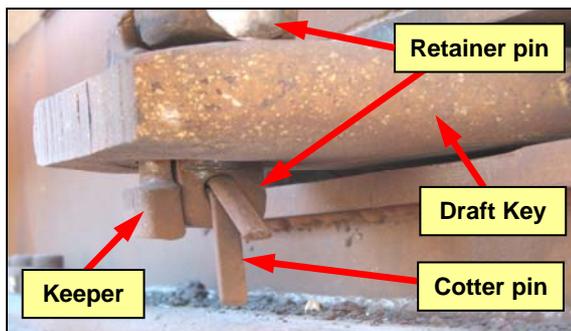
Figure 6: Detail assembly of draft key with Azee key retainer, keeper and cotter pin.

Subject matter published by Ireco LLC, the manufacturer of the Azee draft key retainer assembly, states that the keeper 'bendable tab can be straightened and reused several times.' When assembled, the flat keeper tab folds over the top of 'T' shaped retainer pin. The Azee key manufacturer states that the cotter pin is an A.A.R⁶ requirement, but it is not required to keep the device within the draft key (Figure 6).

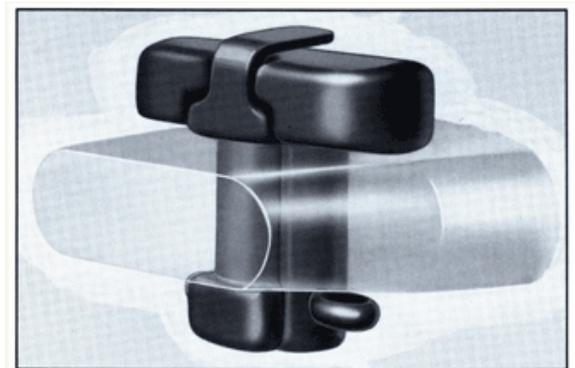
When assembled correctly, the two functions of the Azee key keeper are to key the retainer pin and keeper together and lock the assembled retainer and keeper in the draft key hole as a unit. This means that even if the cotter pin fails and is lost from the Azee key assembly, the Azee key will remain intact as a unit and not work up and out of the draft key hole.

Figure 7: 'Azee' drop forged draft key retainer and keeper assembly

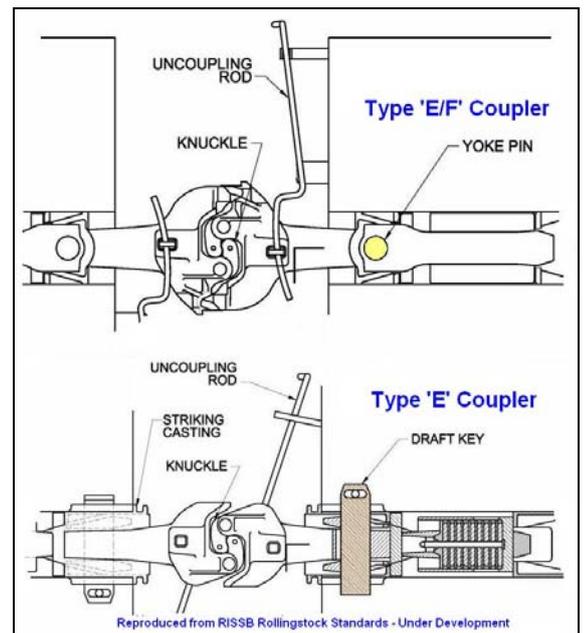
On 12 September 2006, a derailment occurred near Seymour, Vic., as a result of the failure of a coupler on a CFCLA CQBY wagon. The derailment was investigated by the ATSB⁹ and was very similar to the derailment near Manton Dam on 22 April 2008. The ATSB's investigation report highlighted safety issues with CQBY wagons manufactured in China that were shipped with draft key and retainer pin coupler (Type 'E') assemblies. Subsequent CQBY wagons have been manufactured with vertical pin type 'E/F' couplers that eliminate the use of draft keys (Figure 9). The Australian Code of Practice for rolling stock recommends Type E/F coupler assemblies as standard fitment.

Figure 9: Comparison of coupler assemblies - Type E/F (top) and Type E draft key (bottom)
