# Loss of separation involving Boeing 717, VH-NXQ and Boeing 737, VH-VXM

near Darwin Airport, Northern Territory | 2 October 2012

**ATSB Transport Safety Report**  
Aviation Occurrence Investigation  
AO-2012-131  
Final – 2 October 2014

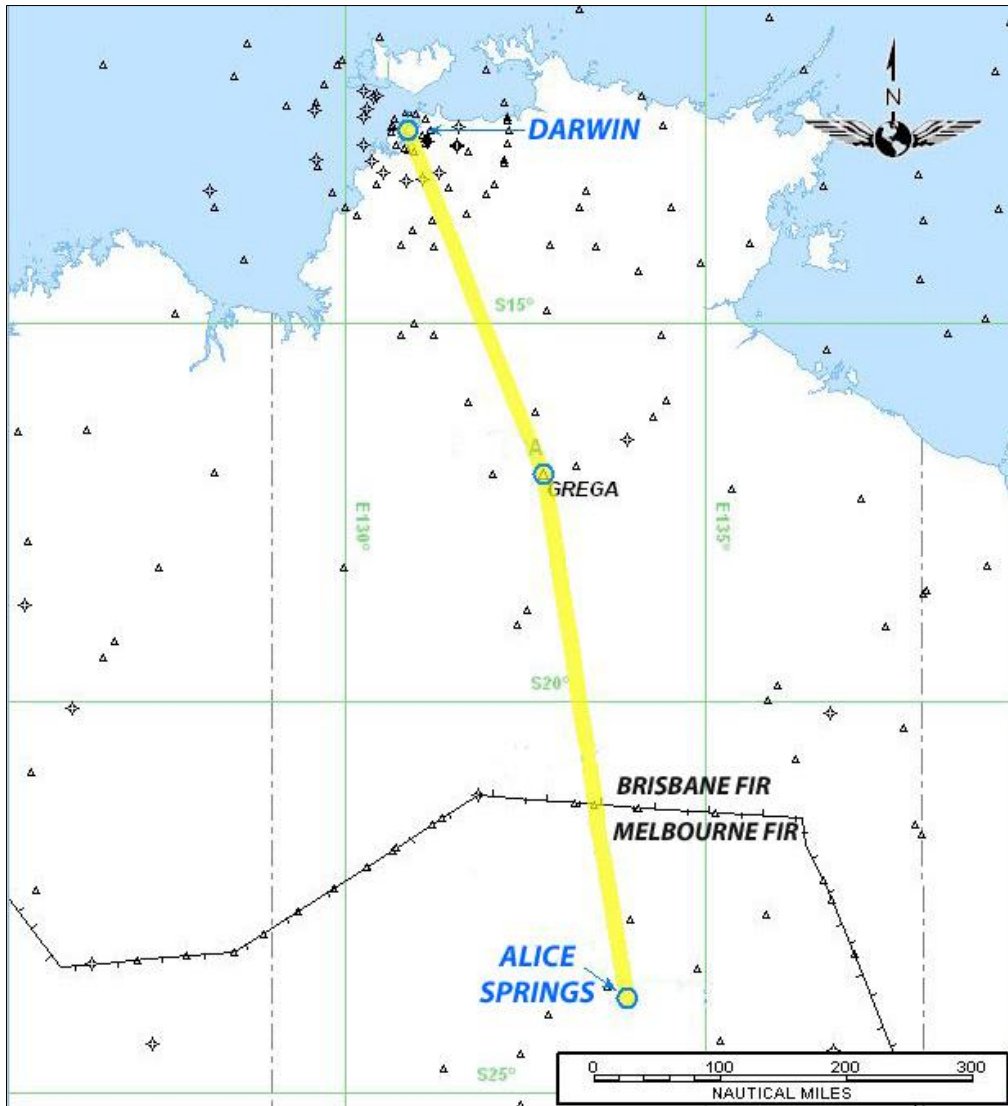
**Figure 2: 717 flight planned route**

At 0620 on 2 October 2012, a flight plan was submitted for the 717's flight from Alice Springs to Darwin. The flight was planned to commence within the civilian-controlled airspace within the Melbourne Flight Information Region (FIR)<sup>3</sup> before entering the Brisbane FIR (Figure 2). The aircraft was scheduled to depart at 1205. The flight plan was disseminated to the civilian air traffic services provider's computer system, The Australian Advanced Air Traffic System (TAAATS), and the DoD's ATC computer system, the Australian Defence Air Traffic System (ADATS).

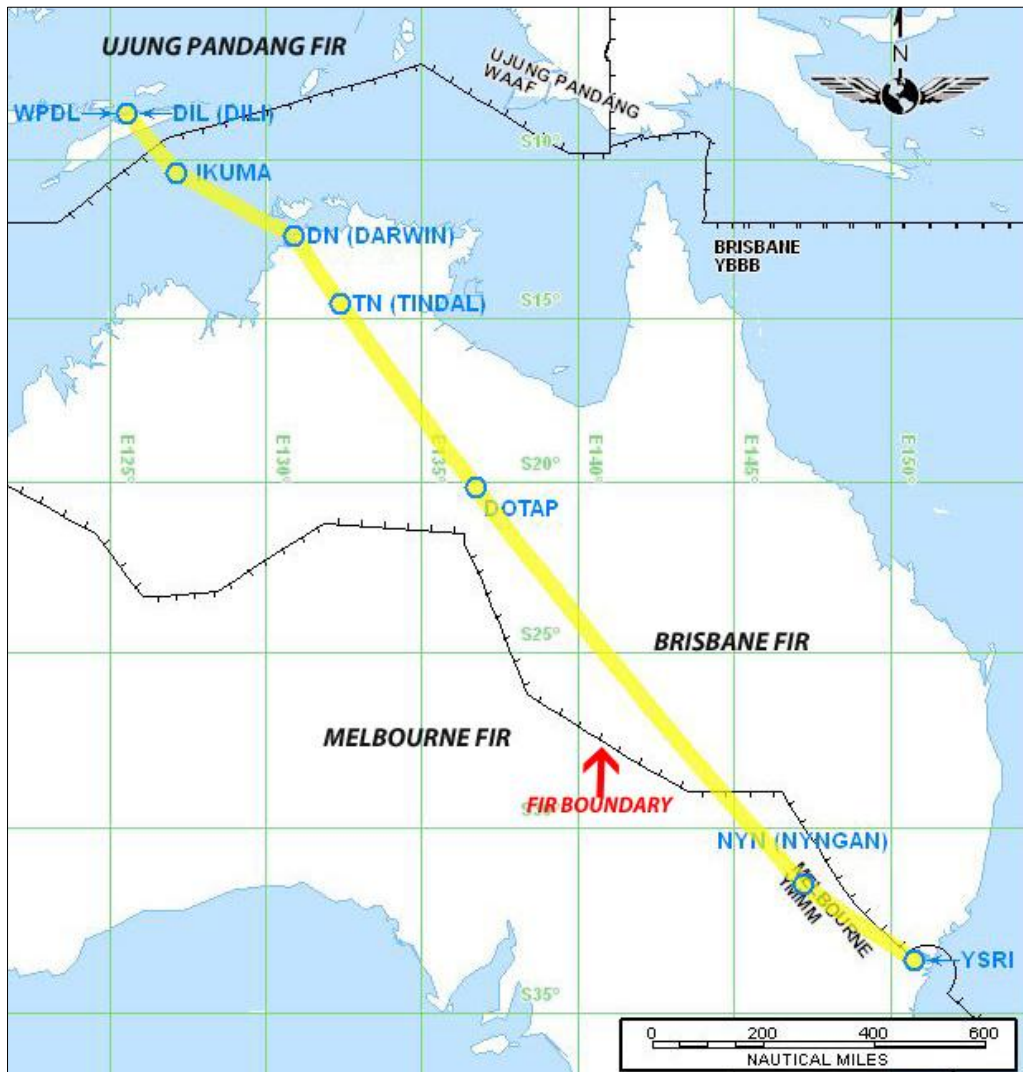
Figure 3: C130 flight planned route

At 0636, a flight plan was submitted for the C130's flight from Richmond to Dili. The flight was planned to enter civilian-controlled airspace within the Melbourne FIR before transiting through the Brisbane FIR into the foreign controlled Ujung Pandang FIR (Figure 3). Within the Brisbane FIR, the flight was planned to transit at high level overhead Darwin under civil ATC jurisdiction (that is, the jurisdiction of controllers from Airservices Australia's Brisbane Centre). It was not planned to descend into Darwin military controlled airspace en route to its destination, and therefore Darwin ATC did not receive a copy of the C130's flight plan.

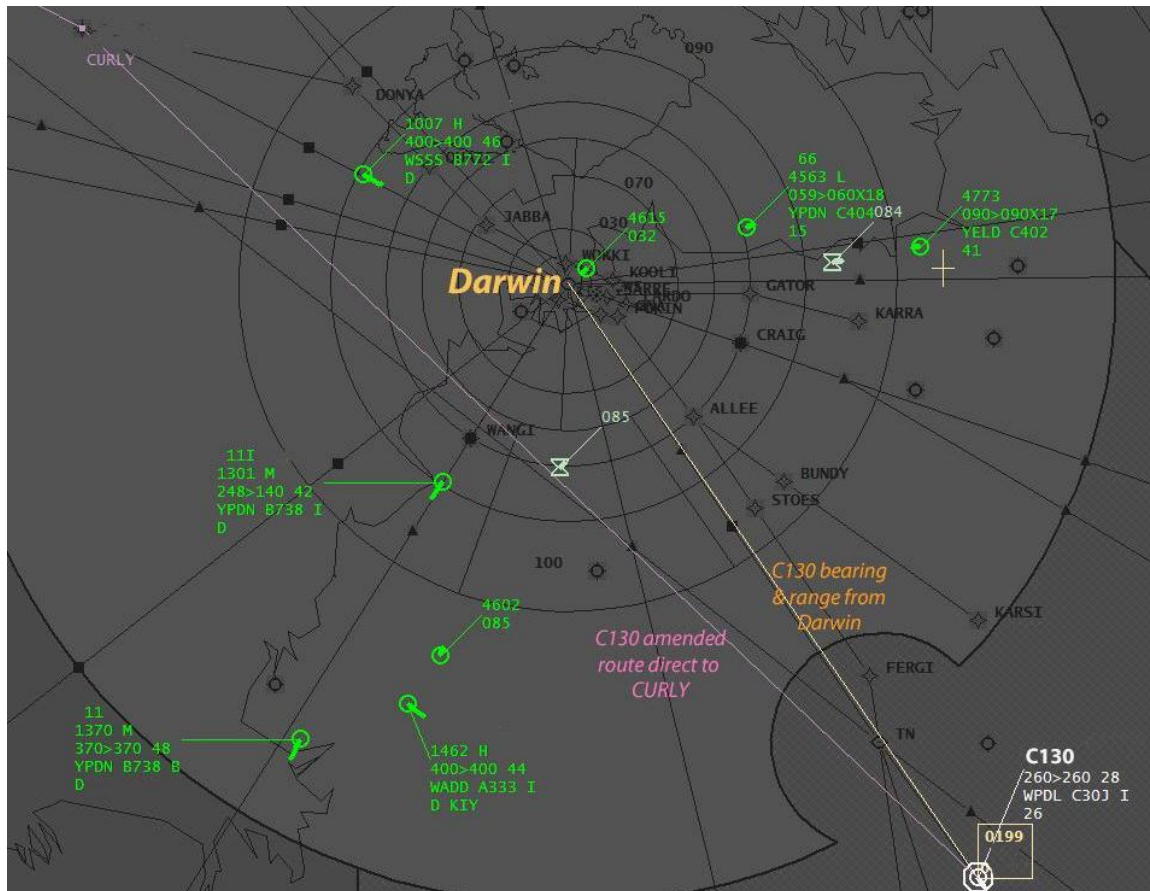
**Figure 4: C130 amended route at 1305:29 (TAAATS display)**

At about 1305, when the C130 was 199 NM (369 km) south-east of Darwin at flight level (FL)<sup>7</sup> 260, Brisbane Centre re-cleared the aircraft direct to position CURLY, which was located 150 NM (278 km) north-west of Darwin. With the amended tracking, the C130 would no longer fly overhead Darwin, but pass to the south-west (Figure 4).

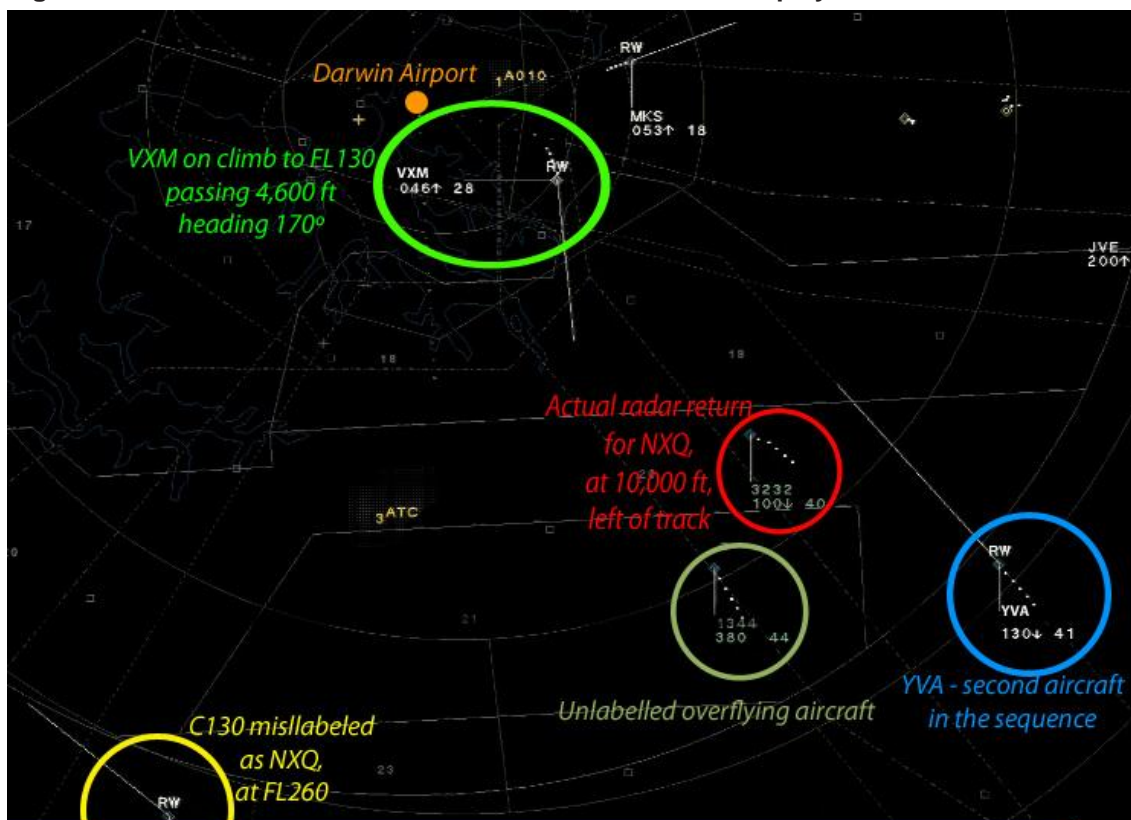
Figure 7: Position of aircraft on the ADATS situation data display at 1343:02

At this time (1343:02), the 717 (with no call sign in its label) was 23.2 NM (43 km) south-east of Darwin, maintaining 10,000 ft, with a groundspeed of 390 kt. In about the 717's 1 o'clock<sup>11</sup> position, at 15.7 NM (29 km), was VXM climbing through 4,600 ft with a groundspeed of 280 kt. YVA was 38 NM (70 km) to the south-east of Darwin, descending through FL 130 with a groundspeed of 410 kt. The C130 (mislabelled as NXQ) was 42.7 NM (79 km) south-south-west of Darwin, maintaining FL 260, with a groundspeed of 290 kt (Figure 7).
