Collision with terrain involving an Air Tractor AT-502B, VH-PTF

45 km W of Moree Airport, New South Wales, on 18 December 2014

ATSB Transport Safety Report
Aviation Occurrence Investigation
AO-2014-191
Final – 26 February 2015

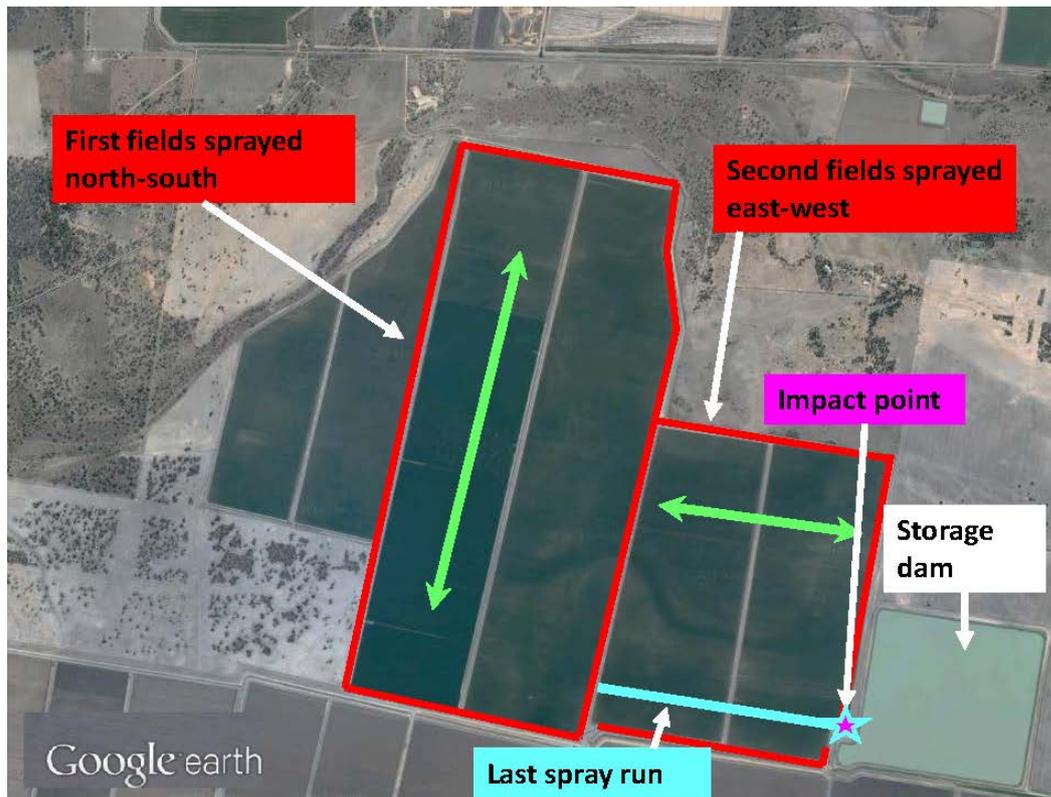
Figure 1: Spray areas and impact location

The job consisted of spraying four fields (Figure 1), and the operator had tasked three aircraft, including PTF, to complete the job. The pilots first sprayed the two western-most fields, operating in a north-south direction. To avoid a property to the north-east of the treatment area, the two remaining fields were sprayed in an east-west direction.

The pilots established three parallel racetrack patterns to operate in, with the pilot of PTF operating at the southern end of the field. The pilot overflowed the storage dam wall heading east, in order to set up the reference points in the GPS, which established the racetrack pattern to be flown. At that time, he observed the dam wall and the sun was rising but obscured by cloud. The pilot then turned the aircraft towards the west and commenced the first spray run, again overflying the dam wall. At about 0700, after completing that spray run, the pilot turned the aircraft to the east again for the second spray run.
