Safety summary

On 3 October 2013, immediately before *HC Rubina* sailed from Beira, Mozambique, the control system for its controllable pitch propeller failed. The ship subsequently made its voyage to Brisbane, Australia, with the propeller's pitch manually operated from the local control station.

On the afternoon of 29 October 2013, a pilot boarded *HC Rubina* for its passage in to Brisbane. While the ship was being manoeuvred off its berth, a flexible coupling for the shaft alternator that was providing power to the bow thruster, suddenly failed. The aft end of the engine room rapidly filled with smoke, forcing the engineer controlling the propeller pitch to leave the local station. Consequently, the ship's propulsion was no longer being controlled and the ship made contact with the wharf, sustaining minor damage.

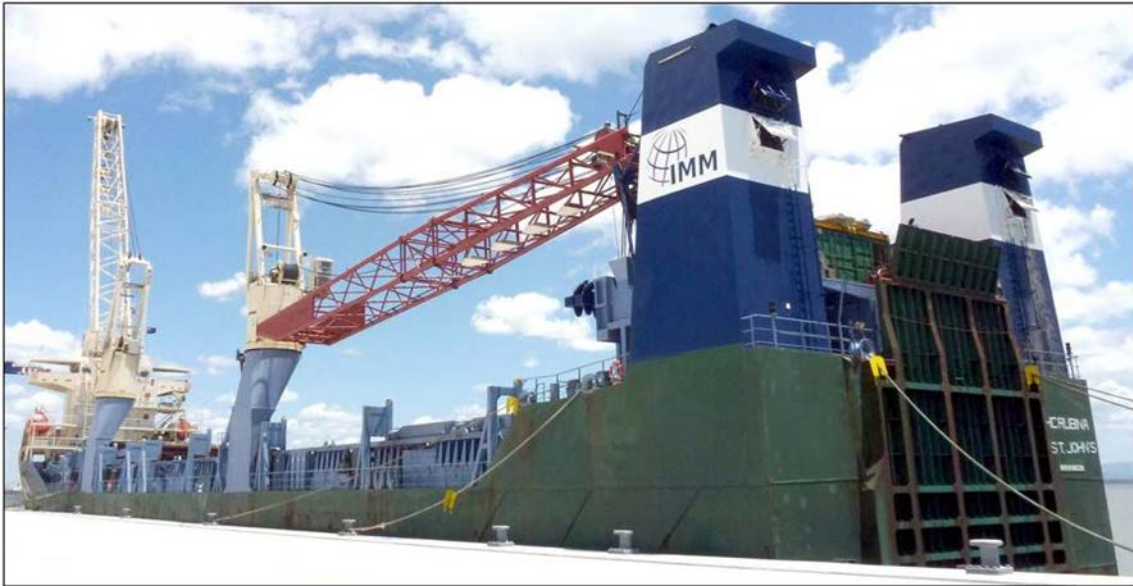
Figure 1: *HC Rubina*

On 3 November 2013, the crew of the 127 m general cargo ship *HC Rubina* (Figure 1) tested the ship's equipment before departing the port of Beira, Mozambique. During the tests, they found that the controllable pitch propeller (CPP) would not respond to bridge or engine control room commands. The CPP could only be controlled using the local station manual controls which were located at the aft end of the engine room, near the main engine flywheel.

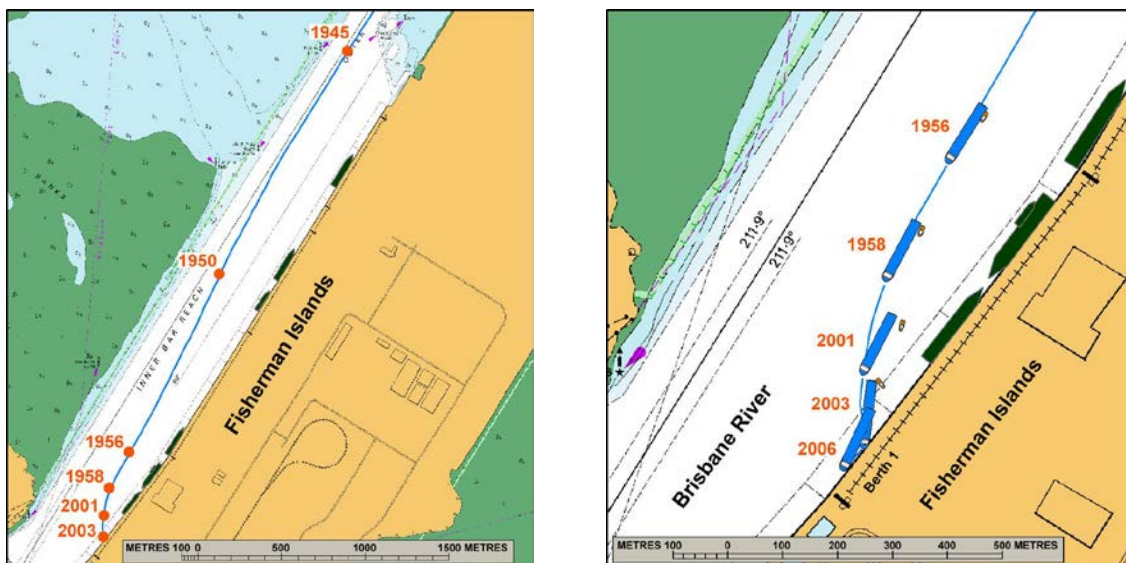
Figure 2: Section of navigational chart Aus 237 showing *HC Rubina*'s track

At about 1945, *HC Rubina* entered the Brisbane River (Figure 2) and the pilot began to slow the ship. At about this time, the shaft alternator was set up to supply power directly to the bow thruster.

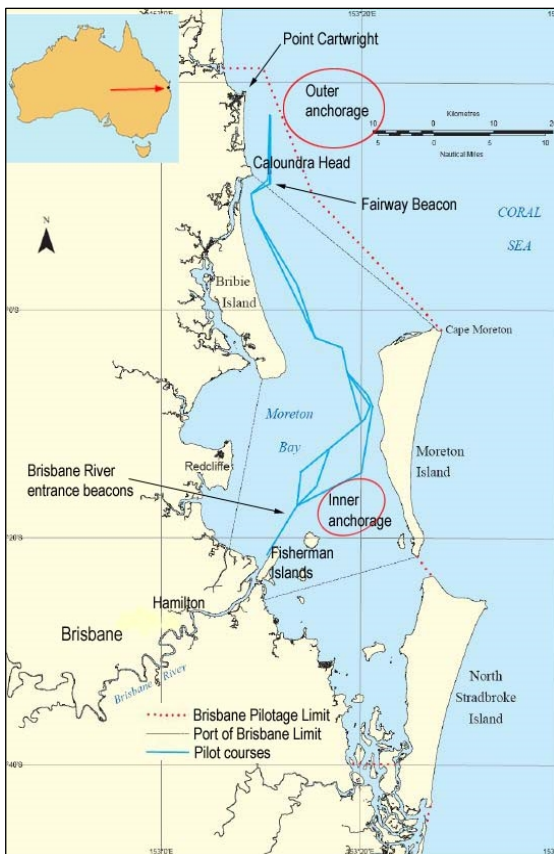
Figure 3: Port of Brisbane

The city of Brisbane lies on Australia’s east coast and is the capital and principal port of Queensland. The city is located in the south-east corner of Queensland on the Brisbane River as it enters Moreton Bay. The port (Figure 3) extends on both banks of the river for about 12 miles⁷ upstream from the entrance beacons. All berths in the port are located in the Brisbane River or at its mouth.
