# In-flight break-up involving a DJI S900 remotely piloted aircraft

Toowoomba, Queensland, on 19 September 2015

**ATSB Transport Safety Report**  
Aviation Occurrence Investigation  
AO-2015-112  
Final – 22 December 2015

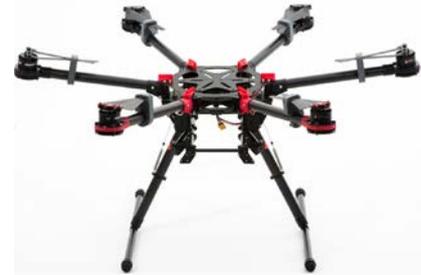
**Figure 1: Innermost layer showing loose filaments**

Within the unidirectional plies around the fracture site, there were regions where the carbon fibres were not well consolidated or bonded with the resin matrix. Figure 1 shows some of the loose filaments observed on the innermost layer of the tube.

The ATSB was unable to determine whether or not pre-existing damage was present from prior operation or transit. However, the ATSB identified regions close to the fracture surface where fibres were not well consolidated within the resin. This may have affected the strength of this arm, possibly resulting in the in-flight failure.

The observed lack of bonding between fibre and resin is a result of manufacturing processes and would not have been caused by damage during transport or operation.
