Smoke and fumes event involving Boeing 787, N36962

110 km E of Port Macquarie Airport, New South Wales, 17 April 2016

ATSB Transport Safety Report
Aviation Occurrence Investigation
AO-2016-033
Final – 25 August 2016

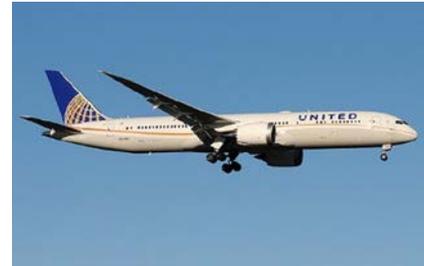
Figure 1: Rear section of a B787-9 depicting aft galley

On 17 April 2016, a Boeing 787-9, registered N36962, operated by United Airlines as flight UAL870, departed Sydney, New South Wales (NSW), for San Francisco, United States. On board were 4 flight crew, 11 cabin crew and 238 passengers. During the departure, cabin crew switched on the aft galley ovens (Figure 1) in preparation for meal services.

After the two ovens were switched on, there was a short burst of smoke, which set off a fire alarm in a nearby toilet for about one minute. One of the ovens displayed a “FAILURE” message. Several cabin crew detected a strong chemical odour and an electrical smell, as well as a blue haze. Other crew described it as an ozone smell. The oven interactive screen displayed a ‘Critical Error- Broken Fuse’ message.
