Synthetic vision display error involving Pilatus PC-12 VH-OWA

Meekatharra Airport, Western Australia, 18 June 2016

ATSB Transport Safety Report
Aviation Occurrence Investigation
AO-2016-064
Final – 17 January 2017

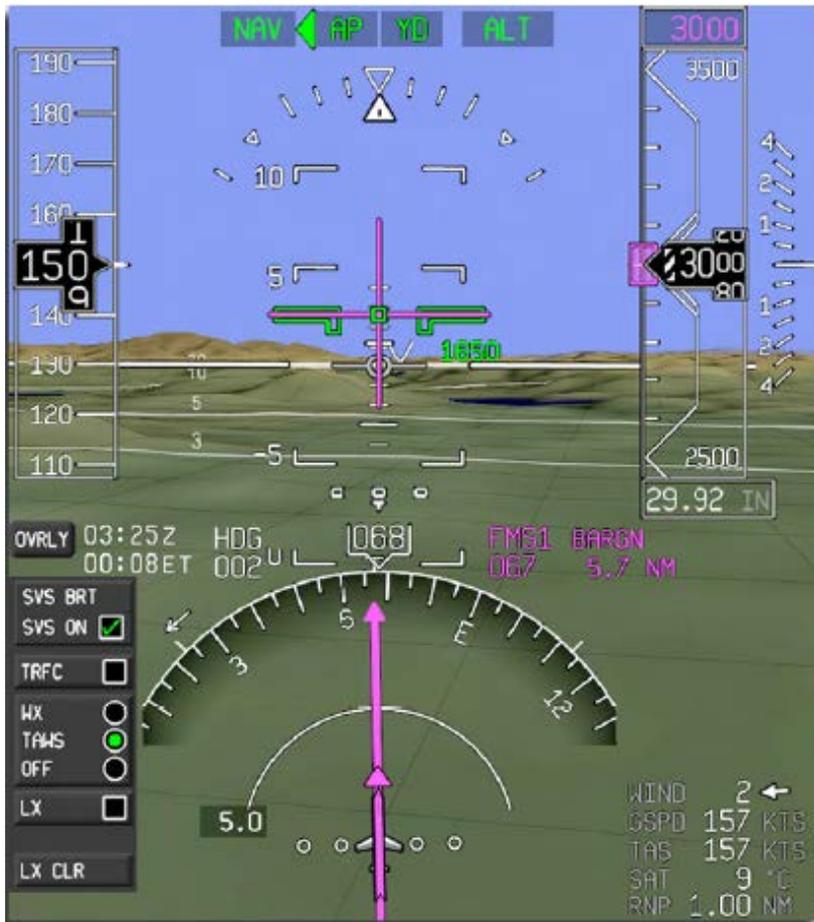
Figure 4: Synthetic vision system example display

The engineers reported that this failure of the radalt antennas was likely to have resulted in the radalt winding down to zero, and the radalt low altitude diagonal bars to appear on the altitude tape to show the aircraft was close to the ground (below 550 ft) (see Figure 4 in *Radio altitude* below). Additionally, the radalt information was used in conjunction with the runway (and obstacle) information in the database to provide the synthetic vision system display. This resulted in the runway appearing to rise up towards the aircraft reference symbol on the PFD.

The synthetic vision system fitted to the aircraft is depicted in Figure 4. It supplies a three-dimensional view of surrounding terrain, obstacles and runways based on a terrain database. Normal attitude, altitude and airspeed information is overlaid on top of the terrain display. The TAWS terrain database provides geometric altitude (obtained from the GPS) in order to display synthetic vision terrain and terrain related items such as runways and obstacles. During this incident, the synthetic vision system provided no failure annunciations.

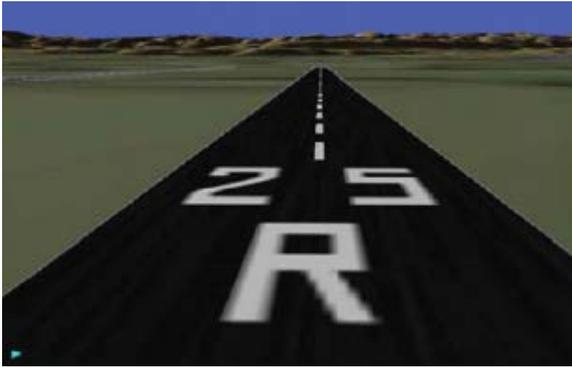
Figure 5: Synthetic vision runway display on approach (at low altitude)

Figure 5 shows a sample image of the runway scale for an aircraft on final approach for reference.

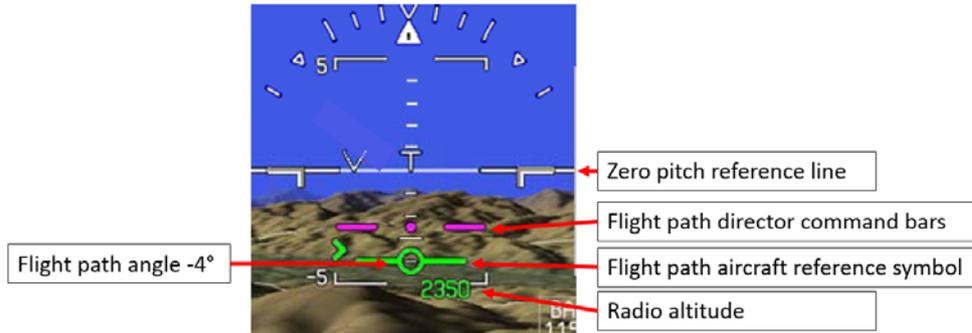
Figure 6: Synthetic vision and flight path indicator symbols

The radalt display is shown in green numbers on the PFD when the radalt data is valid and less than 2,500 ft (Figure 6). If the radalt data becomes invalid, the radalt digital readout is replaced with a radar altitude data (‘RAD’) annunciator and an amber RA 1 FAIL crew alerting system (‘CAS’) message is displayed. The crew did not receive any annunciations during this incident to indicate that the radalt had failed.

The pilot flying was using the flight path indicator on the synthetic vision system. This consists of the flight director command bars (magenta symbol in Figure 6) and the flight path aircraft reference symbol (green symbol in Figure 6). The flight path indicator is a path-based mode and depicts the aircraft's predicted flight path (not just aircraft pitch) and is affected by pitch attitude and the aircraft's ground speed. It shows flight path angles⁶ – up for increasing and down for decreasing flight path angles, whereas the traditional pitch-based mode depicts aircraft pitch angle. The flight path angle depicted in Figure 6 is -4° .

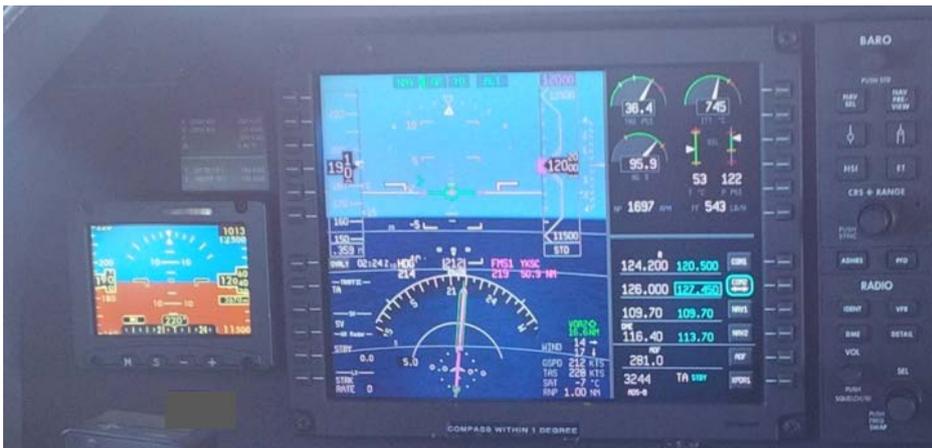
Figure 7: Electronic standby indicator and main PFD in flight (not OWA)

An electronic standby instrumentation system (ESIS) (or electronic standby indicator (ESI)), was fitted to the left of the pilot flying’s PFD. Figure 7 shows the pilot’s side PFD with the ESIS to the left of the main screen in another Pilatus PC-12 aircraft (not OWA). Note in this photo, the synthetic vision is on and the aircraft is over water.
