Taxiing proximity event involving Airbus A321, VH-VWQ, and Boeing 737, VH-VZB

Melbourne Airport, Victoria, on 30 April 2018

ATSB Transport Safety Report
Aviation Occurrence Investigation
AO-2018-040
Final – 6 June 2019

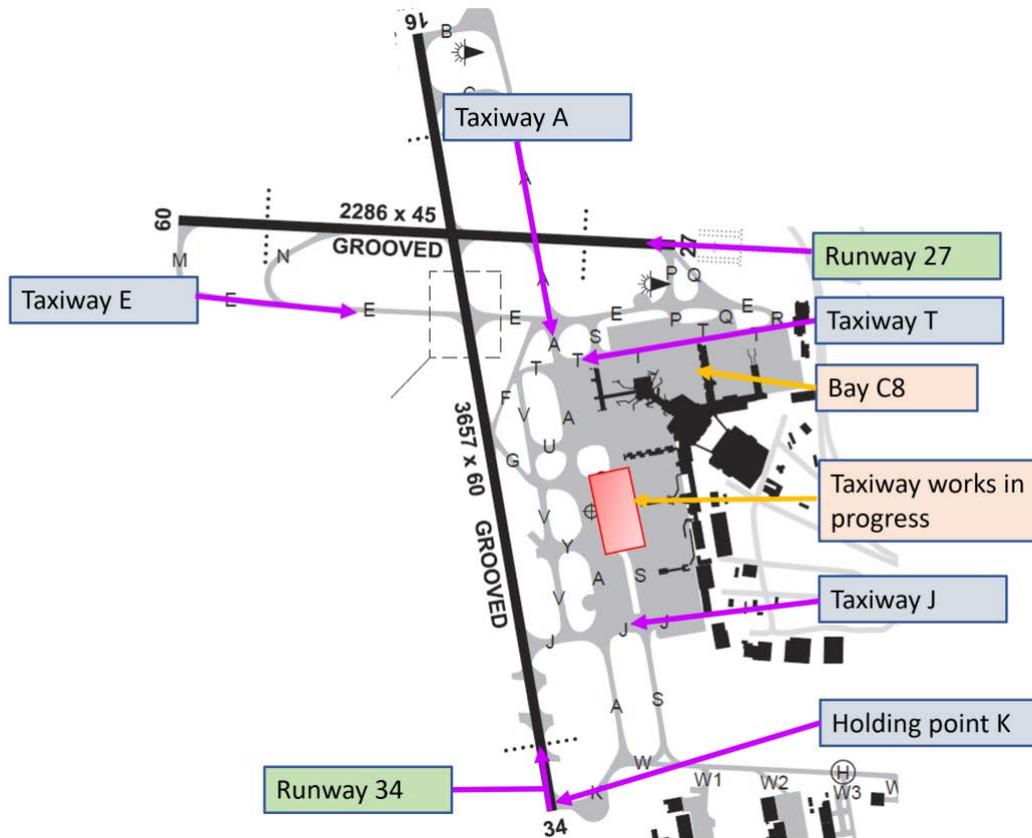
Figure 1: Melbourne Airport apron, taxiways and runways

On the morning of 30 April 2018, the surface movement controller (SMC) at Melbourne Airport, Victoria was conducting on-the-job training of a trainee air traffic controller. Runways 27 and 34 were in use, with aircraft landing on runway 27 and departing from either runway 27 or runway 34 (Figure 1).
