# Engine failure during take-off involving Bombardier Dash 8, VH-ZZE

Darwin Airport, Northern Territory, on 11 November 2019

## **ATSB Transport Safety Report**

AO-2019-060

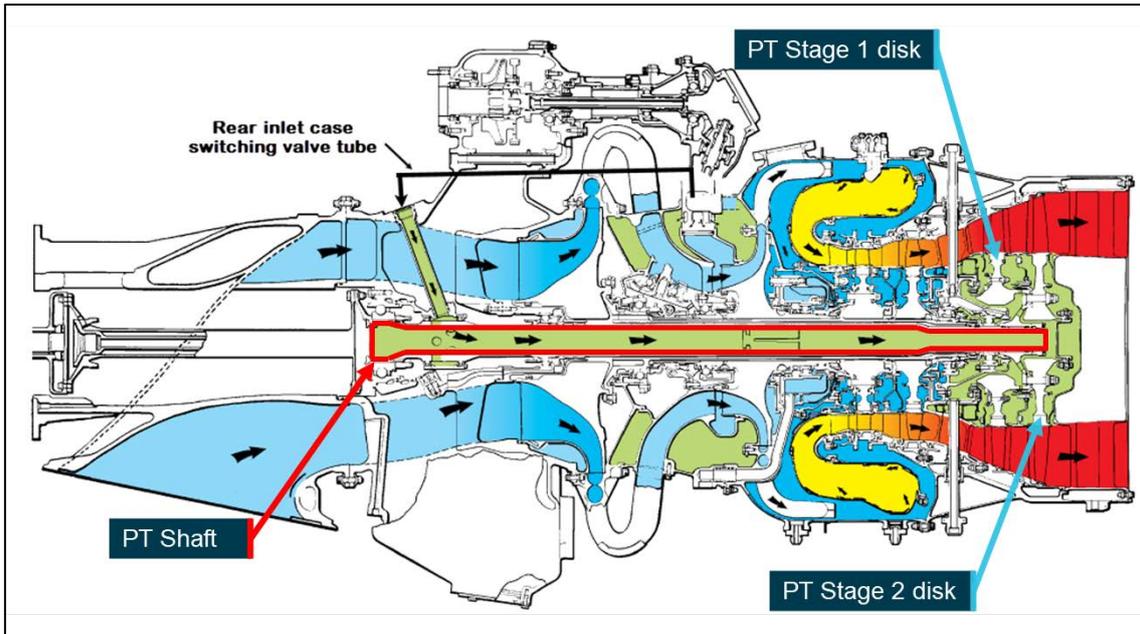
**Figure 6: PW100 series air system**

During normal engine operation, some of the air flowing through the compressor is delivered to the inside of the PT shaft via internal and external tubes. This air is used to seal bearings and cool the PT stage 1 and stage 2 disks (Figure 6).

The black arrows show the direction of air flow. The green colour denotes PT shaft related air flow  
Source: P&WC, annotated by ATSB

Internal corrosion resistance is provided by an aluminium coating applied to the inside of the shaft during manufacture. P&WC stated that during the metallurgical analysis, it was not possible to evaluate the coating near the surface fractures. However, there were no other indications, such as delamination, which would suggest the coating had been incorrectly applied. P&WC also indicated that based on in-service experience, the aluminium coating had historically provided good corrosion protection.
