# Engine room flooding on board *Great Majesty*

Port Kembla, New South Wales  
 27 October 2008

ATSB-23

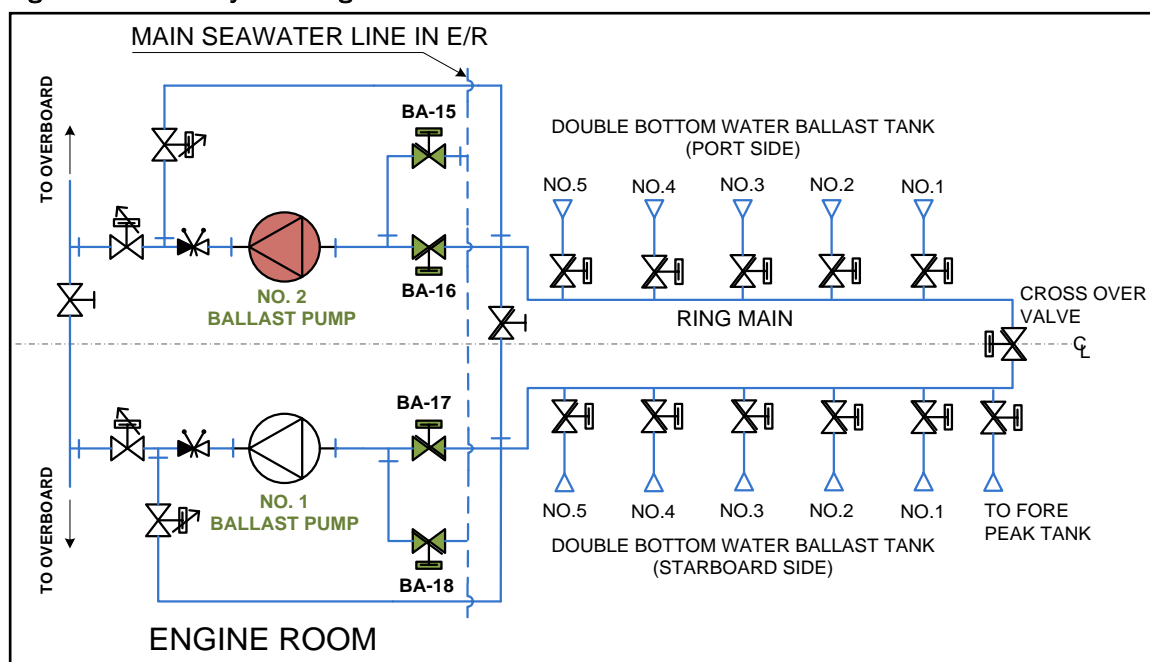
Figure 2: Ballast system diagram

*Great Majesty* has ten double bottom WBTKs, five on each of its port and starboard sides. It also has an after peak and a fore peak WBTK. The total ballast capacity of the tanks is 13,835 m<sup>3</sup>. Cargo hold number three can also be used as a ballast hold, which gives an additional capacity of 12,500 m<sup>3</sup>. All WBTKs are connected to a 'ring main' ballast piping system (Figure 2).

The ballast pumps are connected to the engine room seawater main through either of the remotely operated butterfly valves, BA-15 and BA-18 (Figure 2).
