Depressurisation – 475 km north-west of Manila, Philippines – 25 July 2008

Overview of October 2009 report

FACTUAL INFORMATION UPDATE

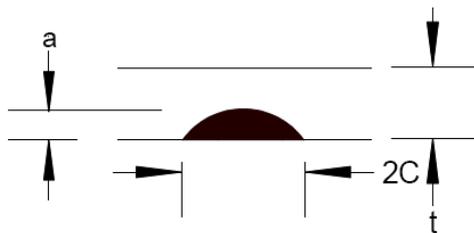
Figure 9: Surface flaw schematic

Two potential locations were considered for the possible presence of critical semi-elliptical flaws within the failed cylinder (Figure 8):

Through the preparation of residual strength diagrams that demonstrate the relationship between flaw size and pressure vessel stress, a conservative representation of critical sizes for semi-elliptical flaws of various aspect ratios⁴ was prepared for two nominal values of fracture toughness (K_{1c}) of the shell material (50 / 75 ksi√in).

The analysis results illustrated the key role played by aspect ratio in establishing the critical flaw size, with lower aspect ratio (longer, shallower) flaws proving more critical. From the results presented in Tables 3 and 4, it was shown that the most significant (i.e. smallest) flaw that could present as critical to the integrity of the cylinder type, was a longitudinal defect with a depth of 0.048 in (1.22 mm) and length of 0.478 in (12.1 mm), when evaluated at the cylinder service pressure (1,850 psi) and using a limiting material fracture toughness of 50 ksi√in. It was noted by the analysts however, that the flaw sizes determined by this process were likely to be conservative, and should be supplemented by additional analyses using elastic-plastic fracture mechanics techniques (EPFM) and/or a physical test program on cylinders with artificially-produced flaws. The ongoing ATSB investigation will encompass an evaluation of the cylinder performance in the presence of machined external flaws – further detail is provided in the ongoing investigation activities section of this report.
