Department of Transport
Bureau of Air Safety Investigation

INVESTIGATION REPORT
B/925/3042

British Aerospace BAe 146-200A VH-JJP
Near Meekatharra, Western Australia
22 March 1992

February 1994

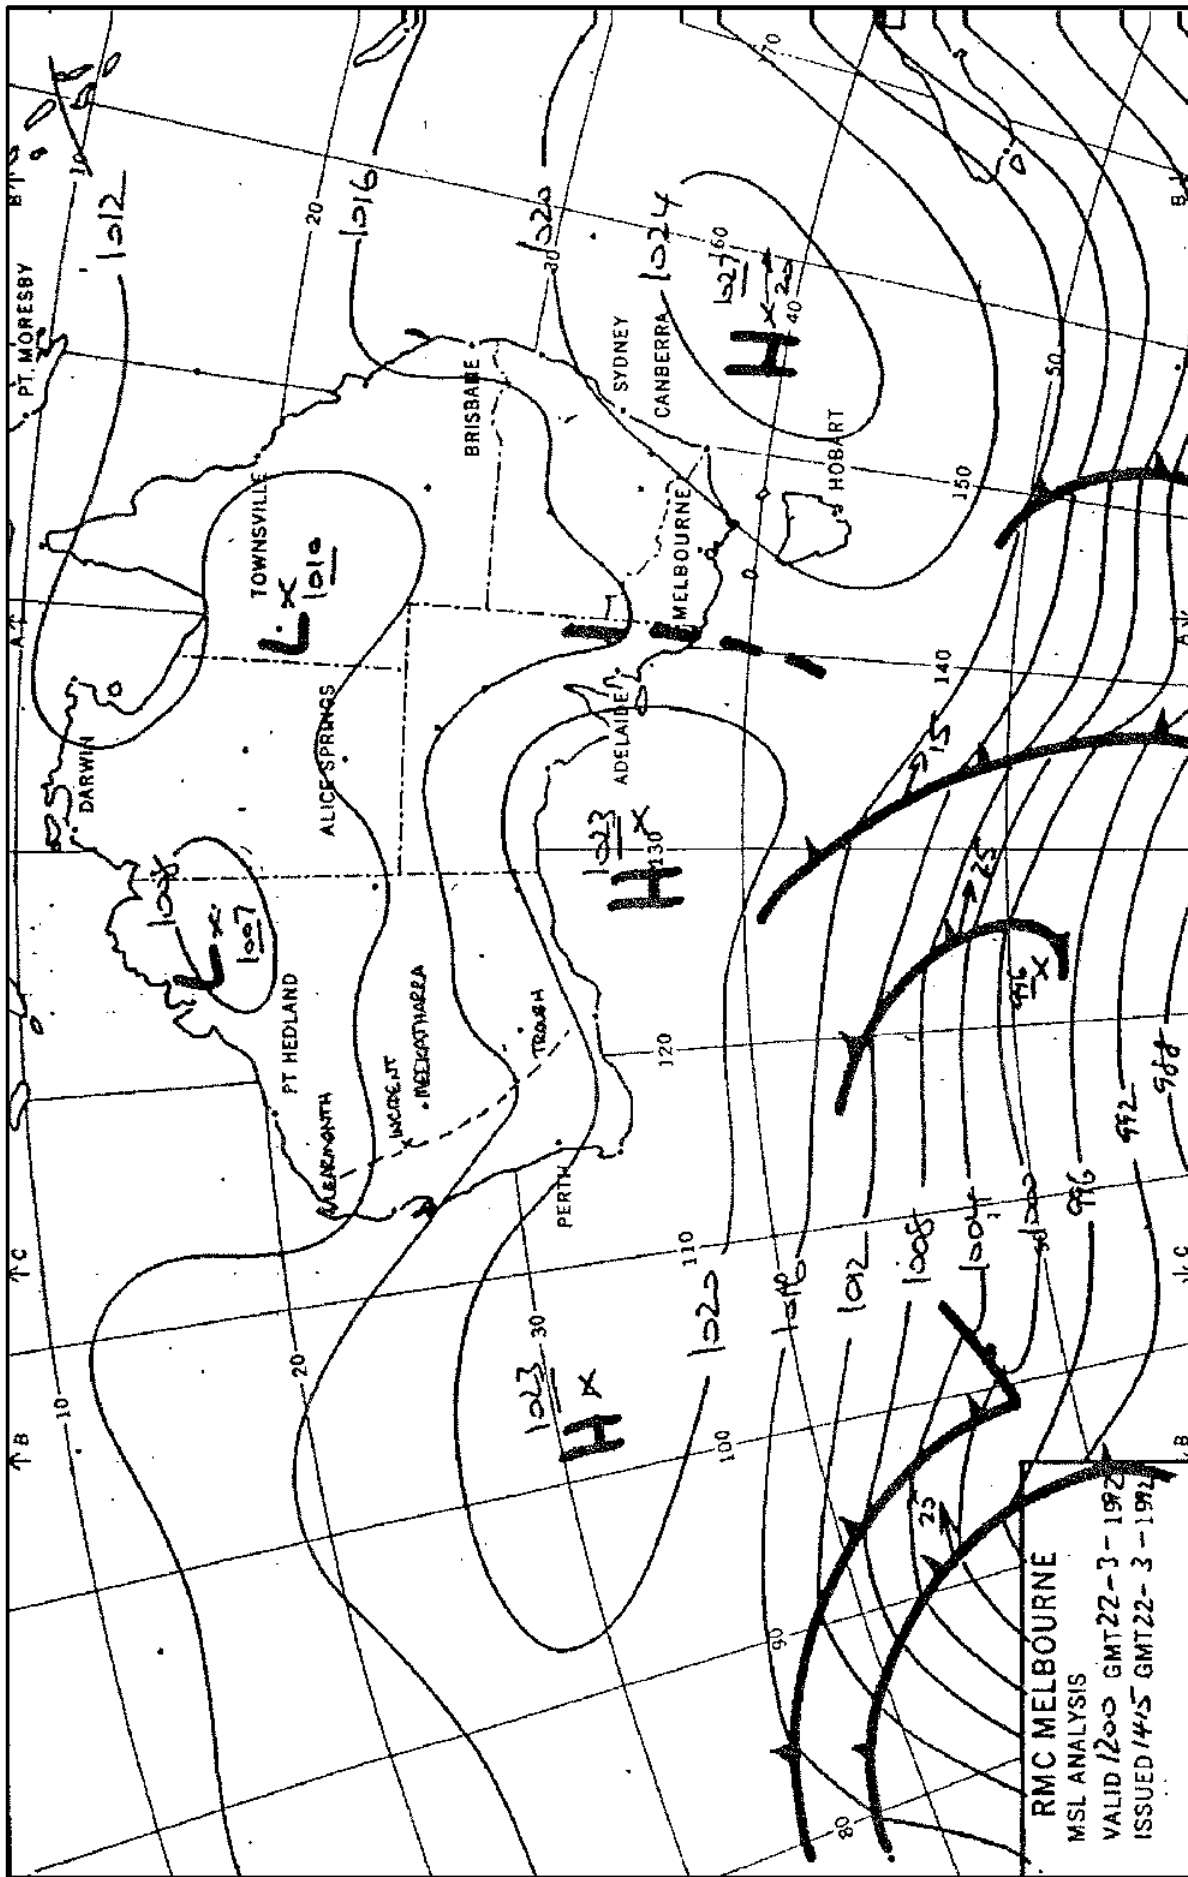
Figure 1: MSLP Analysis for 1200Z 22 March 1992

At 1200Z 22 March 1992, a high pressure ridge lay with its axis to the south of the state. High centres of approximately 1023 hectopascals (hPa) were identified near 31°S 105°E and 36°S 131°E (Figure 1). A low of 1007 hPa was located over the central Kimberley area.

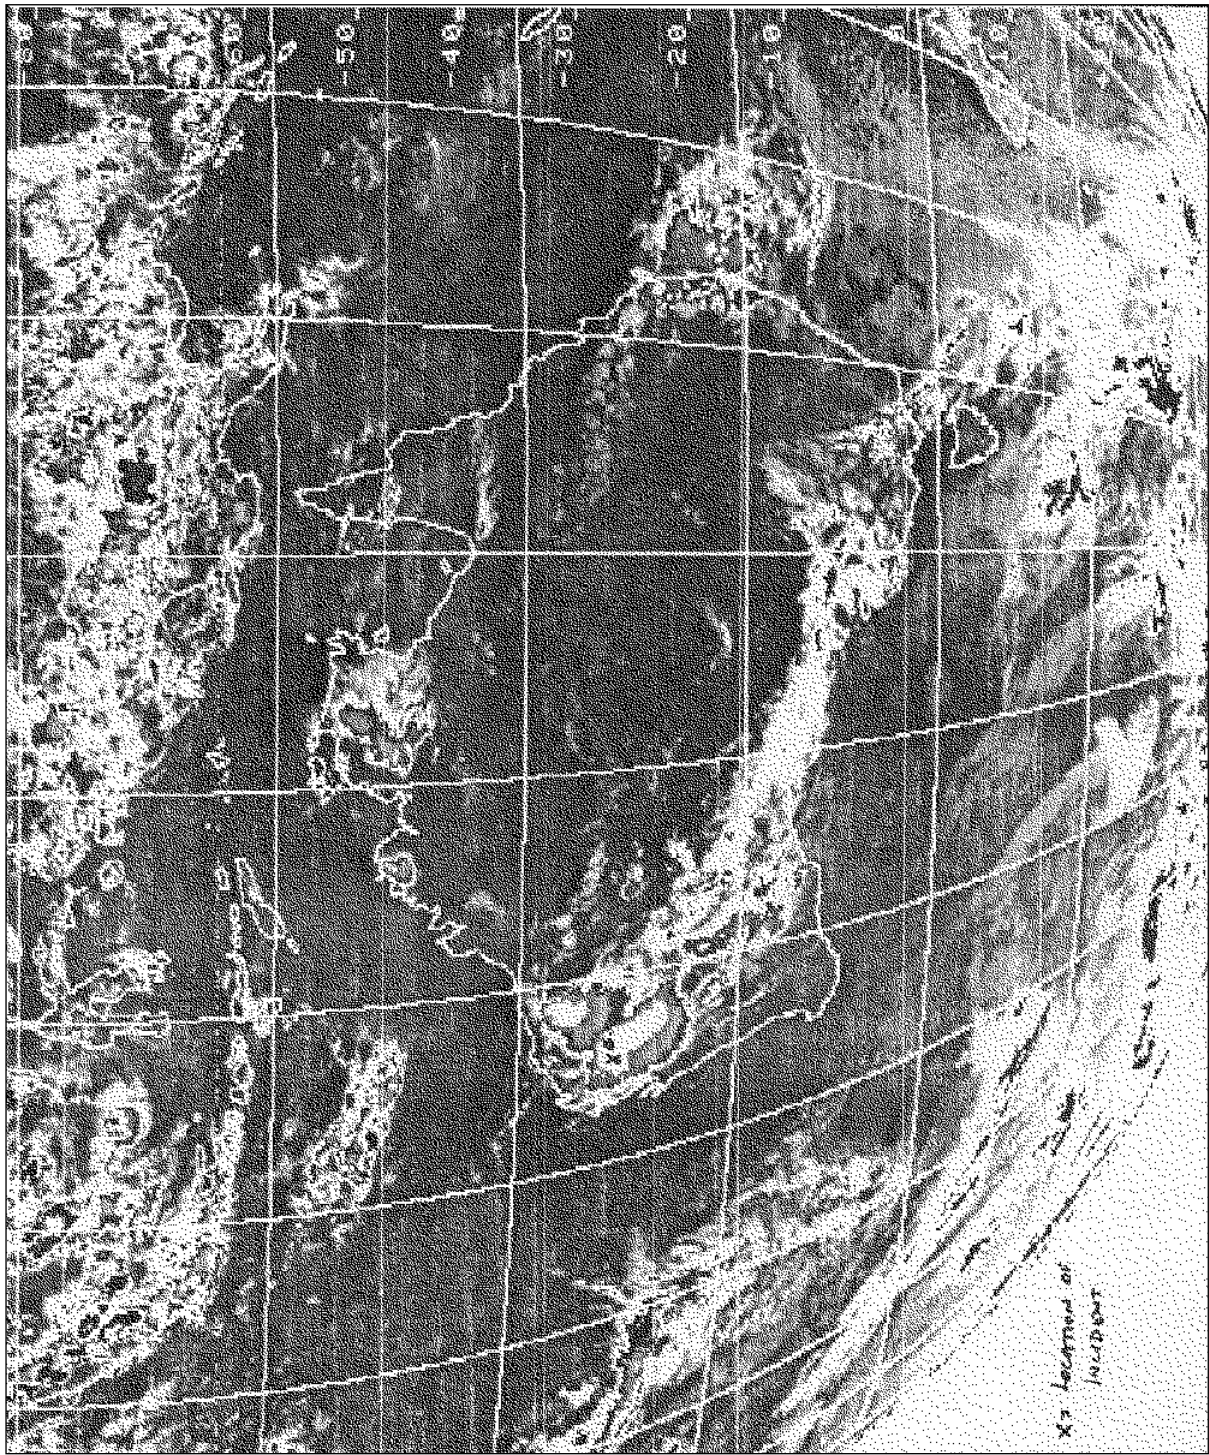
Figure 2: Enhanced Infrared Imagery (GMS4) for 1200Z 22 March 1992

From the infrared satellite image (GMS4) taken at 1130Z on 22 March (Figure 2), it can be seen that the most active weather area Australia-wide was located in the general vicinity of the incident.

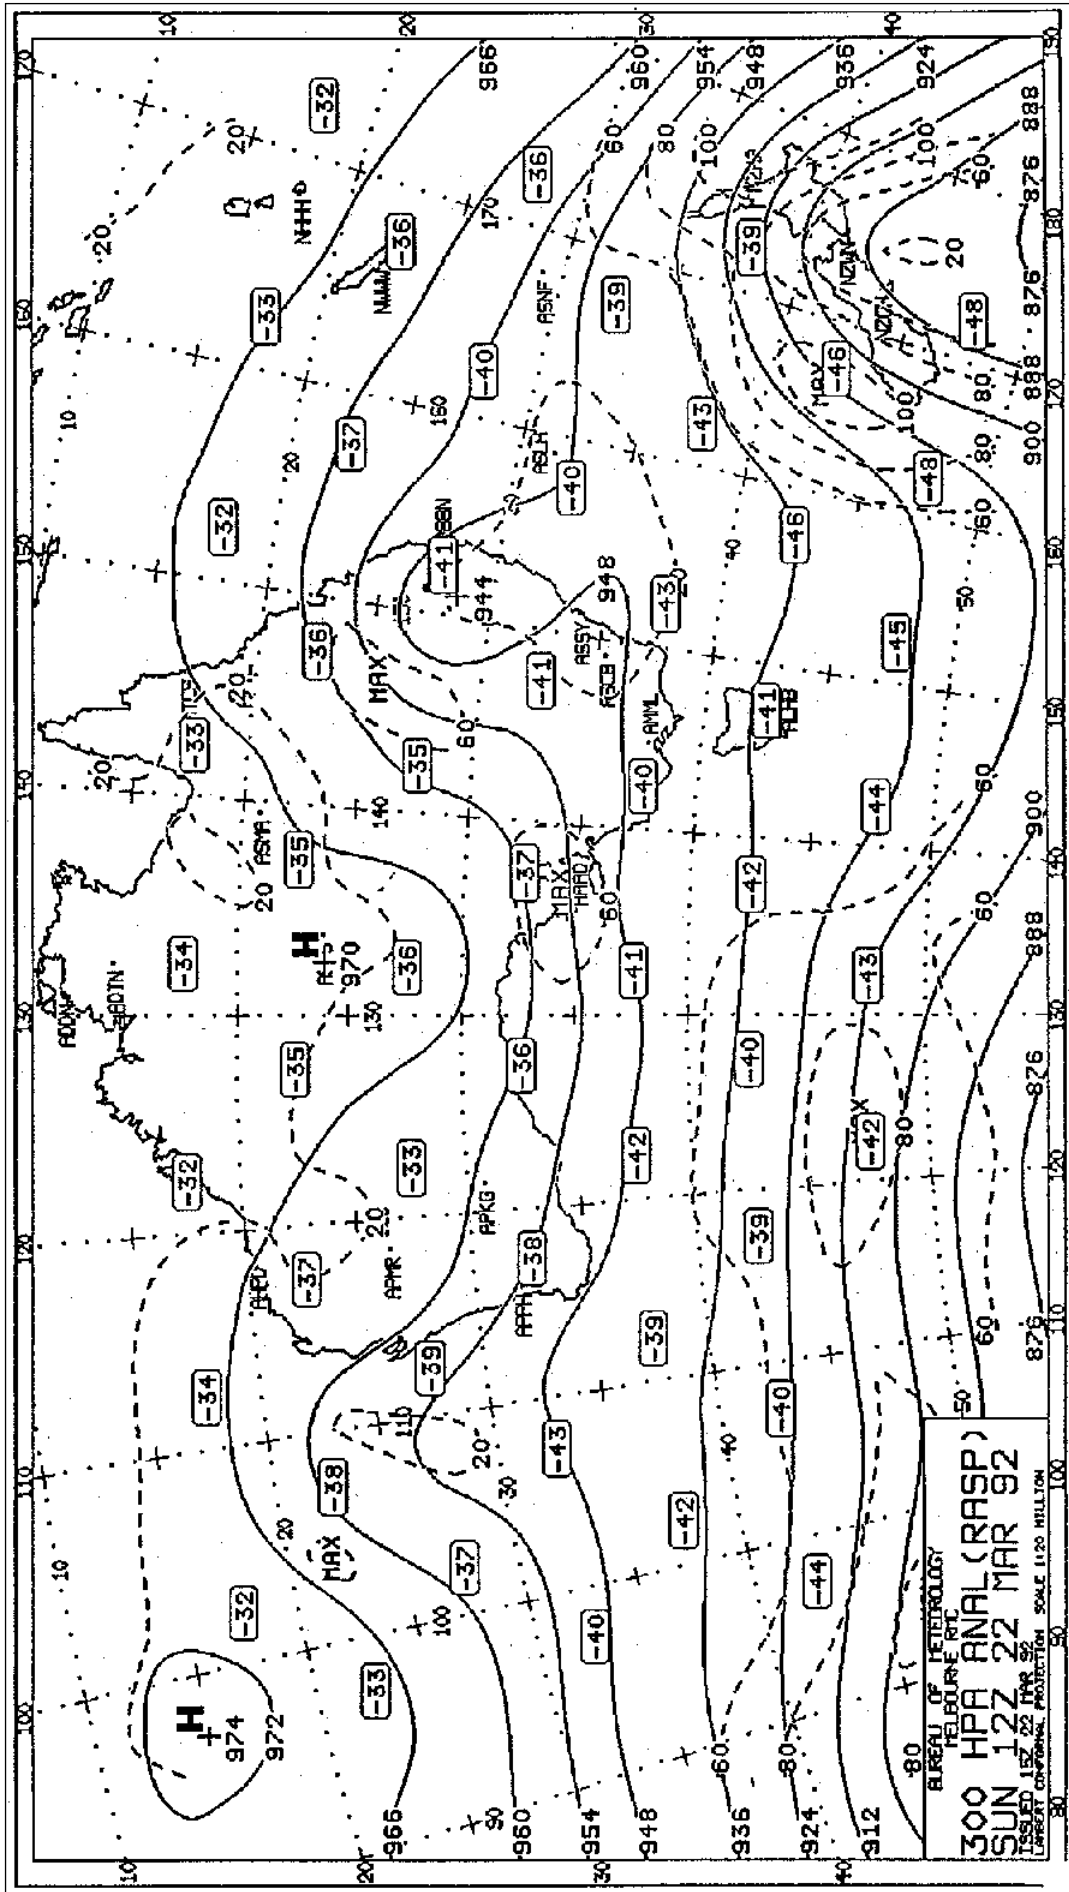
Figure 3: 300 hPa contour height analysis for 1200Z 22 March 1992

The 300 hPa contour analysis for 1200Z 22 March 1992 issued by the National Meteorological Centre (NMC) Melbourne is shown in Figure 3. The Meekatharra area was lying nearly halfway between a ridge over Alice Springs and a trough off the west coast. The pattern was slow moving.
