Departmental investigation
into the accidental release of the free-fall lifeboat
and injury to a crew member aboard the Bahamas flag
geared bulk carrier
MAERSK POMOR
at Gladstone, Queensland on 2 January 1998

Report No. 128

Australia
Department of Workplace Relations
and Small Business

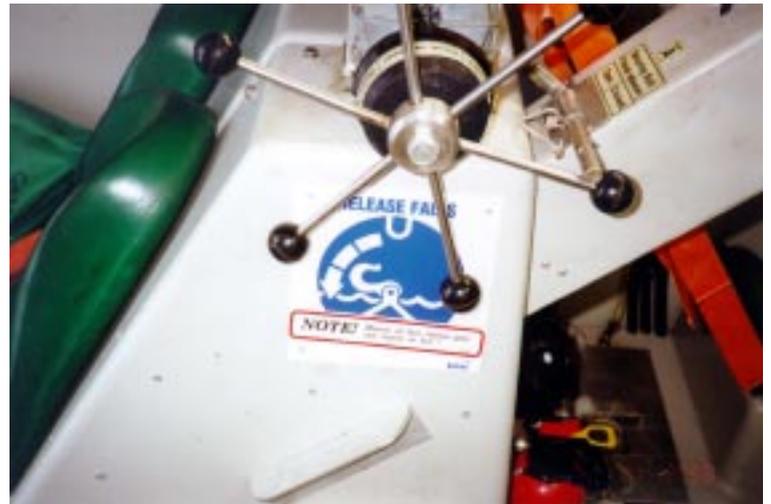
Lifeboat release gear

The release gear, for launching the lifeboat, incorporates a spoked, rimless wheel, located adjacent to the inboard side of the coxswain's seat. To prevent accidental operation of the release gear, the wheel is locked by a stainless steel slip bolt, passed between the spokes, and in turn is prevented from accidental removal by a locking pin.

The lack of knowledge of the three officers about the controls in the lifeboat was the direct cause of the accidental release of the lifeboat. This lack of knowledge also throws considerable doubt as to the effectiveness of the training structure on board *Maersk Pomor*, if indeed the three officers received any training at all on the lifeboat.
