Report No 145

Navigation Act 1912
Navigation (Marine Casualty) Regulations
investigation into a lifeboat accident
and injury to crew
aboard the Antigua & Barbuda flag vessel
WADDENS
at Cairns Harbour
on
14 February 1999

Issued by the
Australian Transport Safety Bureau
October 2000

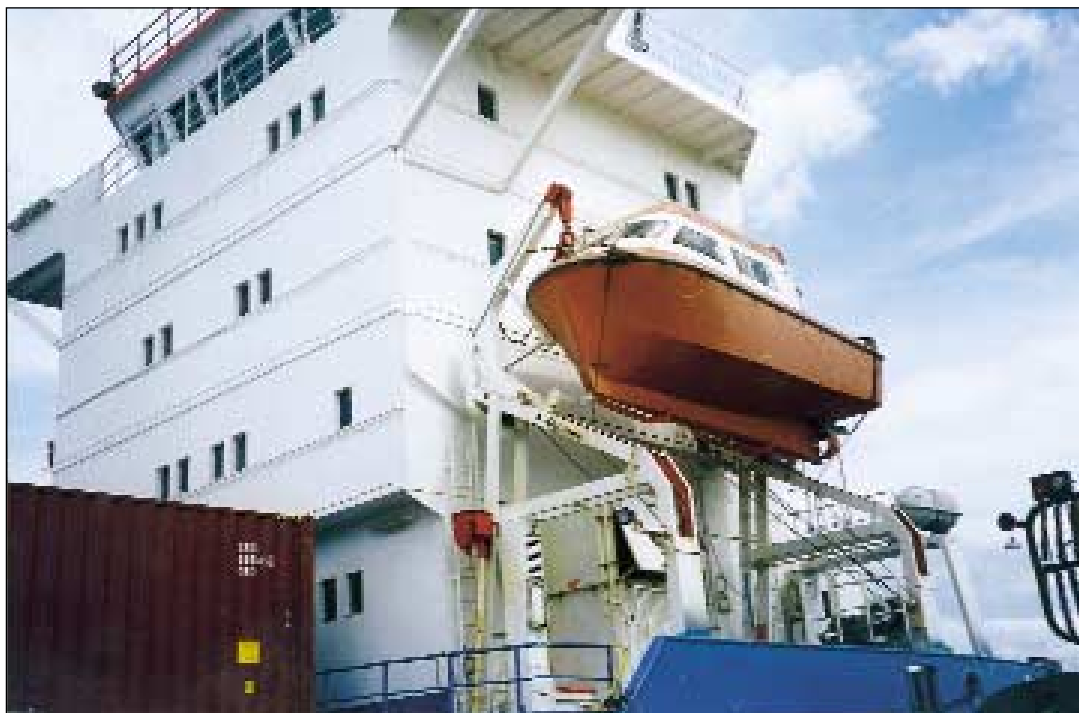
FIGURE 2.
Waddens port lifeboat

Waddens is equipped with one lifeboat on each side stowed in gravity davits, each with a capacity of 18 persons. The boats, manufactured by Ernst Hatecke in Drochtersen, Germany, are closed motor boats with a length of 6.6 m, a breadth of 2.5 m and a depth of 1.18 m. Both boats have cabins extending aft for about 3.8 m from a short, raised foredeck about 60 cm in length. The after deck extends from the aft end of the enclosed cabin, for just over a metre, to a raised stern (see fig. 2, page 3).

The lifeboat was inspected and found to have no apparent damage. It was attached to the falls once more and hoisted to its stowed position without incident.
