MARINE SAFETY INVESTIGATION
REPORT 160

Independent investigation into the lifeboat incident on
board the Philippines flag bulk carrier

Washington Trader

at Abbot Point, Queensland
on 6 August 2000

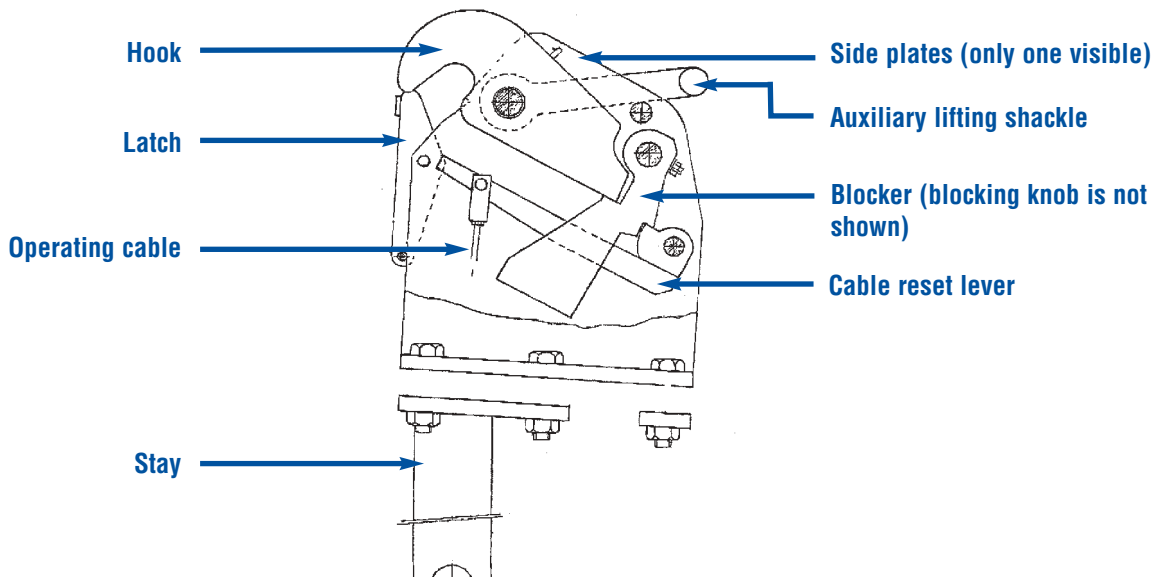
**FIGURE 3:
Hook unit**

The main components of each hook unit are the hook, side plates, blocker and blocking knob, cable reset lever, latch and auxiliary lifting shackle (figure 3). When the operating lever is actuated the operating cable moves the cable reset lever down until its quadrant clears the notch on the back of the blocker. The blocker is then free to rotate and release the toe of the hook which allows the hook to rotate to the

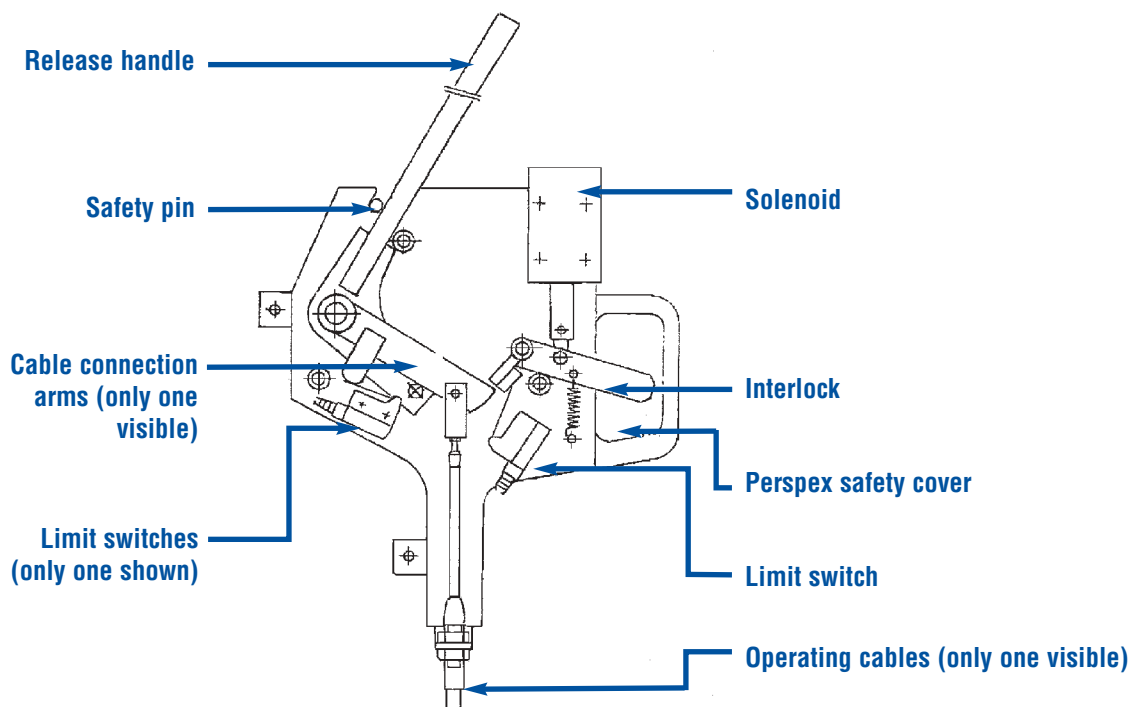
**FIGURE 4:
Operation unit**

The main working components of the operation unit (figure 4) are the release handle, the cable connection arms connected to each hook unit operating cable, the interlock and the solenoid

which drives it. Actuation of the release handle (when the interlock is not in the blocking position) raises each cable connection arm with the resulting motion transmitted to each hook unit via the operating cables. There is a safety pin to lock the release handle in the stowed position.

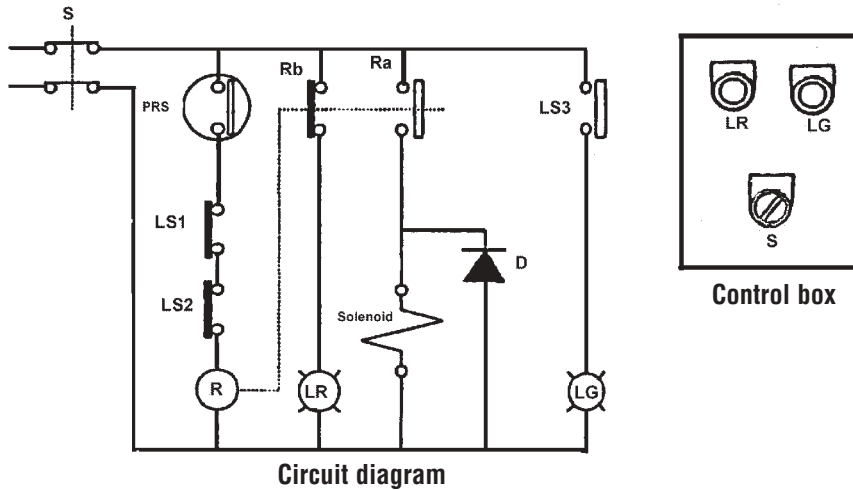
FIGURE 5:
Pressure switch and alarm light control box

The pressure switch and alarm light control panel indicate the status of the release system with red (LR) and green lights (LG) and controls the hydrostatic interlocking (figure 5). The limit switches on each cable connection arm (LS1 and LS2) are wired in series with the

water pressure switch (PRS) and are used in the control circuit to energise the relay (R). The relay contacts in turn control the power supply to the red light and the solenoid.

Under normal circumstances if the power switch (S) is on, the red light will be lit if either of the hooks are not in the reset position or the boat is not waterborne. When the boat is afloat (assuming the hooks are in the reset position) the relay will be energised. The relay contact supplying power to the red light will open (the light will go out) and the second relay contact will close and energise the solenoid. The energised solenoid moves the interlock to the unblocking position. At this time the interlock limit switch (LS3) will close and light the green light to indicate to the operator that it is safe to operate the release lever. Once the hooks are tripped, LS1 and LS2 will open to de-energise the relay which in turn will de-energise the solenoid and relight the red lamp. The interlock will be returned to the blocking position by the spring and when LS3 is opened the green light will be extinguished.

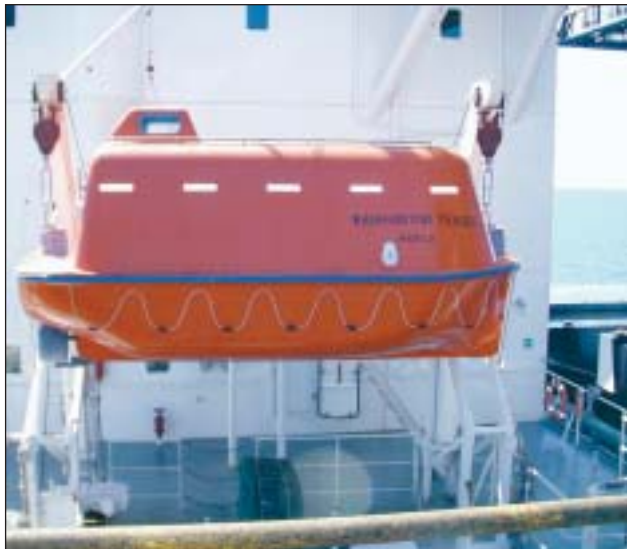
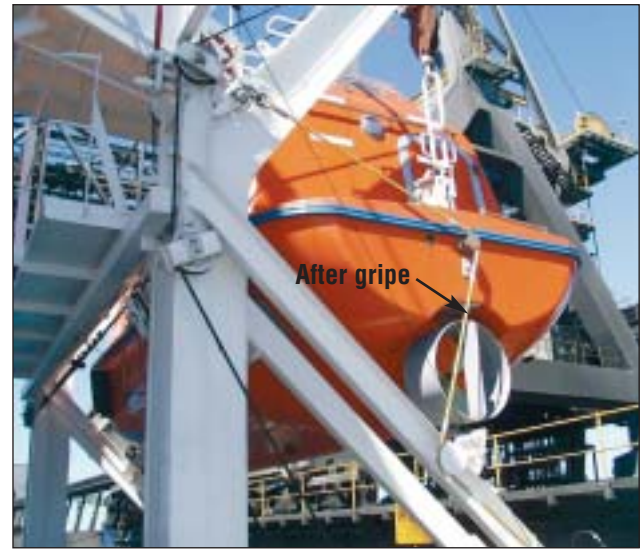
FIGURE 6:
***Washington Trader's* starboard lifeboat**

Washington Trader's lifeboat davits consist of the frame, forward and aft cradles, boarding platform, suspension blocks and falls and a gripe system (figure 6). In the housed position each lifeboat is suspended in the cradles by the suspension blocks with the fall wires running from each suspension block, via a series of sheaves, to the davit winch. Lashing units adjacent to the boarding platform are used to secure each cradle to the davit frame when they are in the stowed position. The cradles are pinned at the base to the davit frame to allow them to pivot; outboard initially when the boat is lowered, and inboard at the final stage of raising the boat. The davits are also equipped with a wire-operated winch brake remote release. The remote release allows an operator inside the lifeboat to lower it from the stowed position. The davit and lifeboat are designed so that normal boarding of the crew takes place with the boat in the stowed position.

A gripe system is used to secure each lifeboat in its cradles when stowed for a sea passage. It consists of two plastic coated yellow wires, one at each end of the lifeboat, which are passed around bollards fitted to the boat's bow and stern. The lower end of each wire is fixed to the base of the davit frame and a ring on the upper

end of each wire is secured by a rotating hook mechanism (lashing lever) attached to each davit cradle. A turnbuckle allows the tension of each gripe to be adjusted. The gripes must be fitted manually when the lifeboats are stowed but are automatically released by the rotating hook mechanism when the boats are lowered.

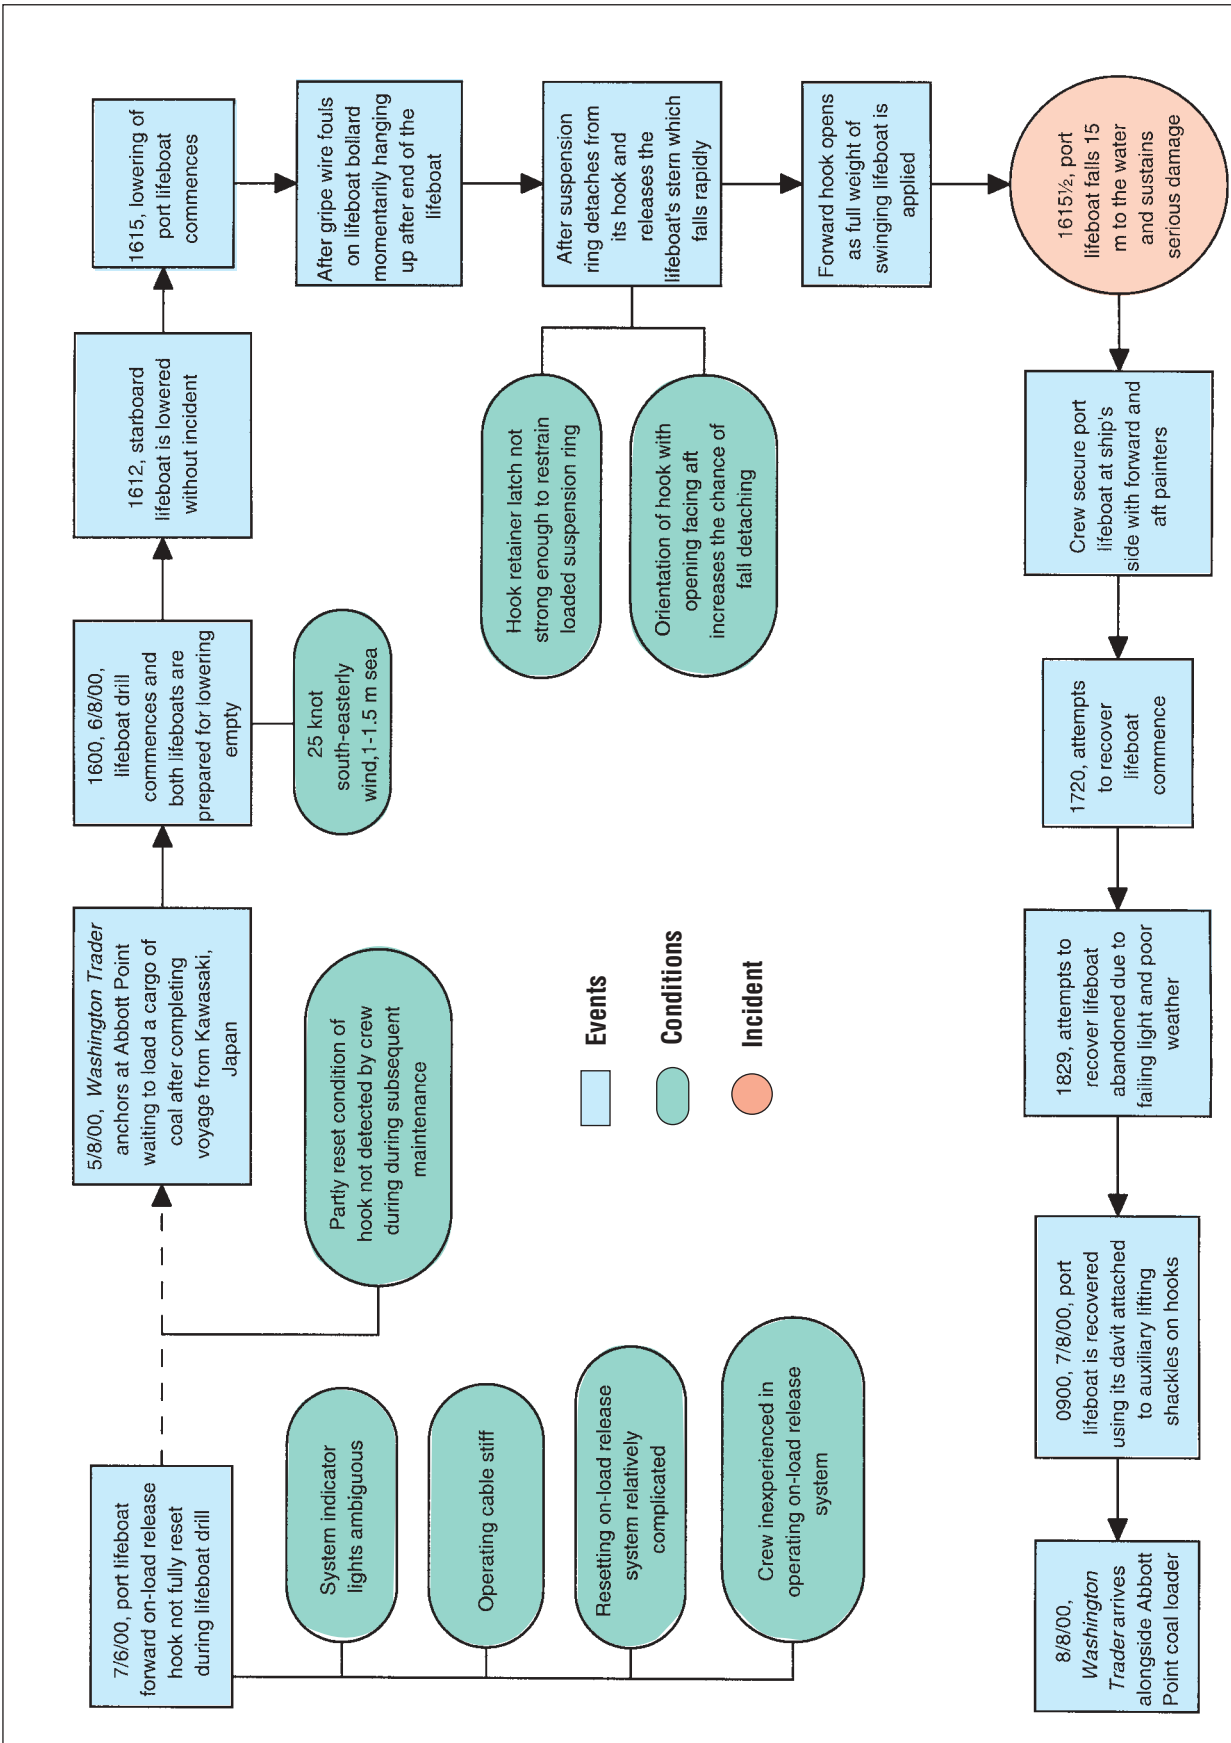
FIGURE 11:
Washington Trader. Events and causal factors chart

7. The orientation of the after hook increased the likelihood of such an incident occurring and in addition made resetting the hook difficult.
8. The design of the hydrostatic interlock was inadequate as it did not engage once the hooks were in a fully reset position prior to the lifeboat being lifted from the water. It was also rendered completely ineffective if either cable connection arm was not in the fully reset position.
