TECHNICAL ANALYSIS REPORT No: 9/02

**Analysis of a failed
Pratt & Whitney JT9D-7R4
turbofan engine**

Boeing 767-238, VH-EAQ

27 November 2001

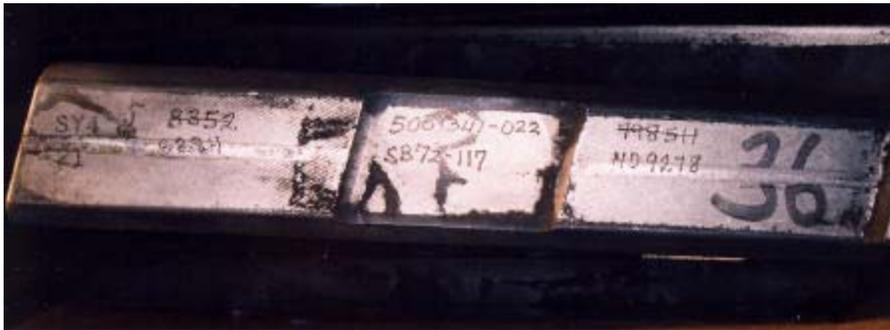
The failed blade carried the following engraved identification on the root underside (fig 23).

SY4 WCT B352 5001341-022 798511 36
 21 B284 SB72-117 ND9278

Fig. 23 Blade identification on the root face.

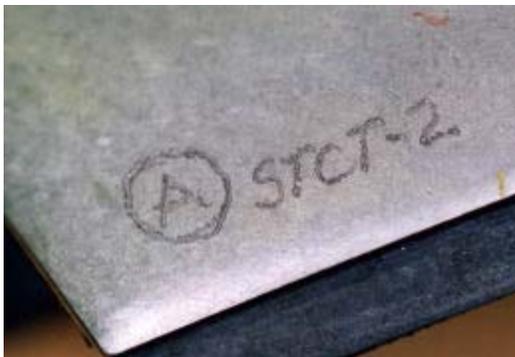
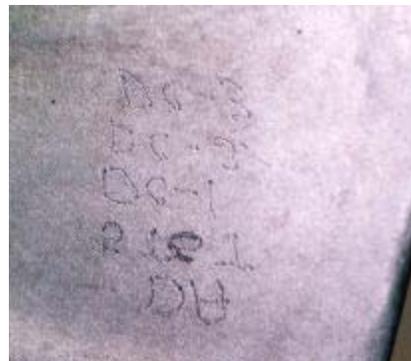
On the upper surface of the blade platform, repair codes as follows were engraved (figures 24 & 25). The meaning of the various codes as identified by the manufacturers engine manual are shown opposite^[2].

Figs. 24 & 25 Blade repair codes present on the upper surface of the flange.
