MARINE SAFETY INVESTIGATION
REPORT 164

Independent investigation into the lifeboat
incident on board the Maltese flag bulk carrier

Alianthos

at Geelong, Victoria
on 24 January 2001

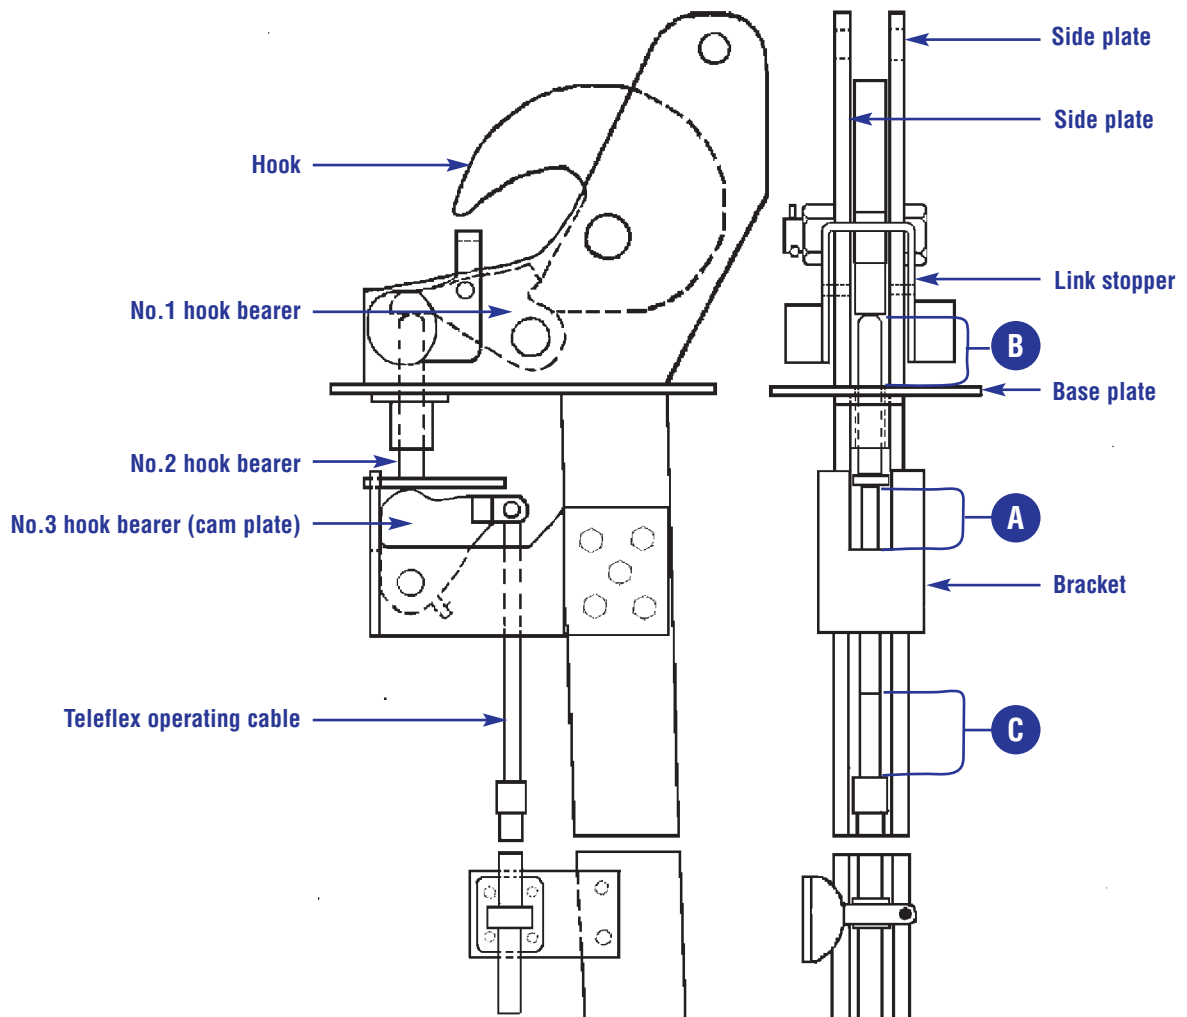
**FIGURE 3:
Hook mechanism**

The after hook was found to be in a tripped, or open, condition (figure 8). The hook locking mechanism was in a partially reset position indicated by the position of the cam plate on the no.3 hook bearer (refer to figure 3). The link stopper on the hook was undamaged with no witness marks to suggest that the suspension ring may have been forced past the stopper and off the hook. The disposition and condition of the various components of the after hook

Various measurements were taken of the forward and aft hook mechanisms. Initially the distance between the bottom of the no.2 hook bearer and the bottom of the slot in the adjacent bracket ('A' on figure 3) was measured to reveal: 30 mm for the forward hook, 18 mm for the after hook. As a reference for this measurement, the distance between the point of contact between the no.1 and no.2 hook bearers and the hook base plate ('B') was also measured

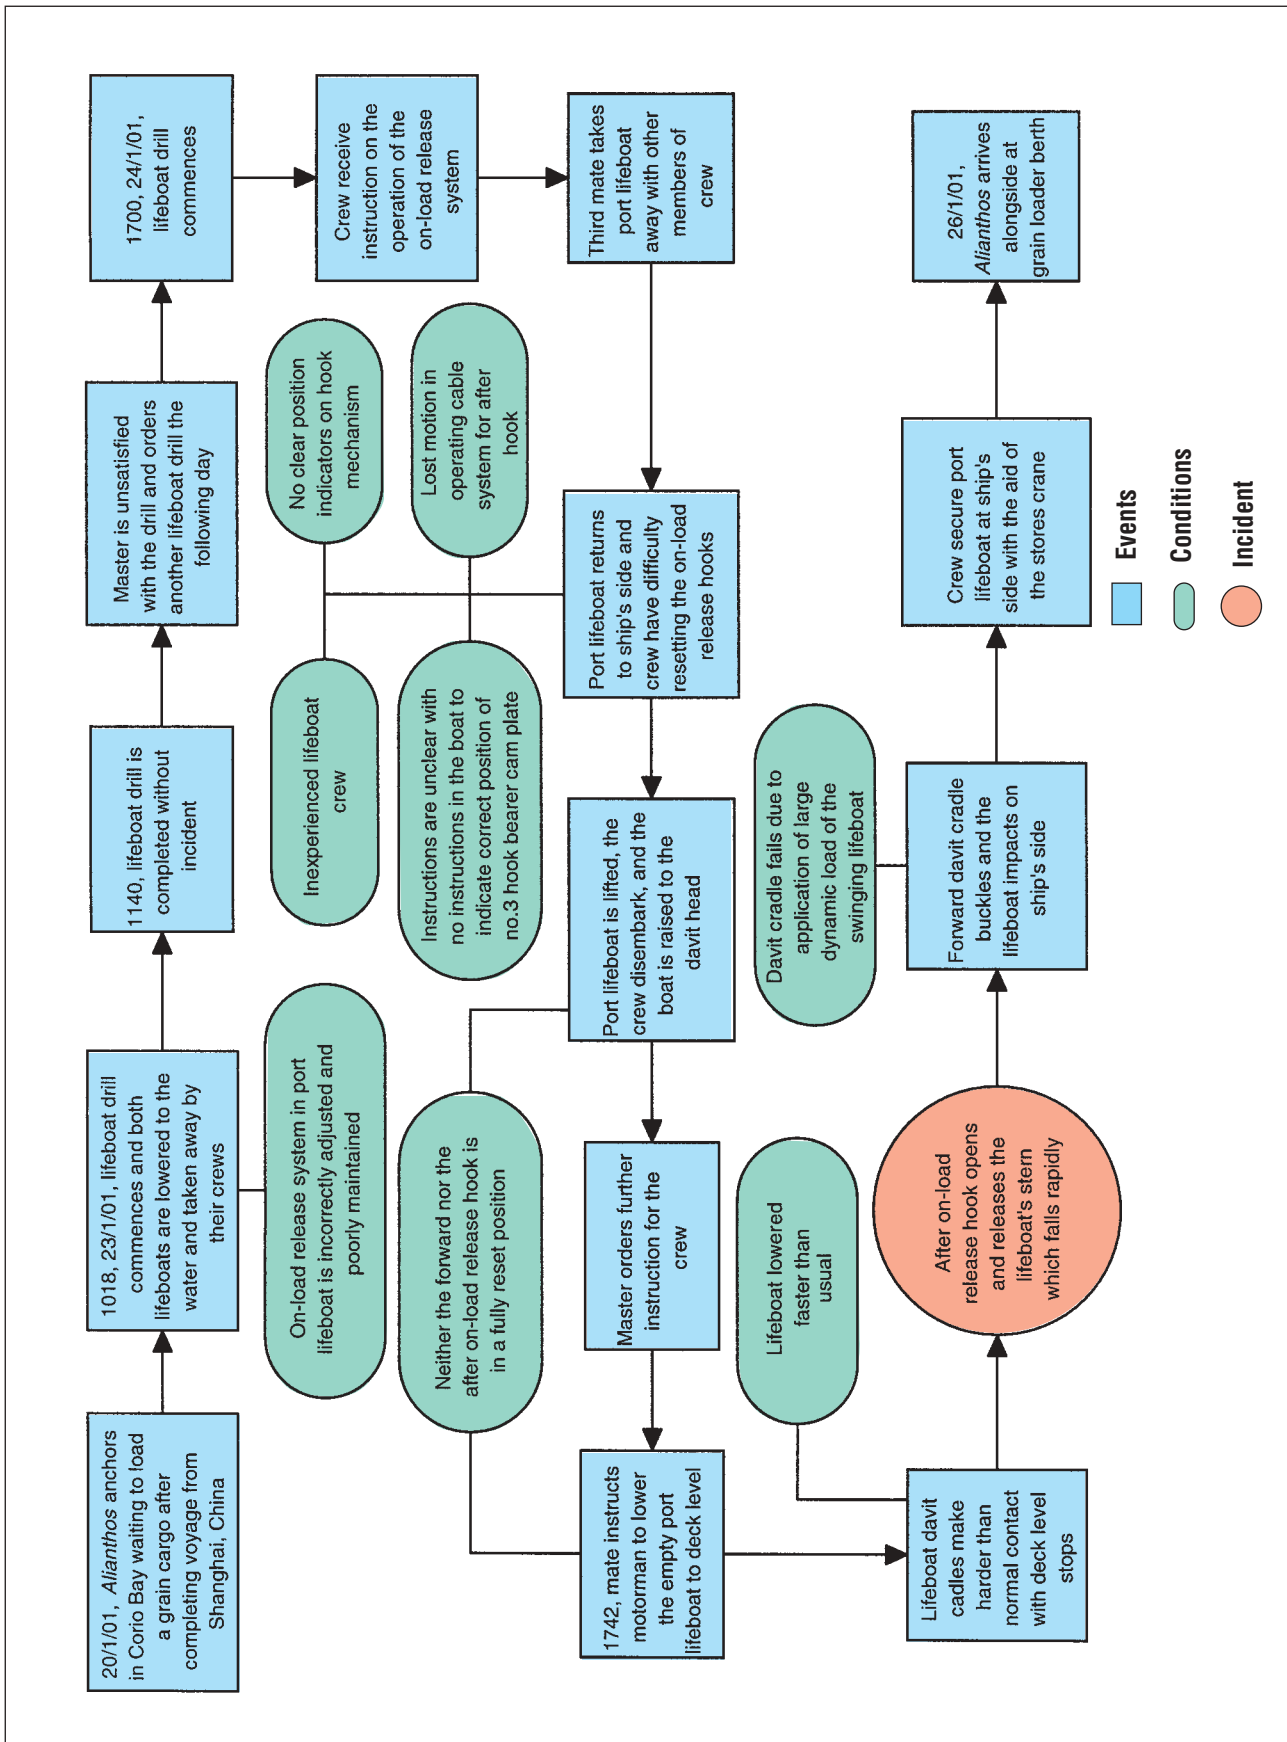
FIGURE 11:
Alianthos: Events and causal factors chart

- It is also considered that:
12. The operation of the davit winch at the time of the incident was not a factor as the after on-load release hook would not have opened when the davit cradles made contact with their stops if it had been fully reset.
