MARINE SAFETY INVESTIGATION

REPORT 173

Independent investigation into the lifeboat
accident and injury to crew aboard the
Panama flag bulk carrier

Cape Kestrel

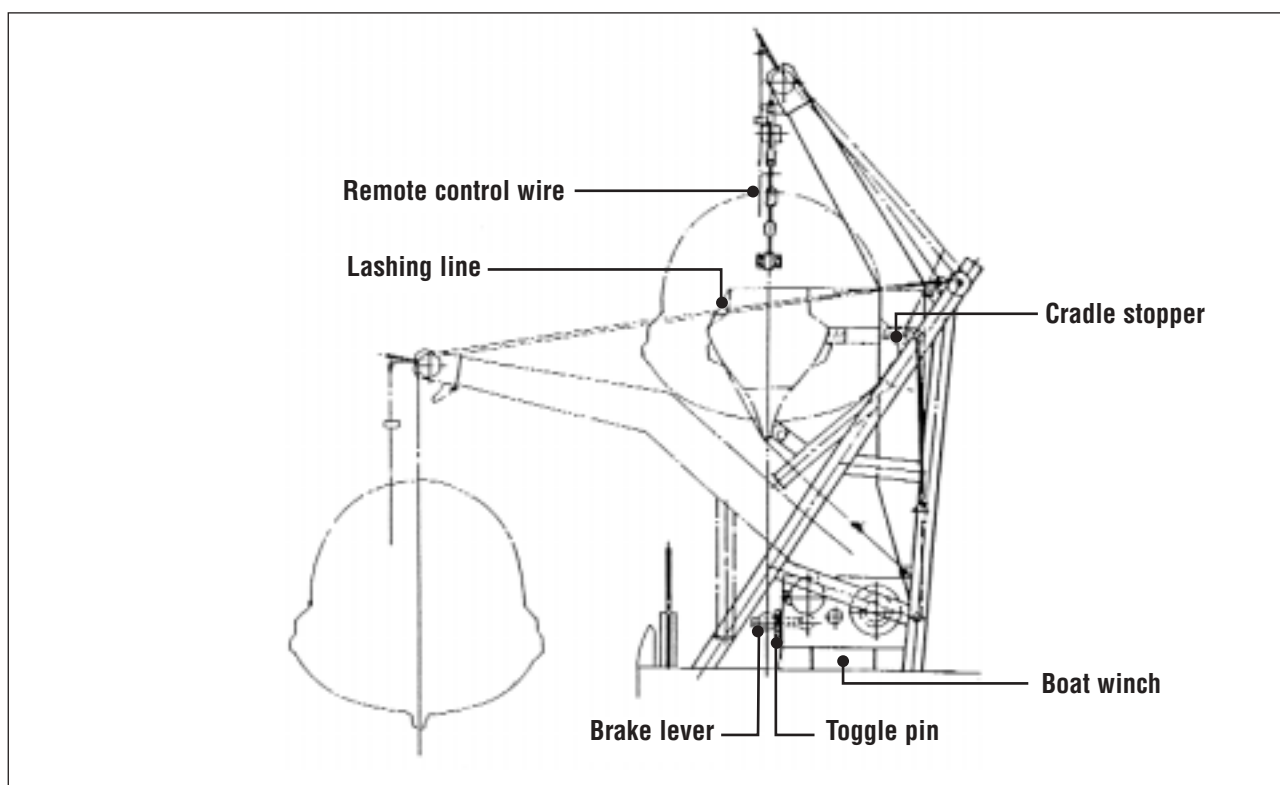
FIGURE 2:
Diagram of *Cape Kestrel's* lifeboat

Cape Kestrel's lifeboats are fitted with Titan on-load fall release systems manufactured in the United Kingdom by William Mills (Marine) Ltd. This system is designed for operation by one person with simultaneous release of both hooks occurring when the release handle is actuated. The system is fitted with an hydrostatic interlock, designed to prevent the actuation of the hooks until the boat is waterborne. The interlock may be manually bypassed in an emergency to release the hooks if the boat is clear of the water.

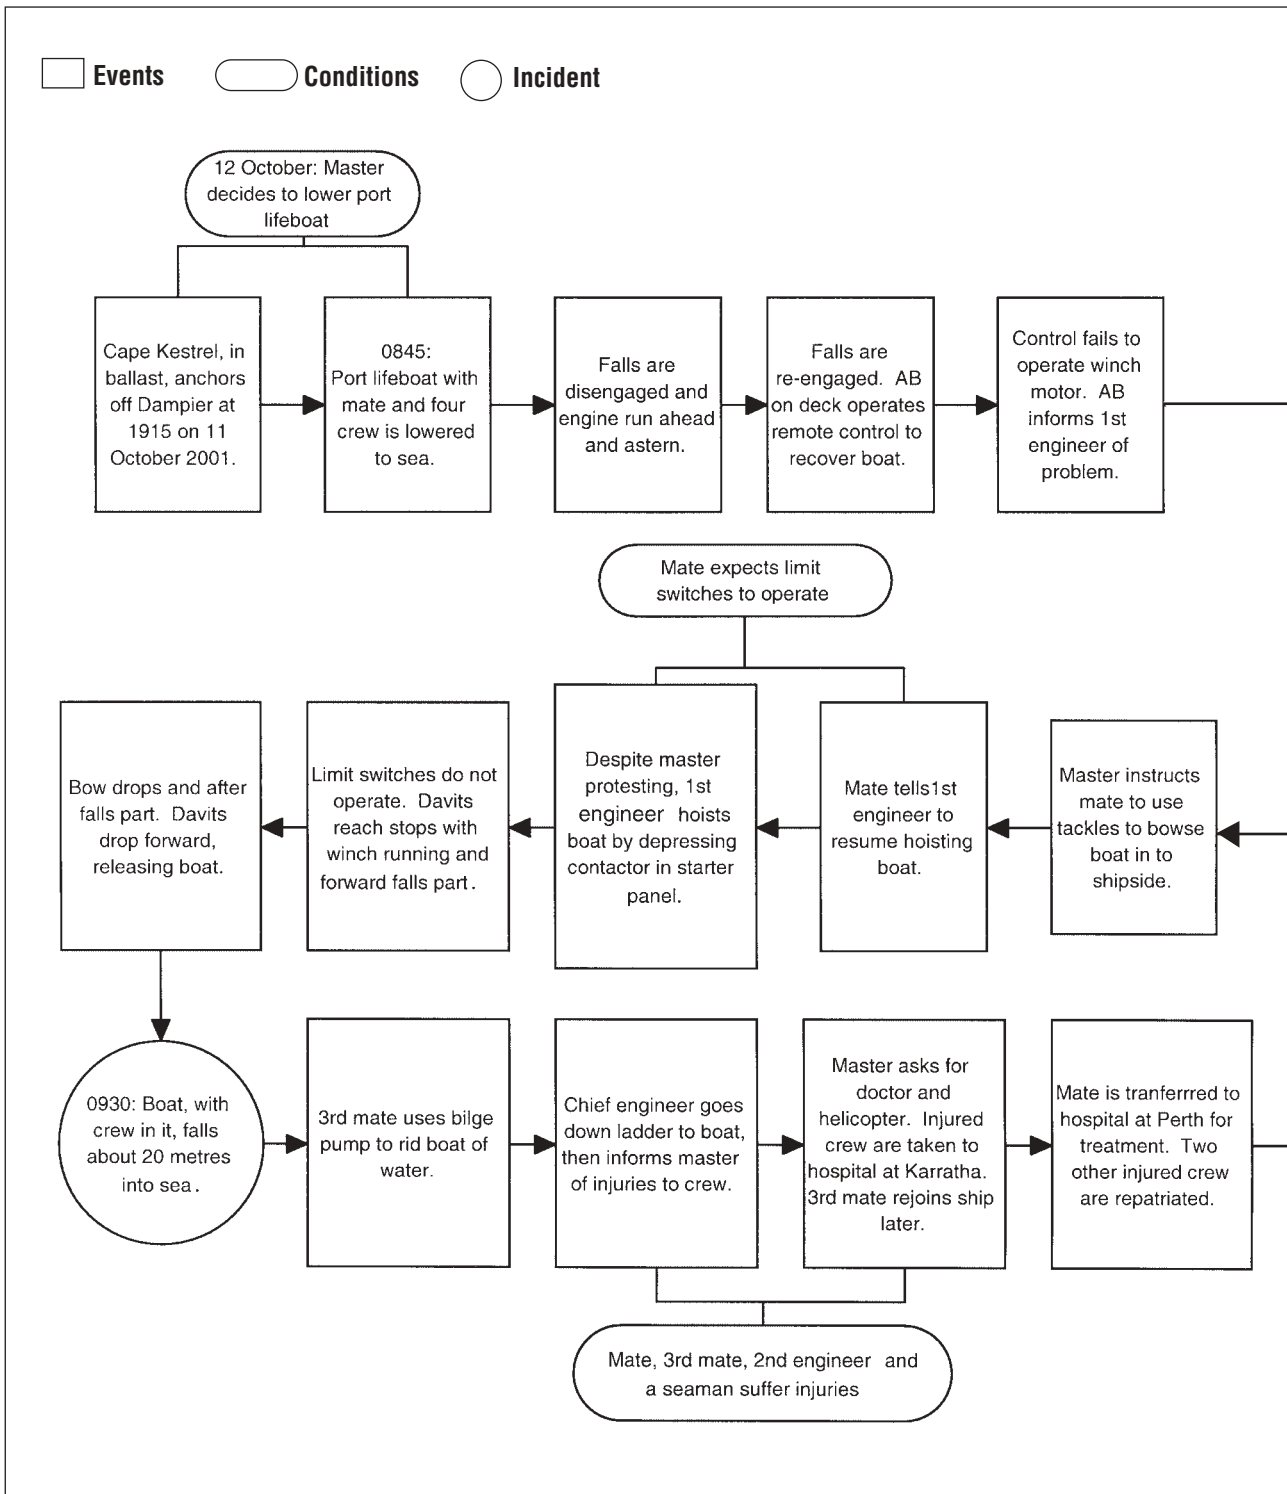
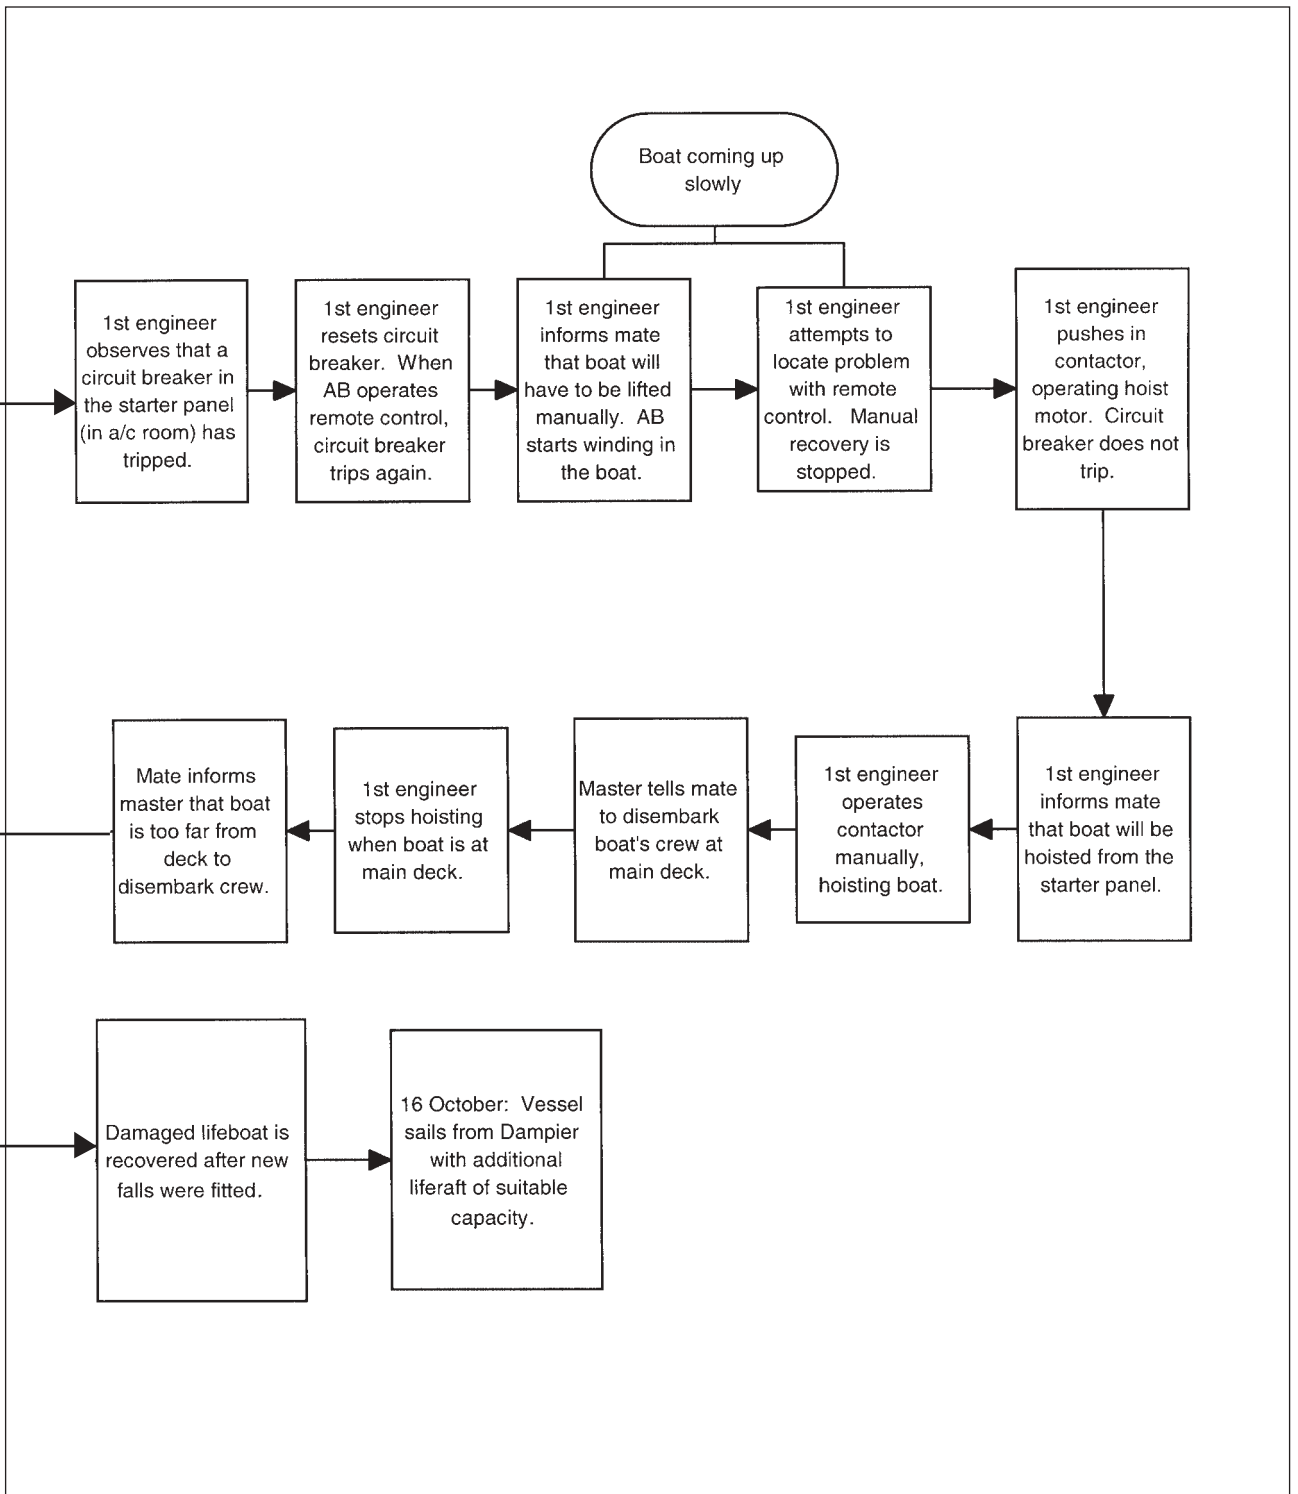
FIGURE 8:
Cape Kestrel: Events and causal factors chart

These conclusions identify the different factors contributing to the incident and should not be read as apportioning blame or liability to any particular individual or organisation.
