# Lifeboat accident at Port Botany, NSW

## 20 October 2003

## Lifeboat accident injures officer aboard *Port Arthur*

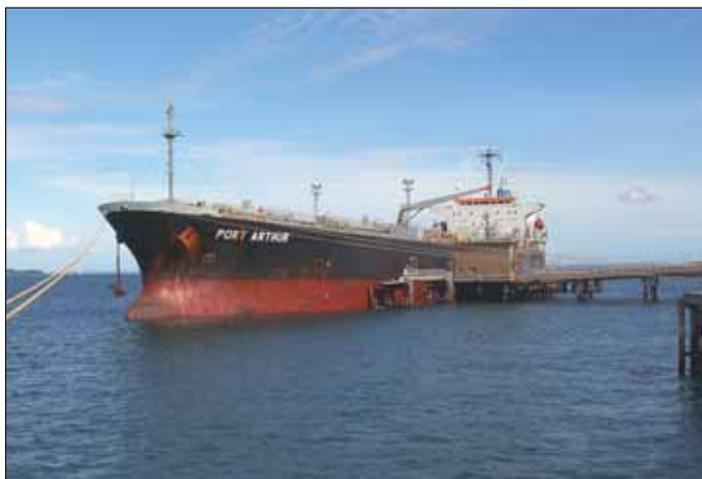
**FIGURE 1:**  
*Port Arthur*

*Port Arthur* is a product tanker of standard design with the cargo tanks forward of the engine room and accommodation superstructure (figure 1). The vessel has a length overall of 181.61 m and a deadweight of 41 490 tonnes at its summer draught of 11.77 m.

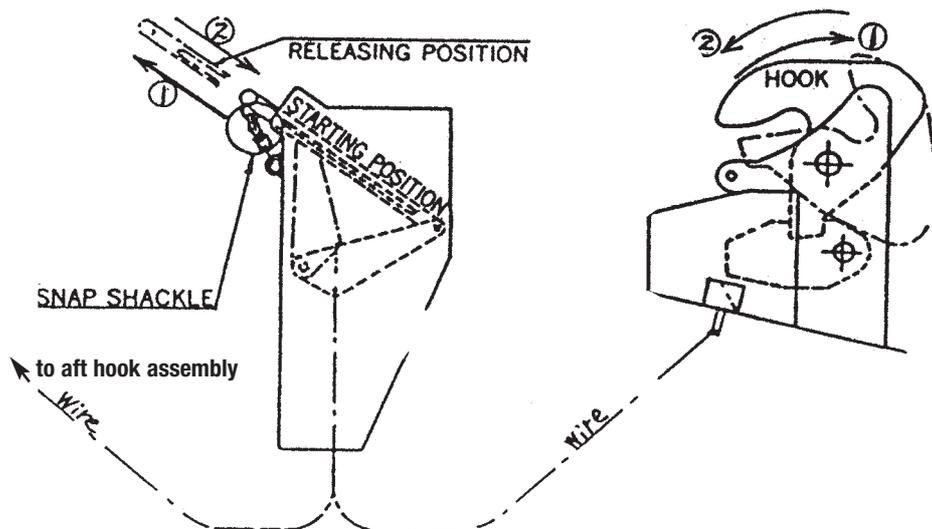
**FIGURE 2:**  
Diagram for use of releasing lever as supplied to ship

Each lifeboat is fitted with an on-load fall release system designed by the lifeboat manufacturer. The on-load release system (figure 2) consists of the release lever mounted on the starboard side of the steering console, the locking mechanisms for each hook and teleflex cables which connect the release lever to the hook mechanisms. There is no hydrostatic interlock, to prevent release of the hooks before a boat enters the water, fitted to either lifeboat.

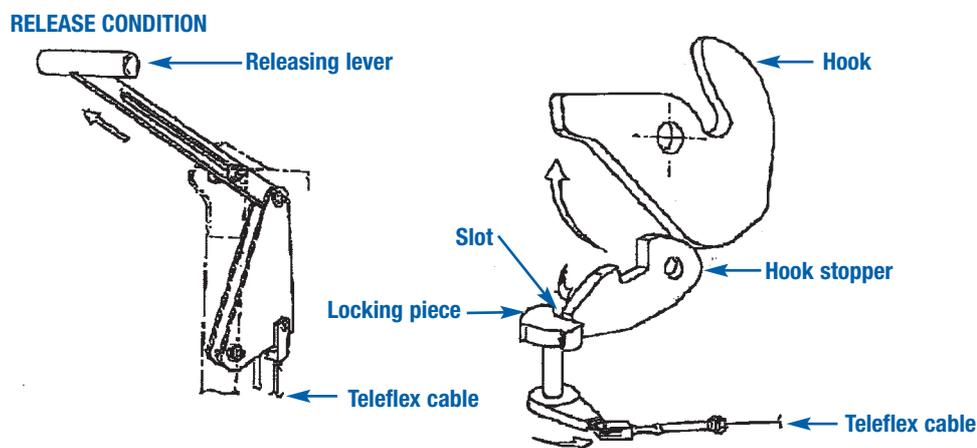
**FIGURE 3:**  
Layout of releasing system (supplied by manufacturer to ATSB)

To release the hooks, a snap shackle securing the release lever is disconnected and the release lever is pulled upwards. The teleflex cables transmit the motion of the release lever to the 'locking pieces' in the operating mechanisms for each hook. The locking pieces are rotated in the horizontal plane until the

ends of each 'hook stopper', which lock the tail of each hook, are free to rotate downwards into a slot in each locking piece. The hook stoppers then release the tail of each hook, allowing the hooks to rotate and open, releasing the lifeboat falls (figure 3).
