ATSB TRANSPORT SAFETY INVESTIGATION REPORT
Marine Occurrence Investigation No. 209
Final

Independent investigation into the man overboard fatality
and subsequent lifeboat accident on board the
French registered Antarctic support vessel

L'Astrolabe
in the Southern Ocean

27 January 2005

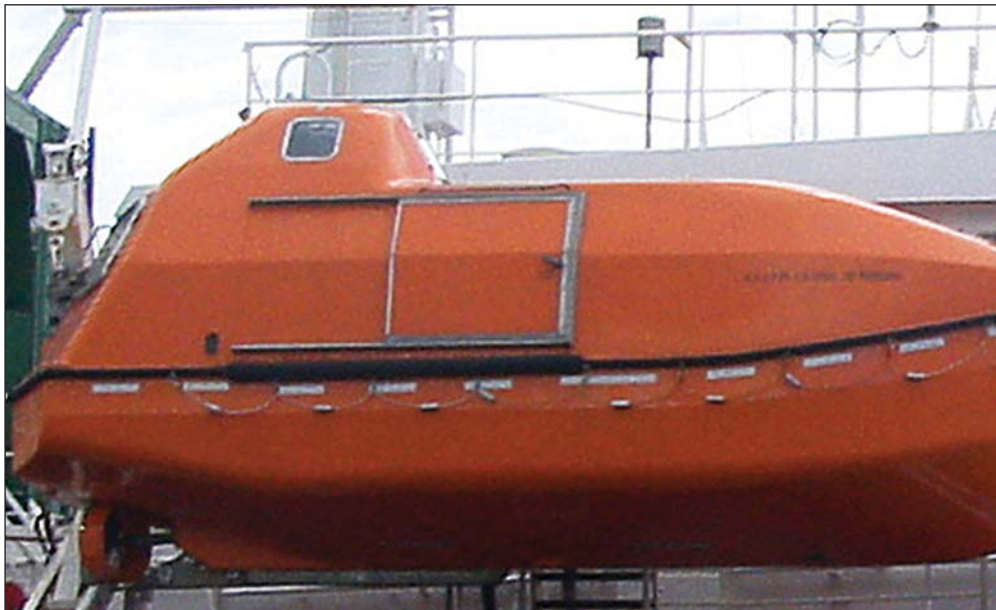
Figure 2: Starboard lifeboat in stowed position

The lifeboats are normally lowered from the embarkation deck, using direct control of the davit winch. They can also be lowered using a winch brake release wire controlled from the coxswain's position inside the boat.

Each lifeboat is fitted with an on-load fall release system. The on-load release system is operated by a release lever mounted on the starboard side of the steering console. Locking mechanisms for each hook are connected to the operating mechanism by teleflex cables (also known as morse cables). After the lifeboat falls have been released from the hooks, the mechanism must be manually reset so that the fall blocks can be reengaged when the lifeboat is recovered.

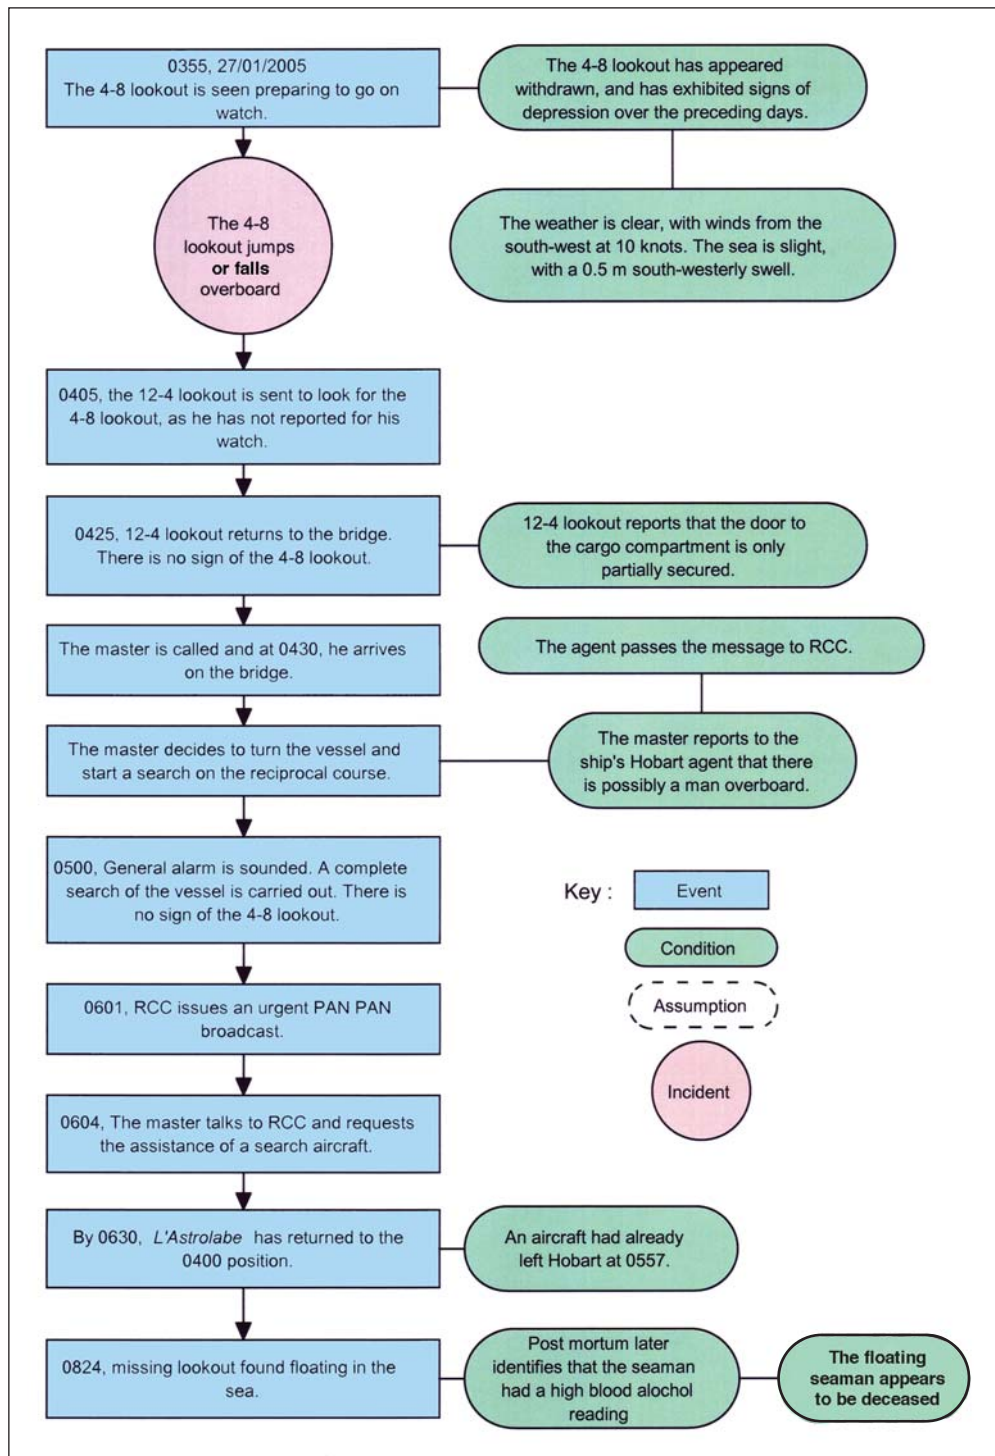
Figure 15: Man-overboard events and causal factors chart

- The crew member had died as a result of drowning before the vessel was able to locate him.
- A very high blood alcohol level found during the post mortem examination of the deceased crew member was probably highly significant in the circumstances of his death.

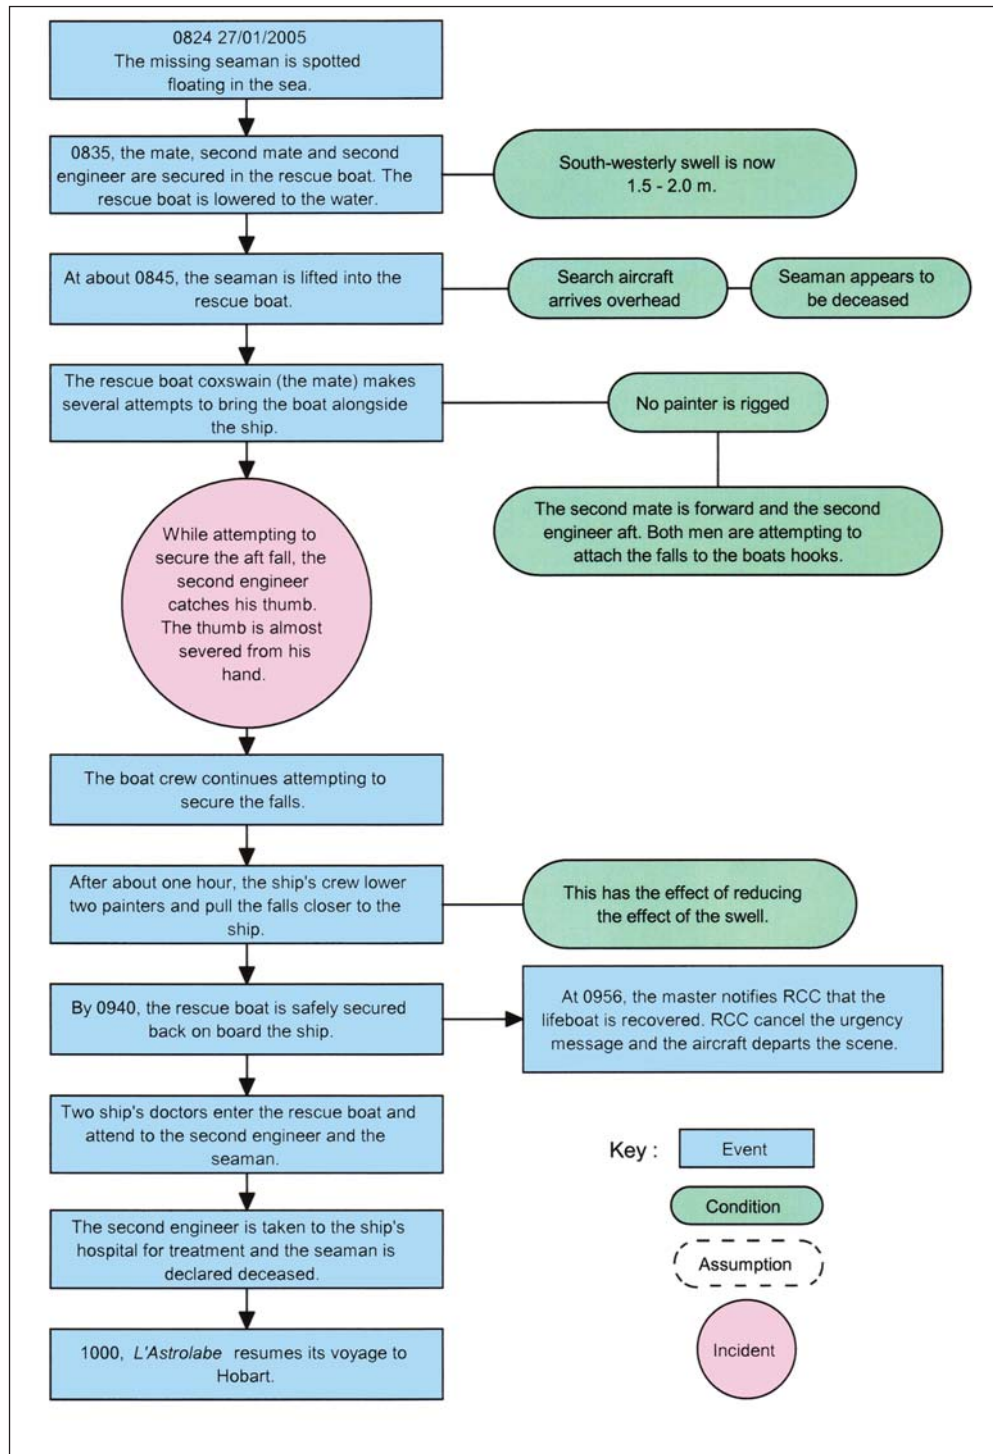
Figure 16: Lifeboat accident events and causal factors chart

- A painter was not left attached to the forward fall block when the lifeboat departed *L'Astrolabe* to recover the deceased crew member.
- The vessel's movement in the seaway made the lifeboat recovery operation difficult, and resulted in damage to the lifeboat and its fittings.

During the recovery operation, the lifeboat suffered a significant amount of damage from both the swinging fall blocks and from contact with the hull of the ship.

Given the area of operation of the vessel, and the inherent risks associated with a crew member safely handling a fall block from a restrictive access hatch, it would have been prudent for the operators of *L'Astrolabe* to have provided the vessel with recovery strops for both lifeboats.
