Aviation Occurrence Report – 200601688

Engine power loss – Bankstown Airport – 5 April 2006

VH-ZNZ

Amateur-built Lancair 360

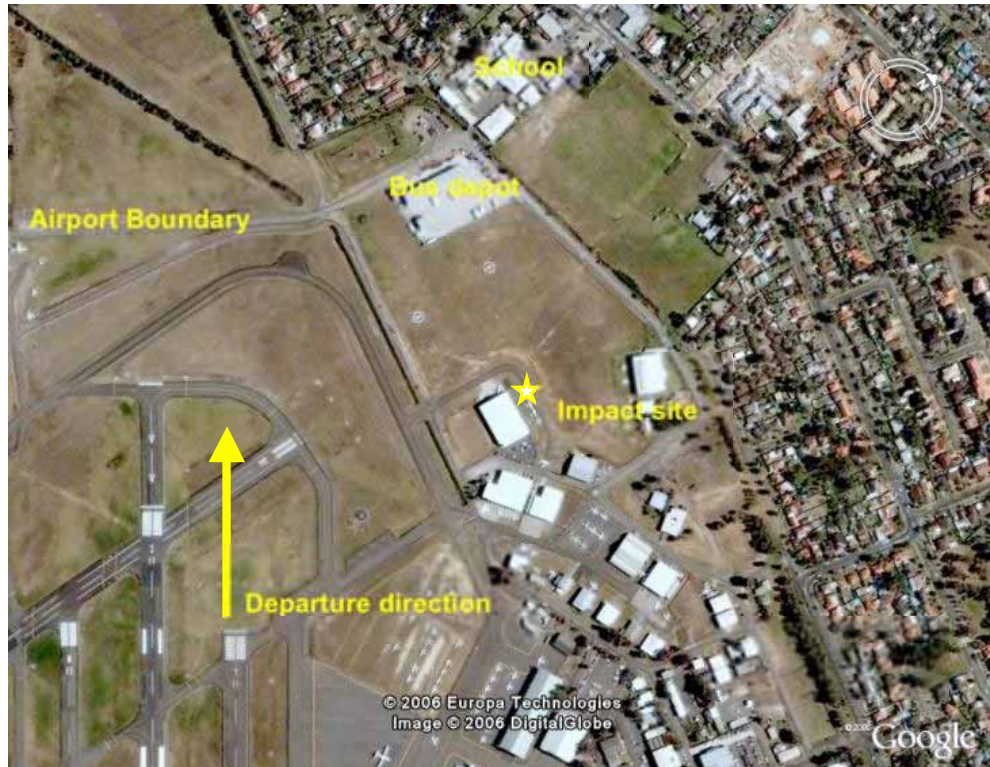
Figure 1: Accident location at Bankstown Airport

At a position corresponding to an early downwind position of a very close circuit and at a height not above 500 ft, the turn was seen to quickly steepen and the aircraft's nose dropped into a steep descent. The majority of witnesses reported that the engine noise ceased at about the same time. When close to the ground, the aircraft's nose was seen to rise and the wings move towards level, but the rapid descent continued and the aircraft heavily impacted a taxiway on the north-western part of the airport (figure 1). The pilot was fatally injured and the aircraft was destroyed.

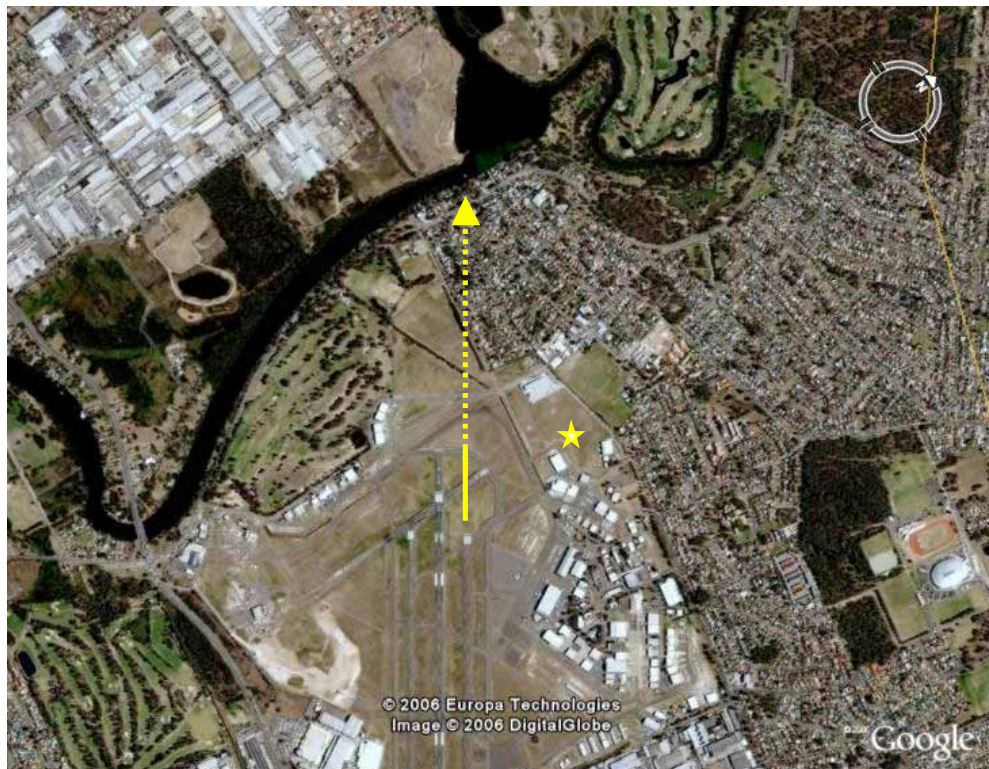
Figure 2: Area to north-west of Bankstown Airport

In figure 2 the extended centreline of runway 29R is depicted as a series of dots and the accident site as a star. Outside the airport boundary, the area adjacent to the extended centre line of runway 29R was generally populated with houses and was bounded by a river. To the left of the extended centreline was a non-populated area and golf course, also bounded by the river.
