ATSB TRANSPORT SAFETY INVESTIGATION REPORT

Aviation Occurrence Report – 200601688

Engine power loss – Bankstown Airport – 5 April 2006

Amateur-built Lancair 360

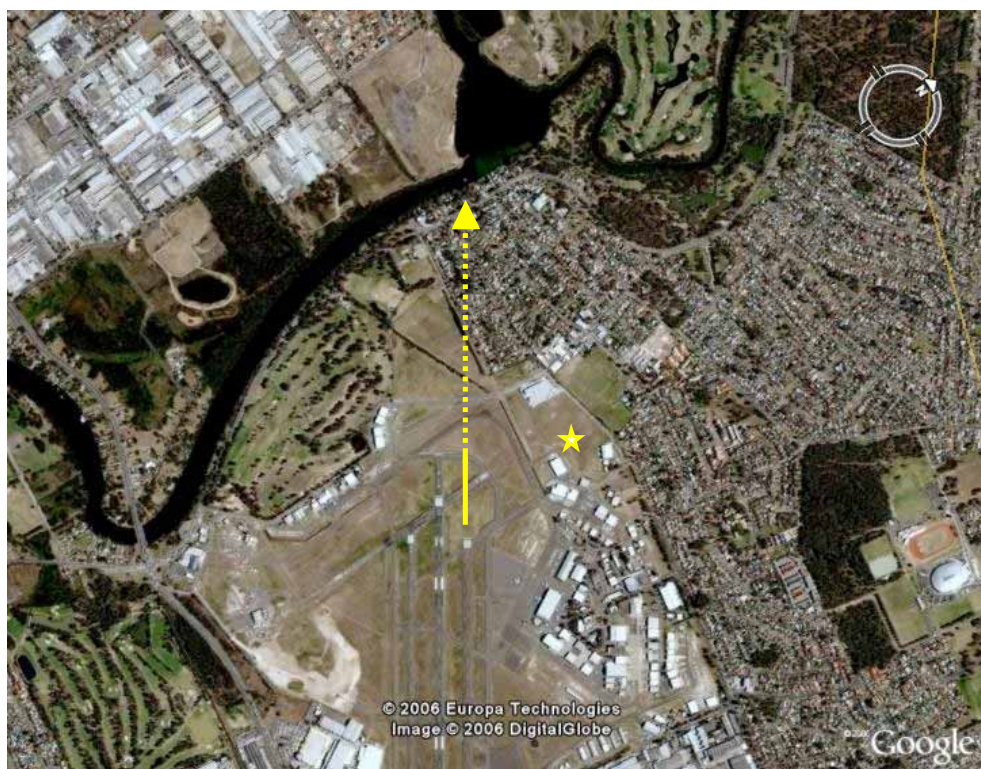
Figure 2: Area to north-west of Bankstown Airport

In figure 2 the extended centreline of runway 29R is depicted as a series of dots and the accident site as a star. Outside the airport boundary, the area adjacent to the extended centre line of runway 29R was generally populated with houses and was bounded by a river. To the left of the extended centreline was a non-populated area and golf course, also bounded by the river.
