ATSB TRANSPORT SAFETY INVESTIGATION REPORT
Marine Occurrence Investigation No. 238
Final

Independent investigation into the boiler explosions
on board the Panamanian registered bulk carrier

Shirane

2 April 2007

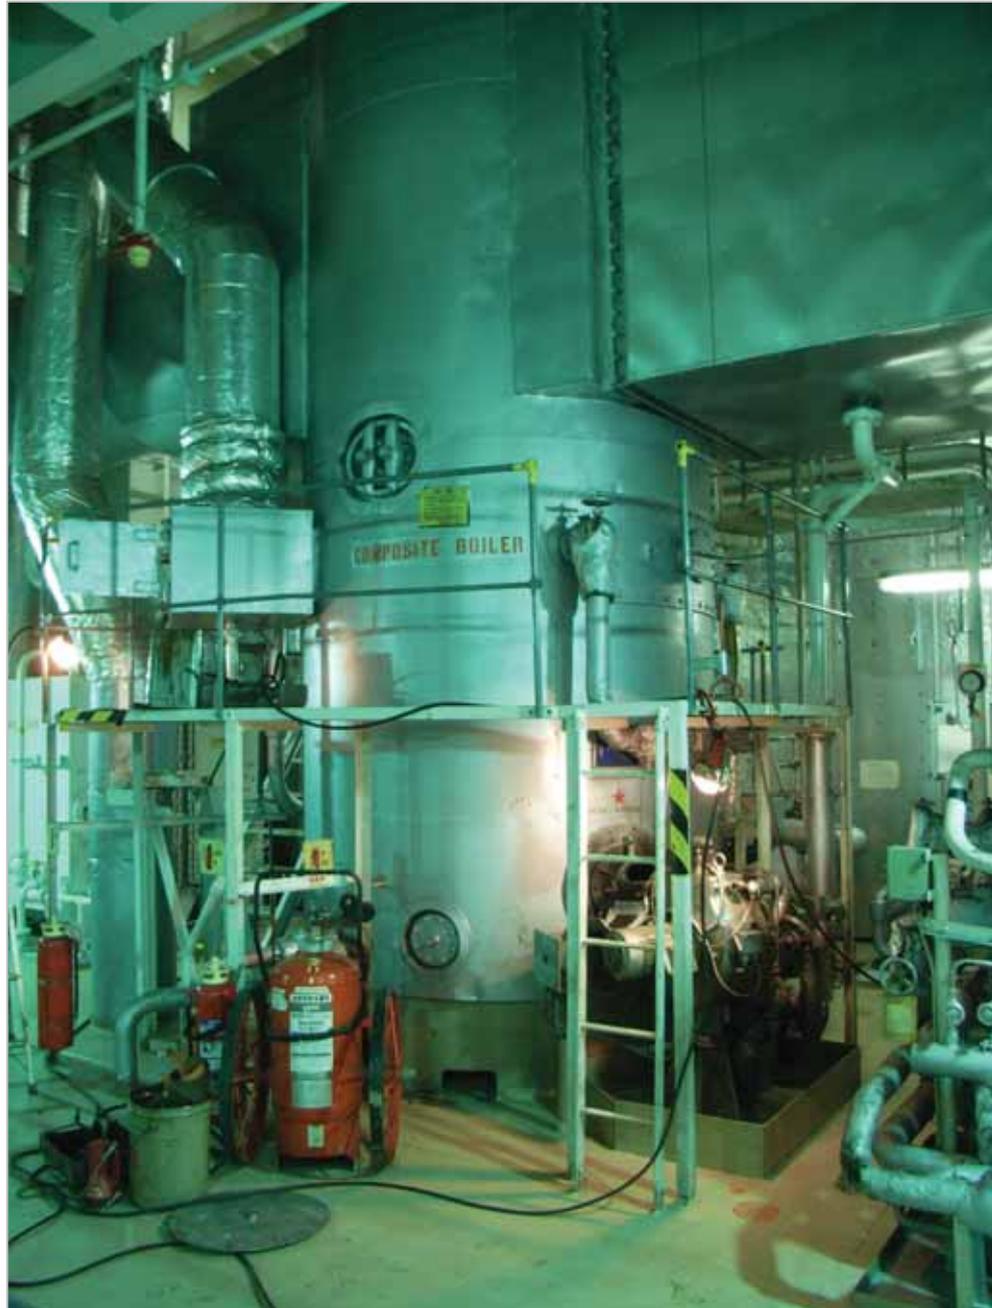
Figure 2: *Shirane's* composite boiler

Shirane is fitted with an Osaka Boiler Mfg Company OEVC2-120/120-20 vertical composite boiler (Figures 2 and 3). The boiler has a working pressure of 6.0 bar³ and uses main engine exhaust gases and/or a packaged oil firing unit to produce steam. Steam is used on board the ship to heat fuel, for treatment before its use in the main and auxiliary engines, and for general heating purposes.

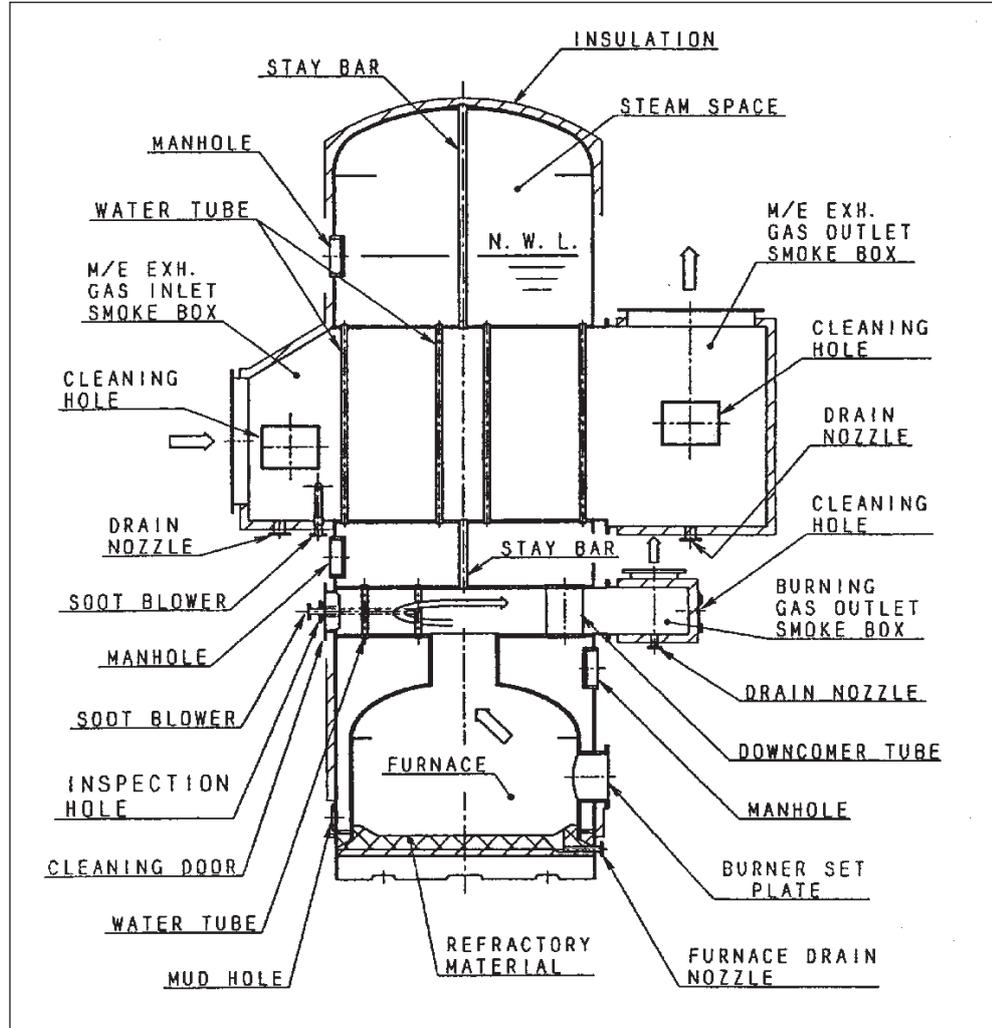
Figure 3: Schematic diagram of boiler

The upper section of the boiler water space houses the economiser part of the boiler (Figure 3). In this section, the main engine exhaust gases are directed over a bank of water tubes. Beneath the economiser section is the smoke box, which has a hot gas inlet from the furnace, another bank of boiler water tubes and an exhaust gas outlet.

The truncated hemispherical steel furnace lies below the smoke box. The furnace chamber has a single oil firing unit opening at one side. When the burner is firing, the flame is directed at the furnace wall opposite the burner opening with the flow of hot gas sweeping the periphery of the cylindrical furnace chamber before rising to the smoke box inlet.

Many auxiliary boiler designs have a water space around the entire furnace that acts to cool the furnace. However, this is not the case with the Osaka OECV2 boiler. While the top part of the furnace is water cooled, the furnace floor is not. Furthermore, the floor is lined with refractory material which cools relatively slowly after the boiler has been firing.

When the oil firing unit was shut down, there was no flow of air through the furnace until the maintenance cover was removed. With the maintenance cover removed, the air flow through the furnace was dependent upon the ambient pressure in the engine room and the natural updraught within the boiler due to the hot uptakes. Consequently, the air flow through the furnace was limited and probably passed directly from the oil firing unit opening to the smoke box inlet, leaving areas adjacent to the furnace walls relatively unswept (Figure 3).

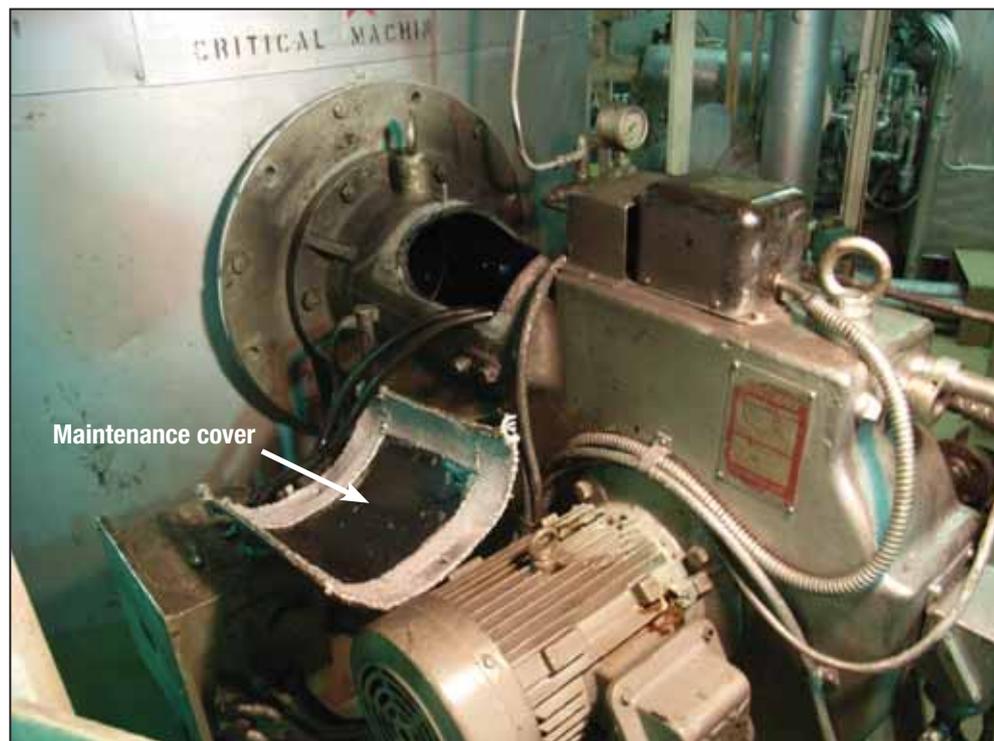
Figure 4: Volcano VJ-140-1 oil firing unit

When the ship's main engine is stopped, or is providing insufficient exhaust gas energy to produce enough steam to meet the demand, the boiler is fired using oil. The oil firing unit, a VJ-140-1, was manufactured by the Volcano Company of Japan (Figure 4). The unit comprises a fully automatic pressure jet oil burner, integrated with a single electric motor driving both the forced draft fan and the fuel oil feed pump. Control of combustion air flow is provided by a single, two-position, damper on the forced draft fan's air inlet housing. The oil firing unit may be fired using either diesel or heavy fuel and has an integrated electric heater for use when firing on heavy fuel. The oil firing unit's controls and monitoring system are located in a cabinet which is mounted on a bulkhead adjacent to the boiler.

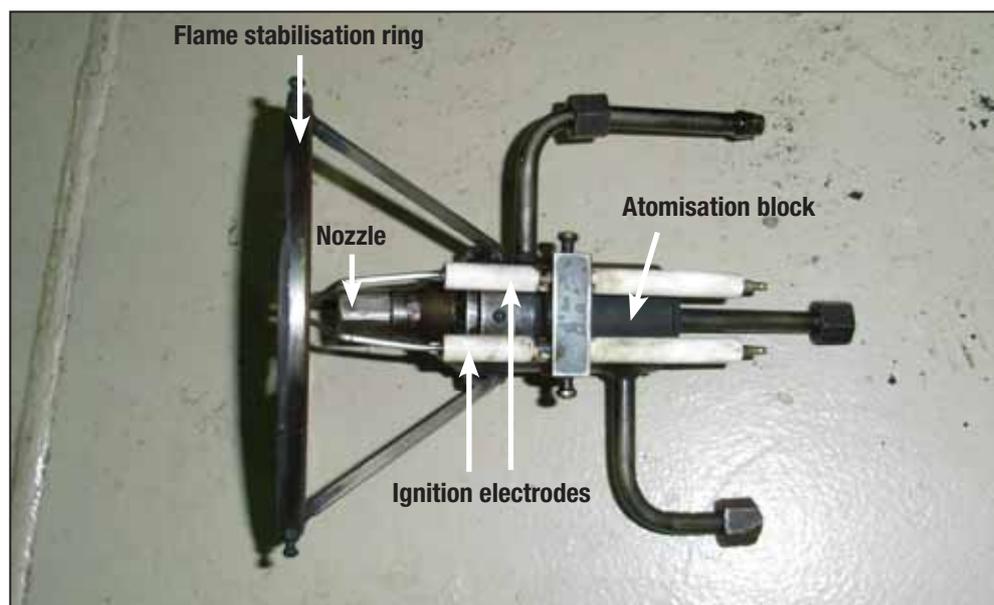
Figure 5: Oil firing unit burner

The burner (Figure 5) is fitted inside the oil firing unit at the boiler furnace opening. The burner consists of an atomiser block, which holds a single fuel nozzle, to which a flame stabilisation ring and a pair of ignition electrodes are attached. The atomiser block has three fuel line connections; one line is led from an electric solenoid valve which supplies the fuel nozzle, and the two other lines allow fuel circulation through the atomiser block. The burner may be removed from the oil firing unit through a maintenance cover at the top of the unit, after the ignition electrode cables and the three fuel pipes have been disconnected.
