**ATSB TRANSPORT SAFETY REPORT**

Aviation Occurrence Investigation AO-2008-070

Interim Factual

**In-flight upset  
154 km west of Learmonth, WA  
7 October 2008  
VH-QPA  
Airbus A330-303**

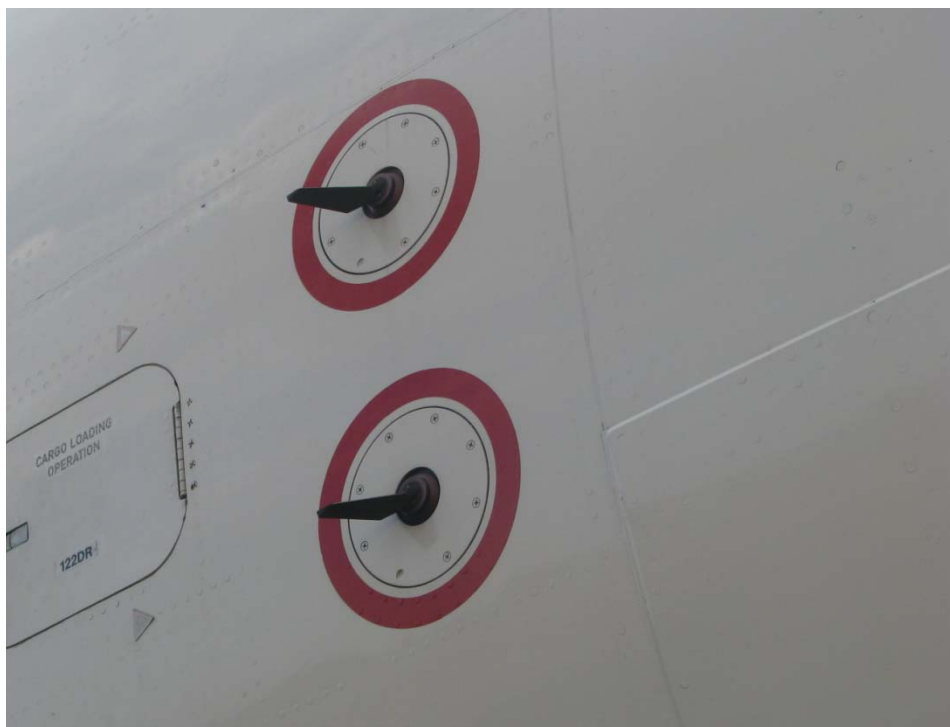
**Figure 8: Right side AOA sensors (AOA 2 and AOA 3)**

Angle of attack<sup>19</sup> (AOA) data was sourced from three AOA sensors (AOA 1, AOA 2, and AOA 3), installed on the forward fuselage. AOA 1 and 2 were installed on the left and right sides of the fuselage respectively. AOA 3 was installed below AOA 2. Figure 8 shows the AOA 2 and AOA 3 sensors of VH-QPA.

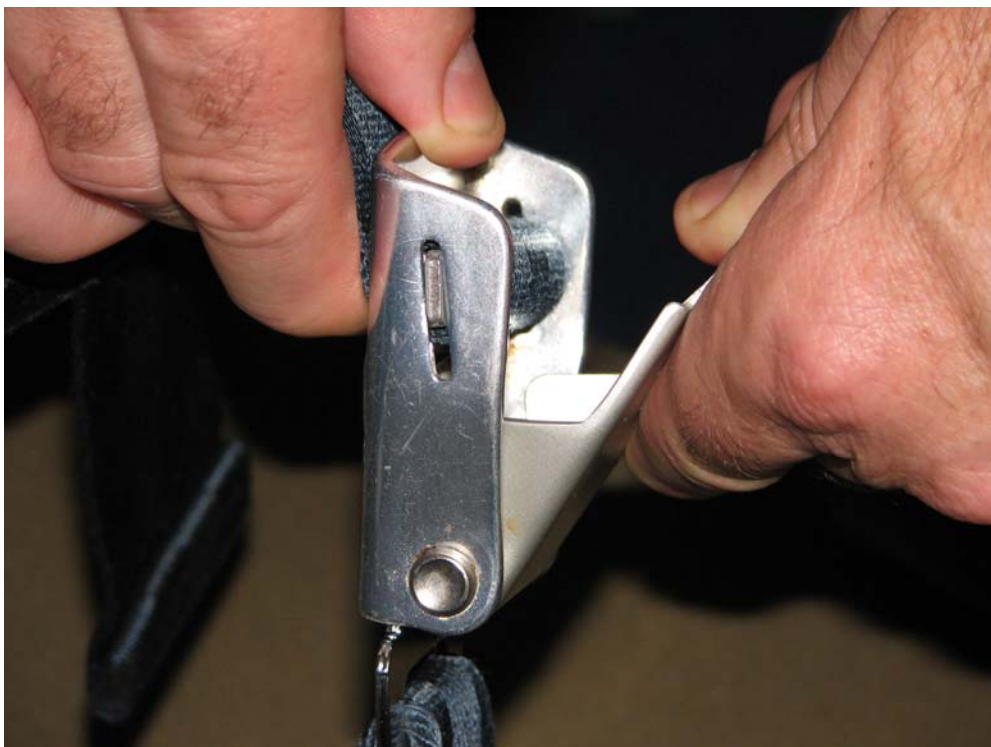
**Figure 12: Seatbelt buckle of type fitted to VH-QPA**

The passenger seatbelts on the aircraft were a common type of lap belt with a lift-latch release mechanism (Figure 12). The buckle was on the passenger’s left side and the tongue on the right side. Passengers could adjust the tightness of the belt by adjusting the distance of the buckle from its anchor point. In general, when the seatbelt was firmly fastened, the buckle was centred across the passenger’s hips.

A sample of 51 seatbelts was examined in detail. The sample included the seatbelts of the four passengers who reported that they were wearing their seatbelts, but the seatbelts did not restrain them to their seats. It also included other passengers who attended hospital and it was not known whether or not they were wearing seatbelts at the time of the occurrence. No problems were identified with the condition of the webbing, buckle or tongue of any of those seatbelts.

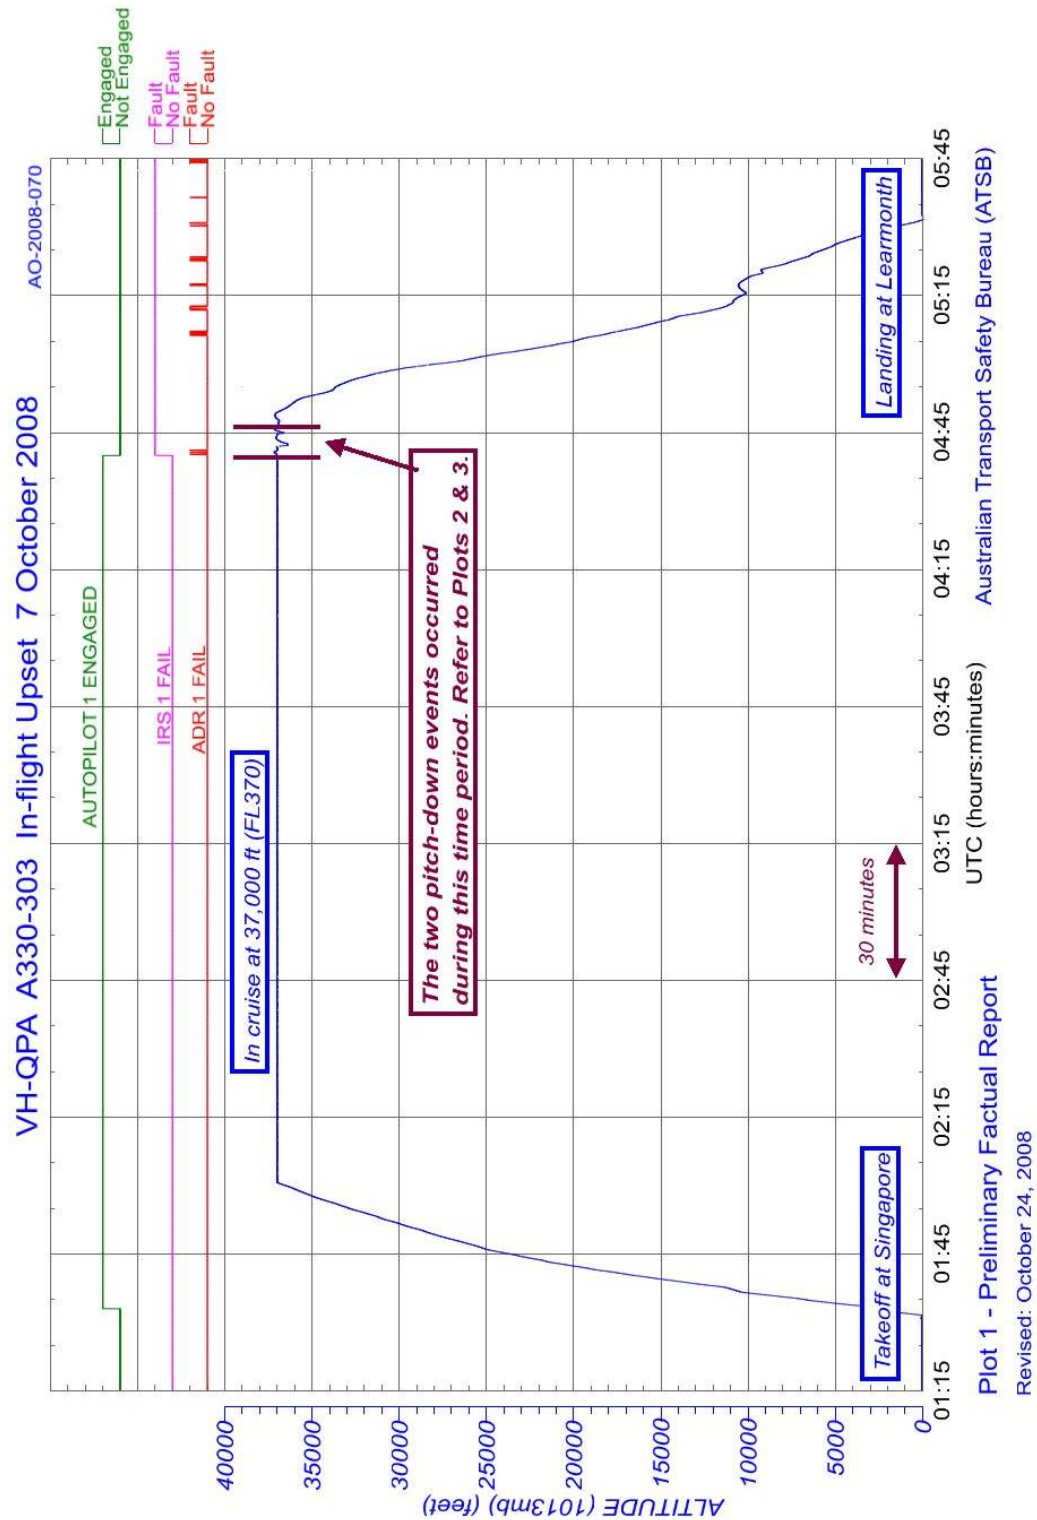
Figure B1: Data plot for complete flight duration

04:40:29	-00:01:56	First master caution was recorded. Cautions occurred during the remainder of the flight.
04:40:31	-00:01:54	IR 1 Fail indication commenced (duration: remainder of the flight)

04:40:41	-00:01:44	First ADR 1 Fail indication (duration: less than 4 seconds)
04:40:50	-00:01:35	First stall warning (duration: less than one second)
04:40:54	-00:01:31	First overspeed warning (duration: less than one second)

At 0440:28 UTC (1240:28 local time), autopilot 1 disconnected involuntarily<sup>22</sup> and the inertial reference system (IR) function of ADIRU 1 began to indicate 'Fail' (04:40:31). The IR 1 Fail indication continuously indicated 'Fail' until after landing at Learmonth.

The first ADR 1 'Fail' indication began at 0440:41 UTC. This indication lasted for less than 4 seconds. Unlike the IR Fail indication, the ADR Fail indication did not continuously indicate 'Fail'. In total, 20 ADR 1 'Fail' indications were recorded before the aircraft touched down at Learmonth. As the ADR 1 'Fail' parameter was sampled once every 4 seconds, a brief ADR 1 fail indication may not necessarily be sampled and recorded. As a result, the number of actual ADR 1 'Fail' indications may have been larger than the number recorded by the FDR.
