INVESTIGATION REPORT  
9701421

Bell Helicopter VH-CKP  
Tartrus Station, Qld  
2 May 1997

INVESTIGATION REPORT

9701421

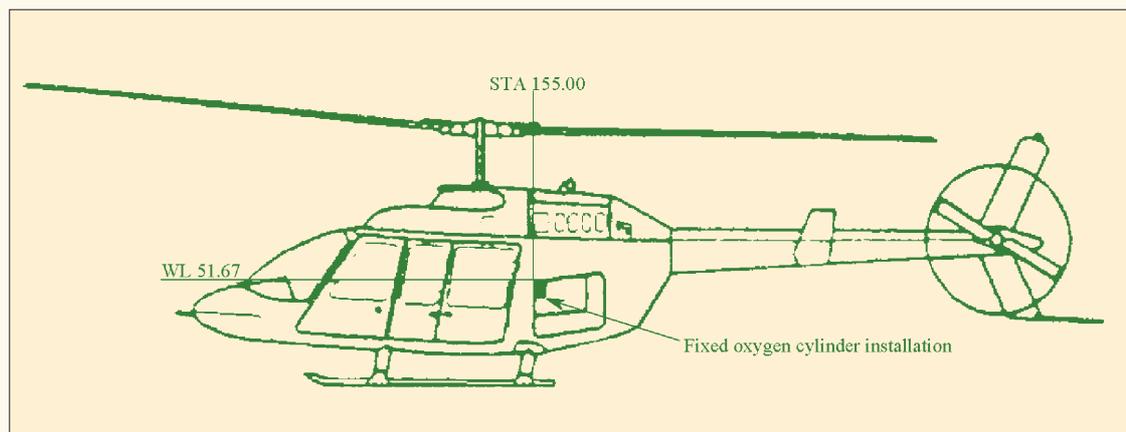
The fixed oxygen system cylinder and regulator were fitted in the rear baggage compartment as shown in fig. 3. This system, as far as could be ascertained, consisted of a single high-pressure (2,700 lb/in<sup>2</sup>) aluminium alloy cylinder fitted with a Comweld Group Medical Products Series-O regulator directly into the cylinder valve. Fitted to this regulator were an exit fitting and a pressure relief valve (both on the low-pressure side of the regulator) and a flexible hose (at cylinder pressure). The flexible hose was attached by three in-line fittings. From the regulator to the hose: a brass 1/4-in BSP male to 3/8-in BSP female adaptor (gauge port outlet fitting), a 3/8-in BSP male-to-male adaptor and a fabricated stainless steel 90° elbow (the exit end of the elbow fitting comprised part of the end of the flexible hose). The fittings had internal diameters of about 7.8 mm, 11.1 mm and 7.1 mm respectively. The flexible hose led from the regulator to a cabin mounted cylinder-pressure gauge. This hose was reported to have been about 1.5 m long. A schematic of the regulator, showing cross-sections taken at 90° is shown, along with the attached fittings, in fig. 4. It will be noted from this diagram that the body of the regulator and the inlet fitting (bull-nose connector) are manufactured from a 'free machining' brass (either UNS37700 or UNS38500) with a lead content of between 1.5% and 3.8% (depending on the alloy).

**Figure 3:** Schematic of the fixed oxygen cylinder position in the helicopter.

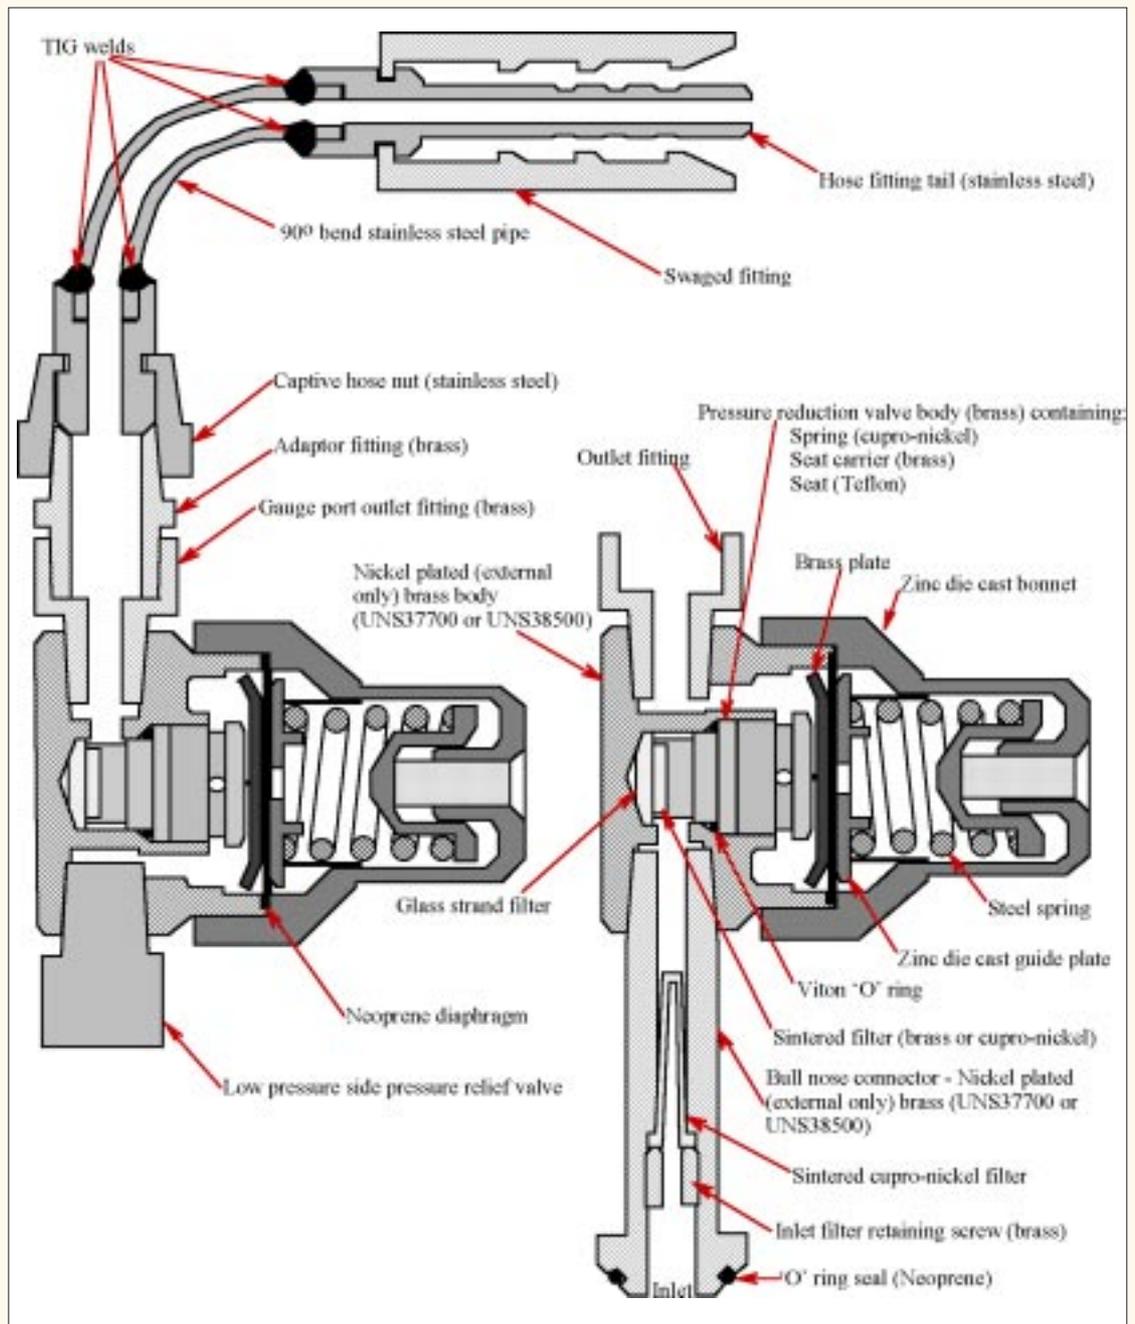
**Figure 4:** A schematic diagram of the fixed oxygen system regulator and the attached fittings. Note that the threads are not represented, and that the details of the relief valve and the pressure reduction valve are not shown. These two views are orientated 90° to one another.

The regulator was found still attached to the cylinder valve, as shown in fig. 7. The bonnet (containing regulating pressure control spring) had melted (probably between 380°C and 420°C, the melting range for common zinc die cast alloys). All polymeric parts had burnt. A schematic of the regulator construction is shown in fig. 4.
