**ATSB TRANSPORT SAFETY REPORT**  
Aviation Occurrence Investigation  
AO-2008-064  
Final

**Stickshaker activation**  
**Boeing 717-200, VH-NXE**  
**Alice Springs, NT**  
**18 September 2008**

Stickshaker activation – Boeing 717-200, VH-NXE, Alice Springs, NT, 18 September 2008

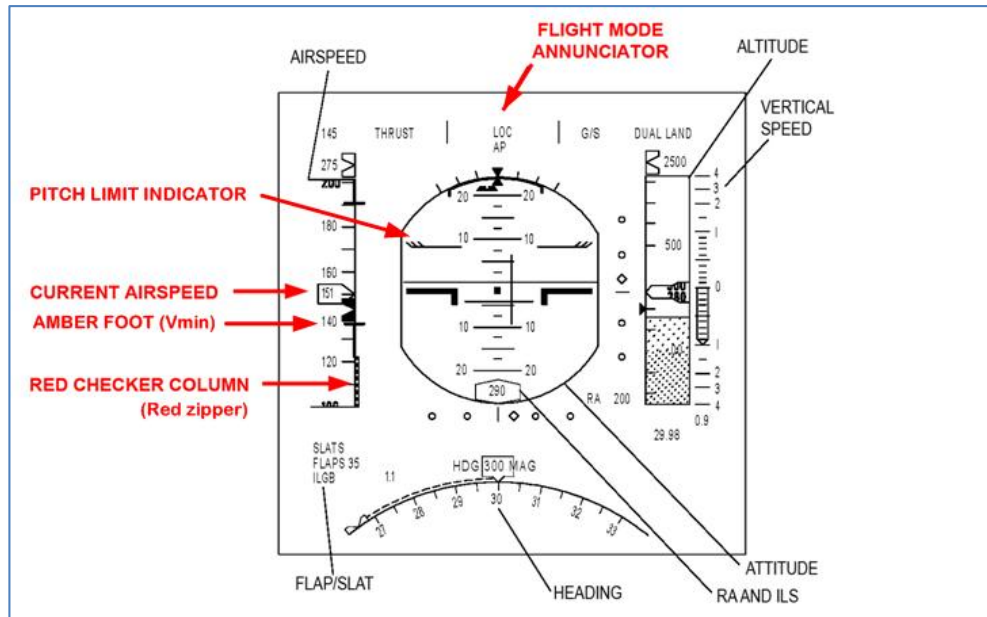
**Figure 3: Primary flight display**

During an approach, the pitch limit indicator (PLI) on each pilot's PFD indicated the difference between the aircraft's angle of attack<sup>15</sup> and the stickshaker angle of attack. The PLI, which was normally cyan in colour, turned amber as the aircraft approached the stickshaker angle of attack and red at the stickshaker angle of attack. The PLI was for information only and was not to be used for guidance command.

Both PFDs displayed the red checker column that moved vertically on the airspeed tape, graphically displaying the margin between the stickshaker activation speed and the current airspeed. The margin between the aircraft's current airspeed and the stickshaker speed was dynamic and displayed throughout the flight and while manoeuvring to land. In addition, the current airspeed indication, shown at the centre of the airspeed tape, would turn amber when the airspeed was below the minimum operating speed (Vmin) and red when the stickshaker activated.
