ATSB TRANSPORT SAFETY REPORT

AVIATION OCCURRENCE INVESTIGATION AO-2009-026

Fuel starvation event, VH-JTI

Coomera, Queensland

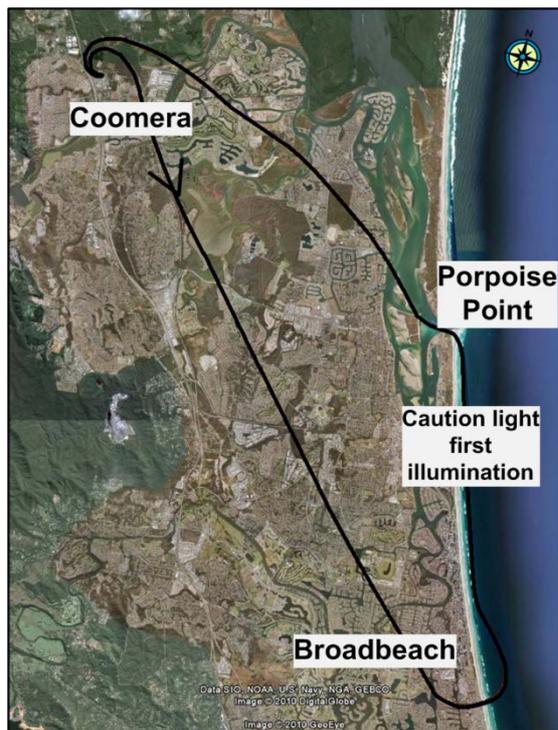
Figure 1: Flight route

The accident flight route was initially south-east from Coomera to Broadbeach, then north along the coast to Porpoise Point, before returning in a north-westerly direction to Coomera (Figure 1).
