# Wheels-up landing involving a Cessna 210, VH-JGA

Cairns Airport, Queensland on 11 November 2014

**ATSB Transport Safety Report**  
Aviation Occurrence Investigation  
AO-2014-178  
Final – 10 June 2015

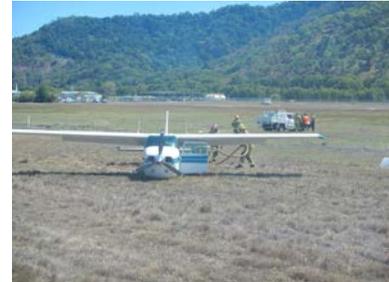
VH-JGA

The pilot of JGA conducted two practice approaches to assess the aircraft configuration and landing area before beginning the approach for a wheels-up landing. The pilot extended the flaps to help slow the aircraft and, after turning onto a long final, briefed the passengers for the landing and instructed them to take up the brace position. Just prior to touchdown, the pilot turned off the master switch and moved the engine mixture control to the cut-off position. At about 1416, the aircraft landed on the fuselage underside on the grass area abeam runway 33 and came to a stop. The pilot and four passengers were uninjured and the aircraft was substantially damaged (Figure 1).

**Figure 1: Damage to JGA**
